Re: 222066
5 North Main Street – Redding, Connecticut
Building Envelope Assessment

On 16 June 2022, Hoffmann Architects submitted a proposal to the BeFoundation for a Building Envelope Condition Assessment at the former Georgetown Bible Church located at 5 North Main Street in Redding, Connecticut. The BeFoundation is in the process of acquiring the historic church and there is a concern regarding water infiltration at the building. On 19 June 2022, the BeFoundation retained Hoffmann Architects to perform the assessment. On Friday 23 June 2022, Mr. Steven J. Susca, P.E. Senior Engineer for Hoffmann Architects, visited the site to begin the assessment.

Built in 1901, the former Georgetown Bible Church is a two-story masonry structure constructed of locally quarried granite block with a slate roof that is reportedly original to the building. The building is part of the larger Georgetown Historic District and is on the National Register of Historic Places.

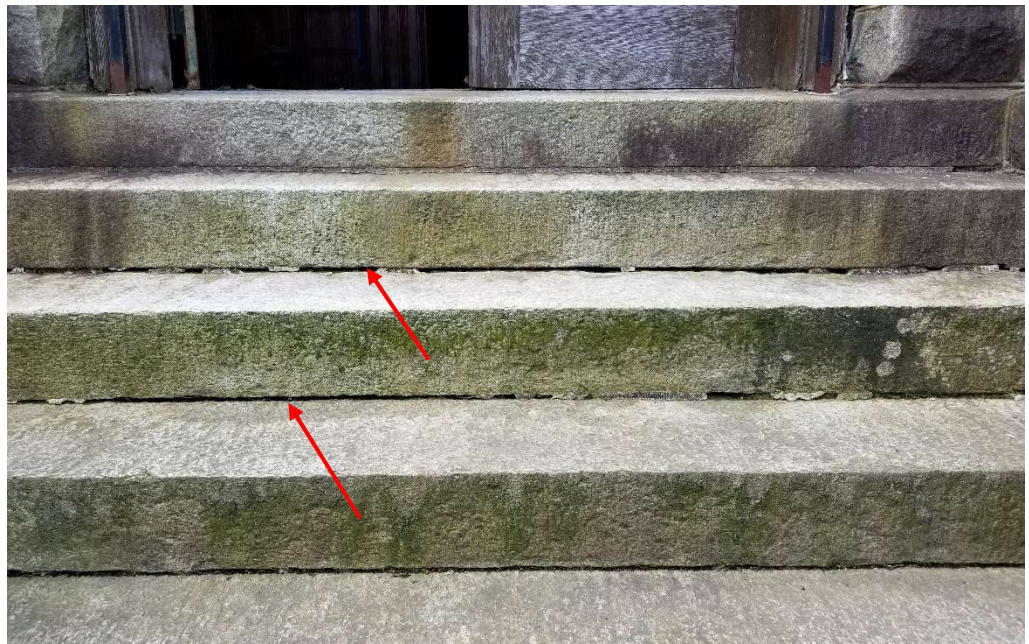
The main entrance to the church is located at the north side of the building. Stone steps bracketed by stone parapets on each side provide entry to the narthex. Considerable mortar joint erosion is present at both the stairs as well as the parapets (Photos 2 and 3). The main door is showing signs of water damage and rot at the base (Photo 4).

Photo 2: Mortar erosion at stairs.

- Perform selective repointing of the mortar joints in the exterior stone masonry.
- Restore wood entry doors.
- Apply waterproofing to the foundation walls. This work will include excavation around the perimeter of the foundation and filling voids in the rubble foundation wall prior to application of the waterproofing. Installation of insulation to the exterior or the foundation below grade should also be performed.

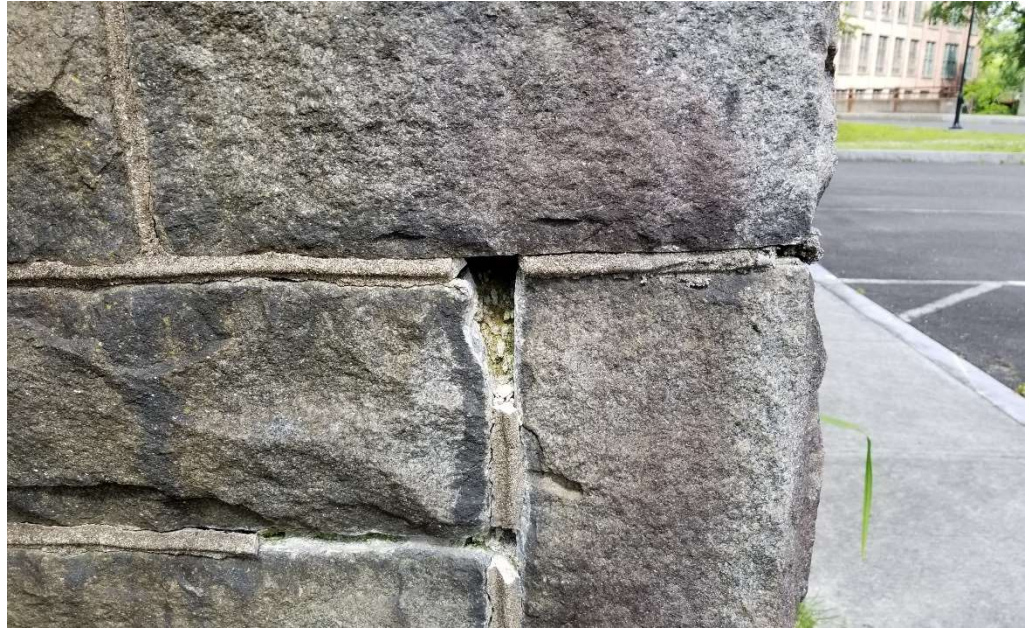
Photo 3: Mortar erosion at parapets.

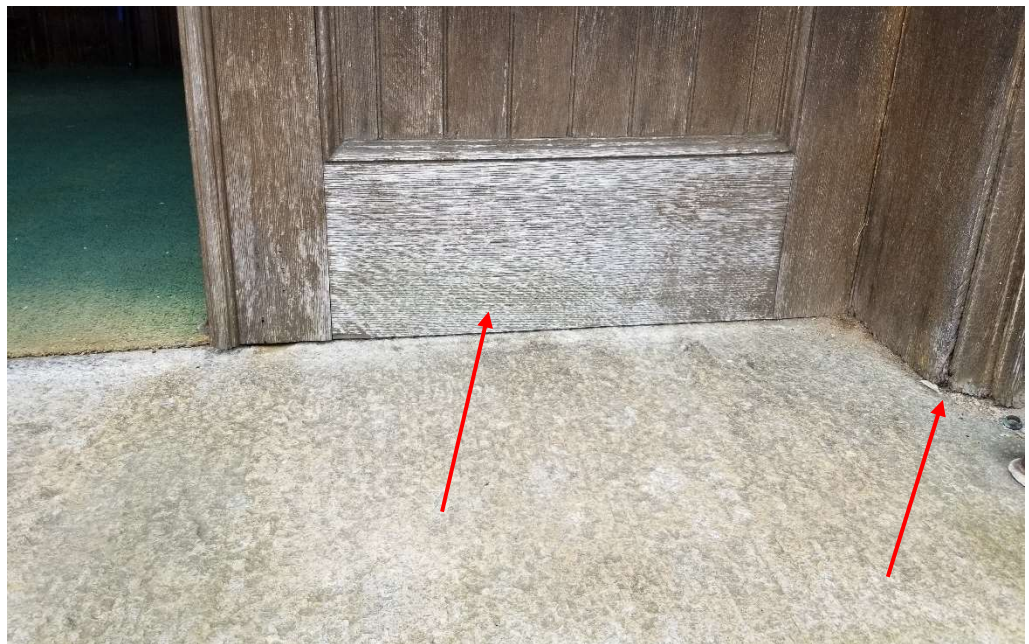
Photo 4: Water damage and rot at the base of wood door.

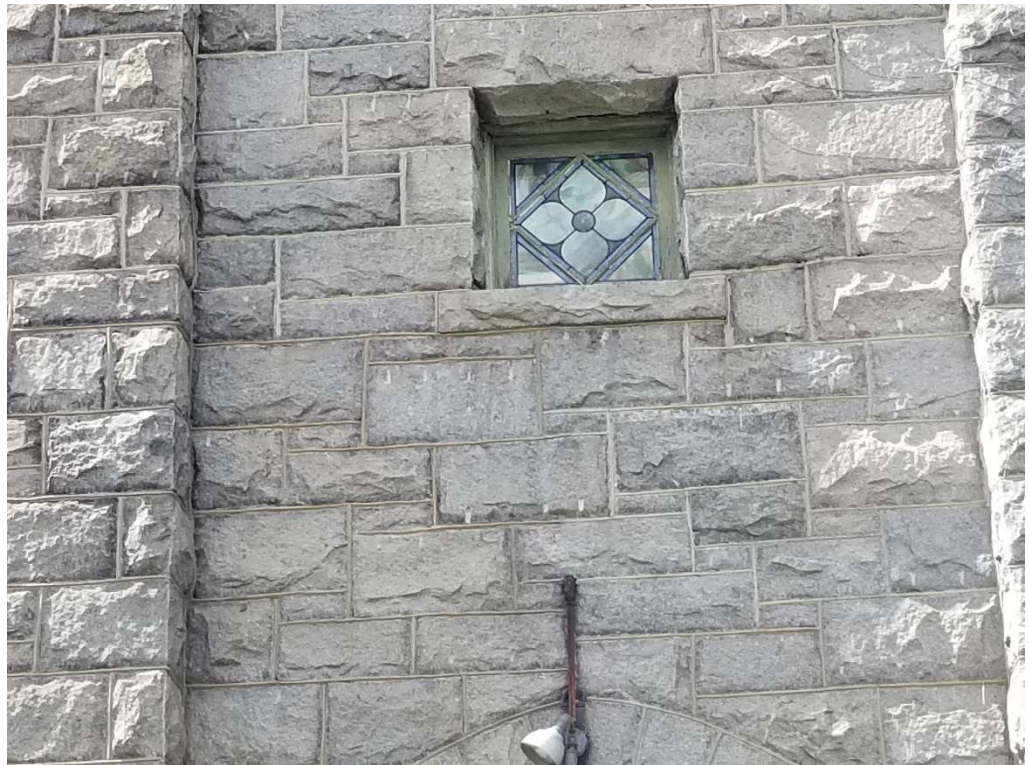
The walls of the church are comprised of large granite blocks that were obtained from a local quarry. The blocks are laid up in a random ashlar pattern with beaded mortar joints between stones (Photo 5).

Photo 5: Exterior stone masonry in random ashlar pattern with beaded mortar joints.

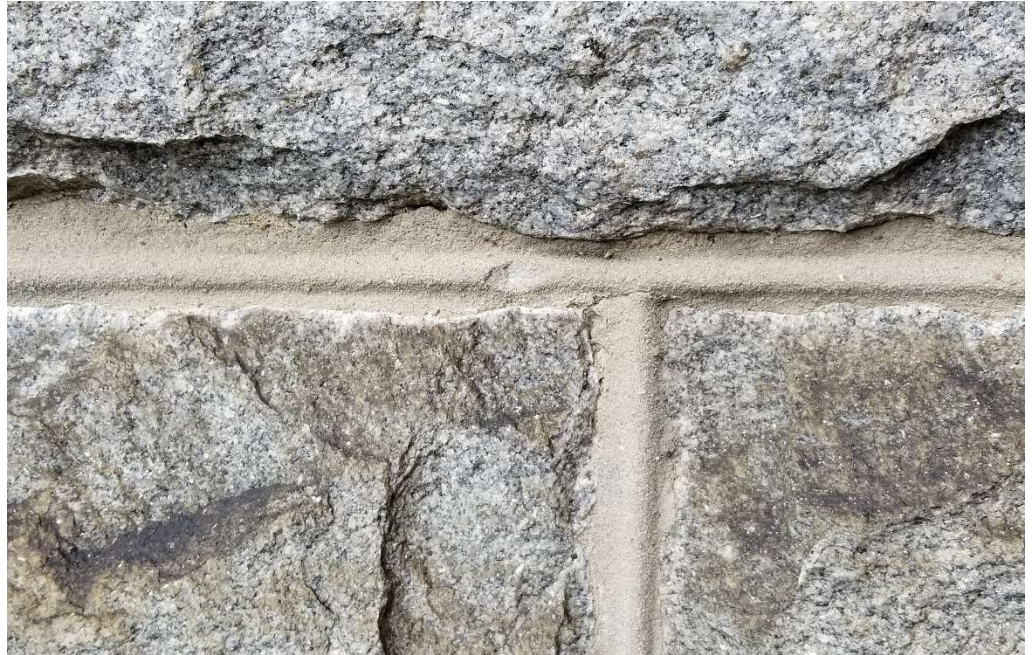
Mortar joints in the block walls are characterized by a raised bead on a flush mortar joint. In general, mortar joints in the exterior walls are in fair to good condition (Photo 6), although in many areas a crack or void between the mortar and stone was observed (Photo 7). Additionally, eroded mortar joints were observed, most typically at shaded areas (Photo 8).

Photo 6: Beaded mortar joints in good condition.

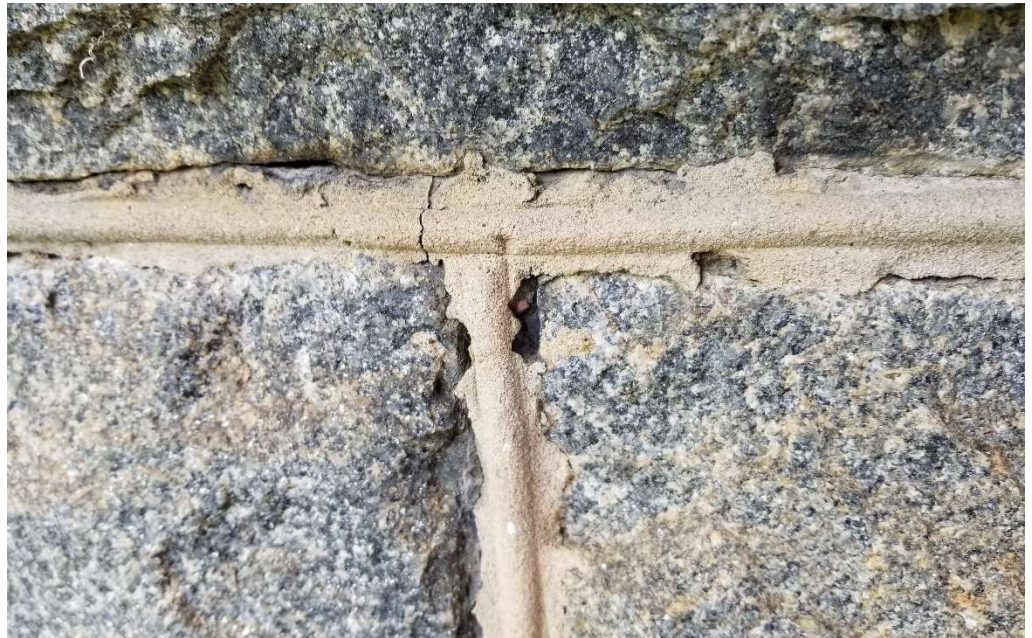
Photo 7: Mortar joints with cracks and voids.

Mortar joint erosion generally results from the gradual dissolution of cement paste from mortar due to the recurrent wetting of the joint. In northern climates this effect is greatly increased by freeze-thaw action during the colder seasons. The erosion has

resulted in many voids where water can enter the wall. From there it can continue to erode the mortar joints at the interior of the wall and eventually result in water infiltration. Left unaddressed, this mortar erosion can result in weakening of the walls, although we saw no evidence of this yet occurring during this investigation.

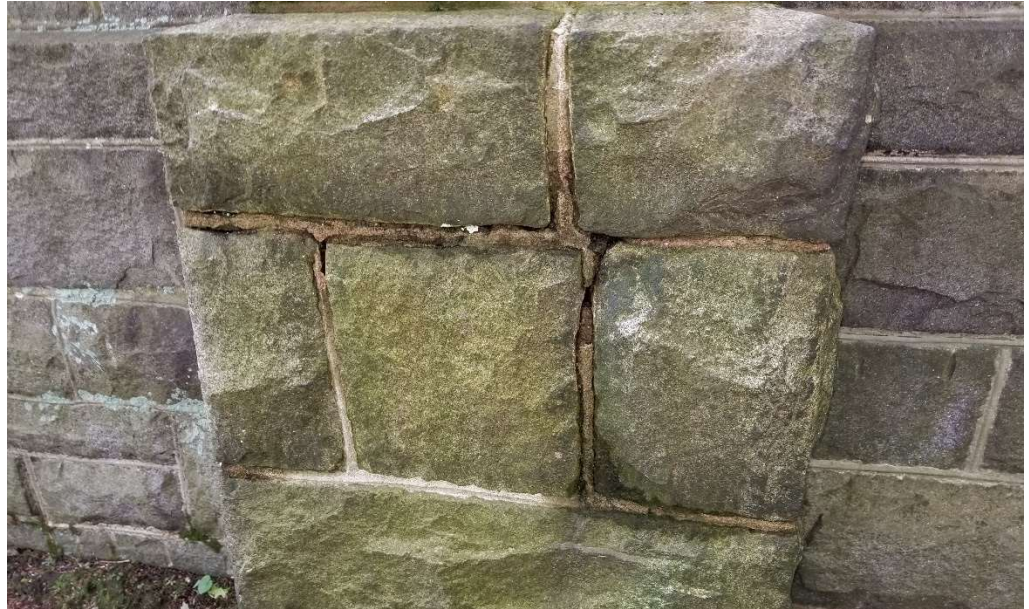
Photo 8: Eroded mortar joints.

The stone masonry is generally in fair condition with the exception of several areas where mortar joint damage and deterioration is occurring. These locations primarily occur in shaded areas that do not dry out as quickly as those areas exposed to sunlight.

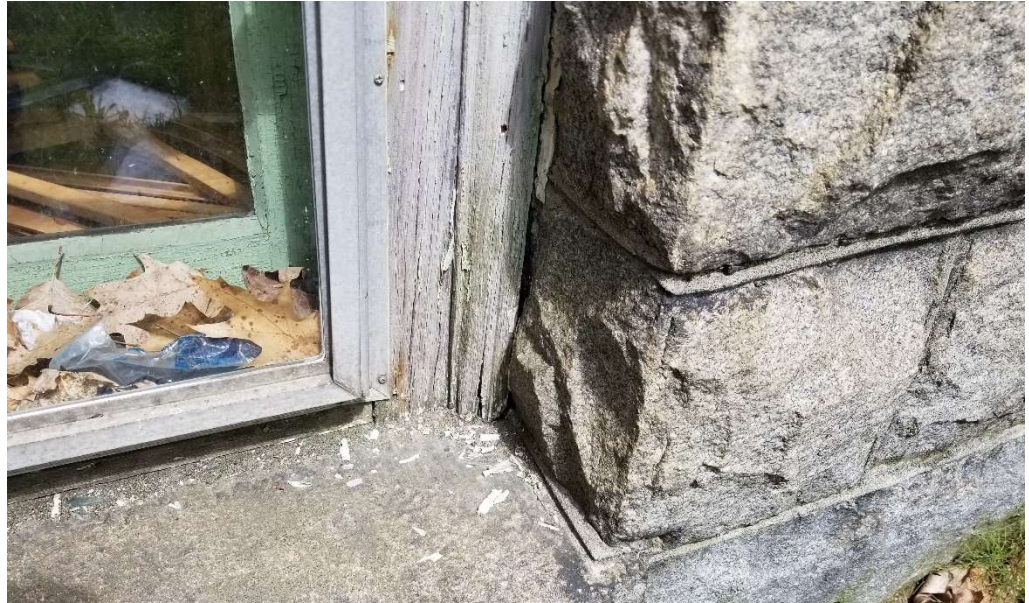
Wood windows are set into punched openings in the exterior stone masonry walls. It is unknown if the windows are original to the building or if they have been replaced at some time in the past. The operable windows on the main floor are double hung with wood sashes. The double hung windows on the main floor are exhibiting signs of deterioration. Peeling paint and the beginning of dry rot is evident in the frames and sashes (Photo 9).

Photo 9: Peeling paint and the beginnings of dry rot in wood window.

Wood windows are poorly maintained and are exhibiting signs of deterioration in the form of peeling paint and the beginning of wood rot.

Wood rot is a consequence of excess or trapped moisture. As it becomes wet, the grain of the wood is raised, thereby allowing moisture to penetrate further into the wood where it cannot evaporate as quickly. The trapped moisture creates an environment conducive to the growth of various forms of fungi. This fungi is the primary cause of wood rot. Therefore, the key to preventing wood rot is to control the amount of moisture that reaches the wood. Generally, if moisture content in the wood is below 20 percent, rot typically isn't a concern. This threshold can be achieved by redirecting moisture away from wood surfaces, providing a method to ensure any wet wood will dry out quickly, and applying a protective coating such as paint to the surface. The paint must be maintained however. Naturally, areas of peeling paint will expose unprotected wood to moisture and fungal growth will begin. Many of the windows and doors in the building are now at the point where the rot has begun. Eventually the wood and, by extension, the windows become unsalvageable. For this reason, it is important to ensure that wood windows are regularly maintained.

- Restore ancillary stained-glass windows around the church.
- Repair or replace double hung and casement windows at the basement, including sealant replacement around window openings,

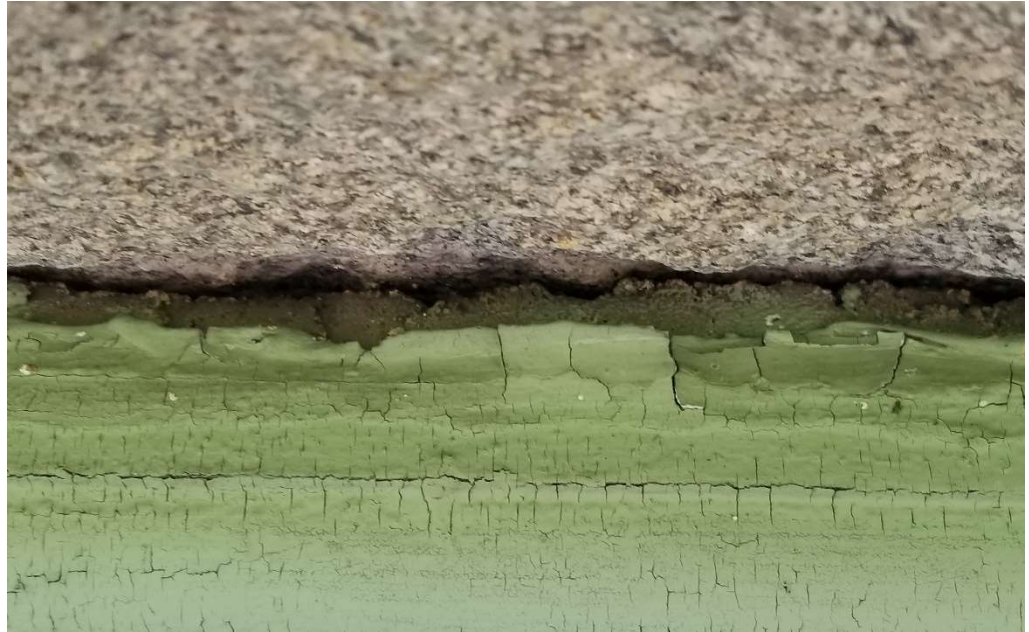
Glazing sealant is dry and cracked as is sealant between the window frames and stone masonry (Photo 10). Similar conditions were found at the casement windows at the partially below grade basement (Photo 11). Many of the double hung windows have had storm windows added at some time in the past. Many of these storm windows are broken (Photo 12).

Photo 10: Dried and cracked sealant at perimeter of window.

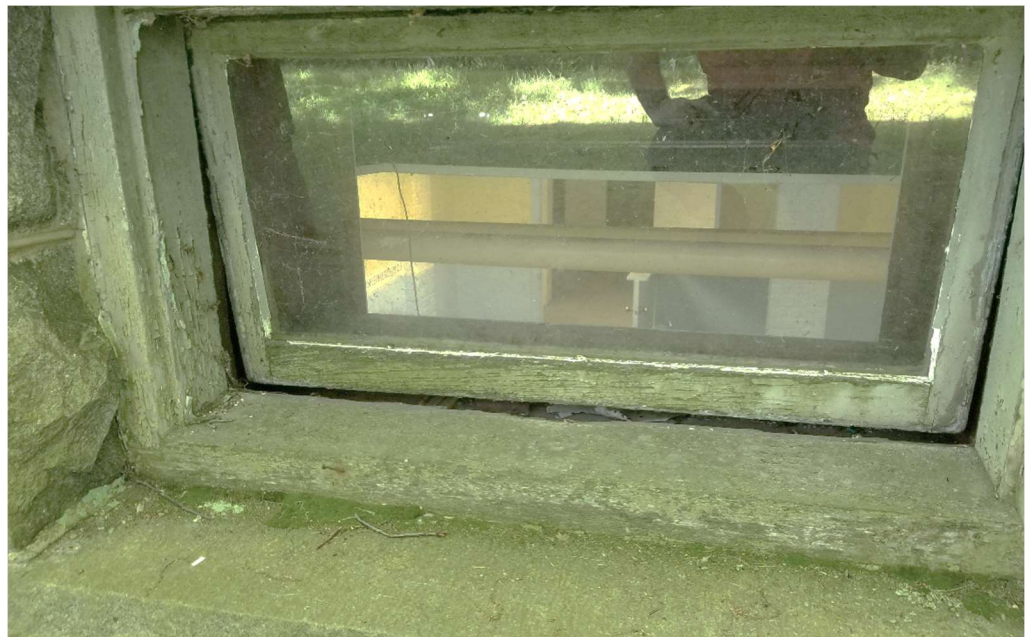
Photo 11: Peeling paint and beginnings of rot in basement window.

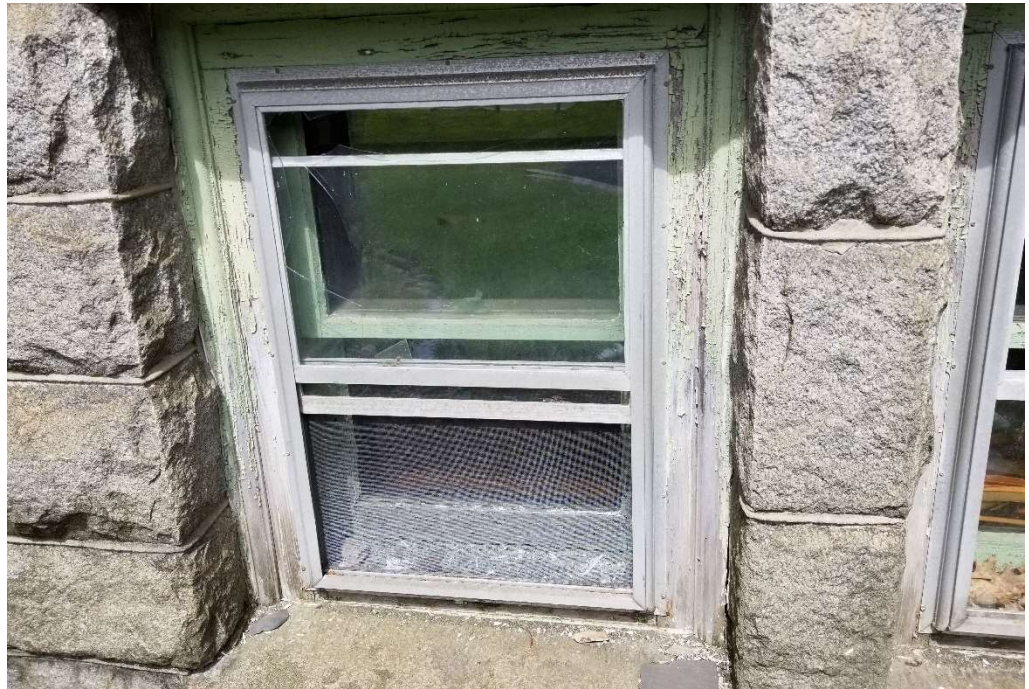
Photo 12: Peeling paint on window frame and broken storm window.

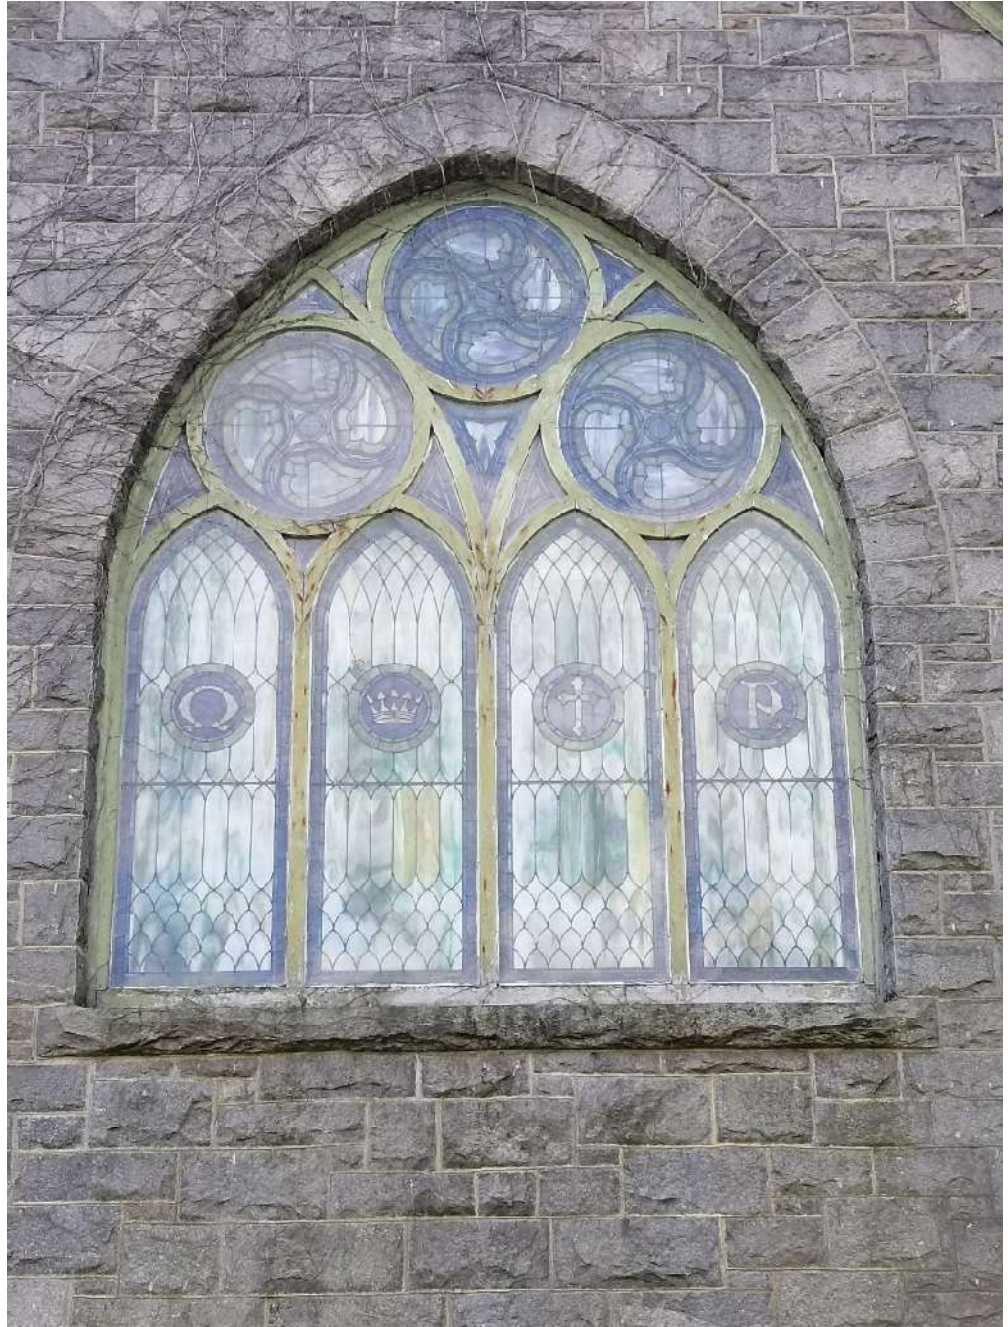
A large stained-glass window is set into the gabled end at the north side of the church (Photo 13). Similar to the wood windows around the basement and main floors, peeling paint and the beginning of rot are present in the window. Rust staining and separation of the wood at the joints was also observed (Photo 14). Glazing sealant is dried and cracked in most areas (Photo 15).

Photo 13: Stained glass window at north gable.

The large stained-glass window at the north gable of the church is in poor condition with the beginnings of rot in the wood along with failed glazing sealant. These defects no longer allow the glass to expand and contract while maintaining a weathertight seal. This allows more moisture into the wood which in turn will cause the deterioration to accelerate.

- Restore the large stained-glass window at the north gable.
 - This will include repairing, prepping and painting wood muntins, and replacement of glazing sealant.

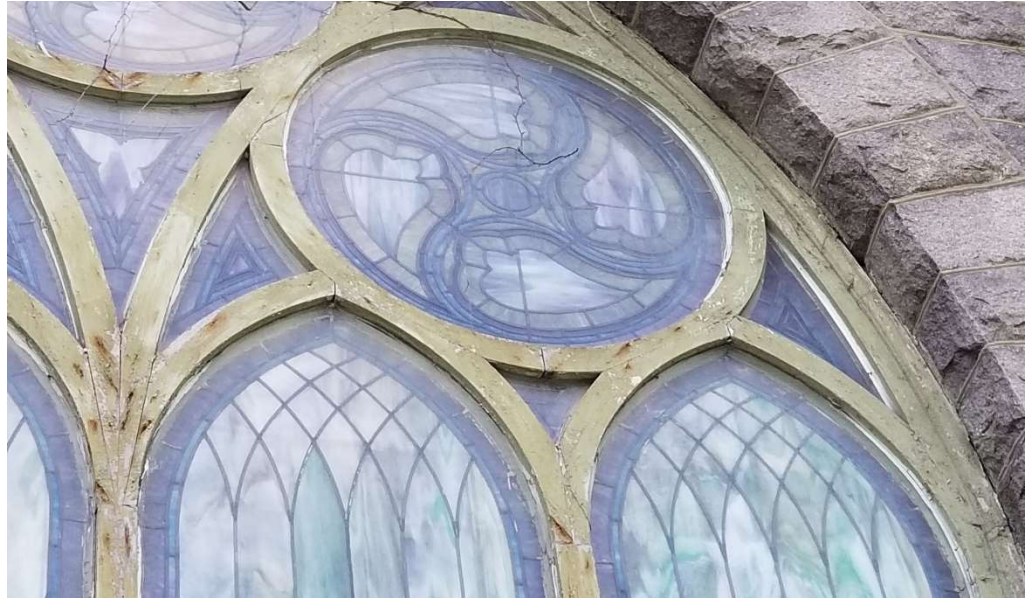
Photo 14: Rust stains, peeling paint and the beginning of wood rot in window.

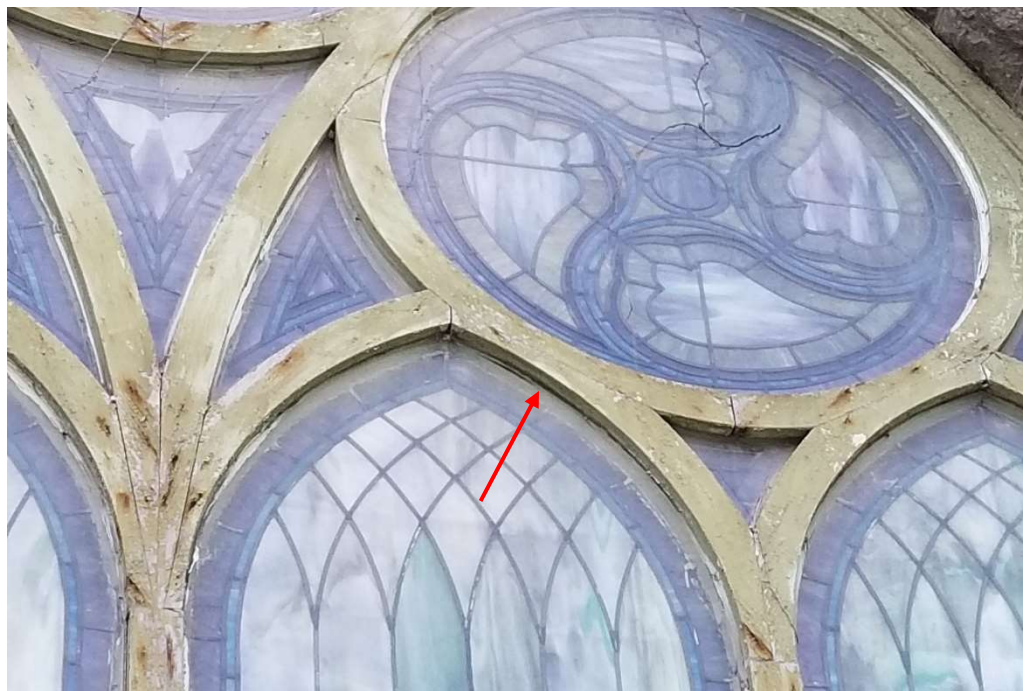
Photo 15: Dried and cracked glazing sealant.

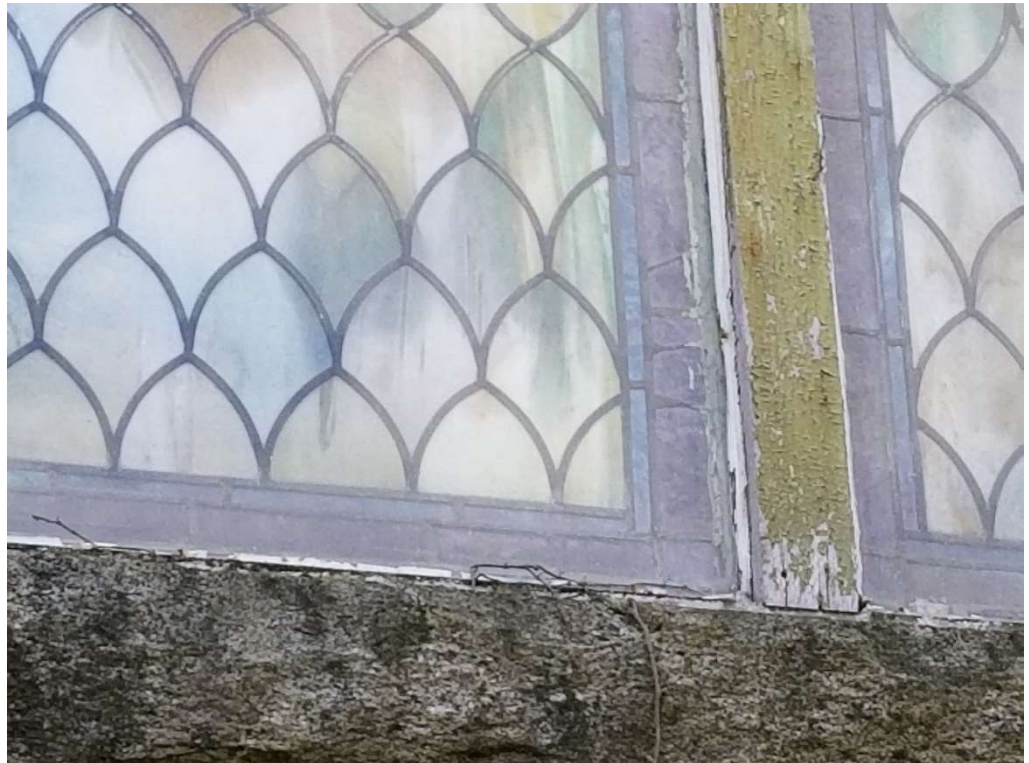
Stained glass windows around the church are in similar condition. (Photo 16)

Photo 16: Stained glass window showing peeling paint, wood rot and failed glazing sealant.

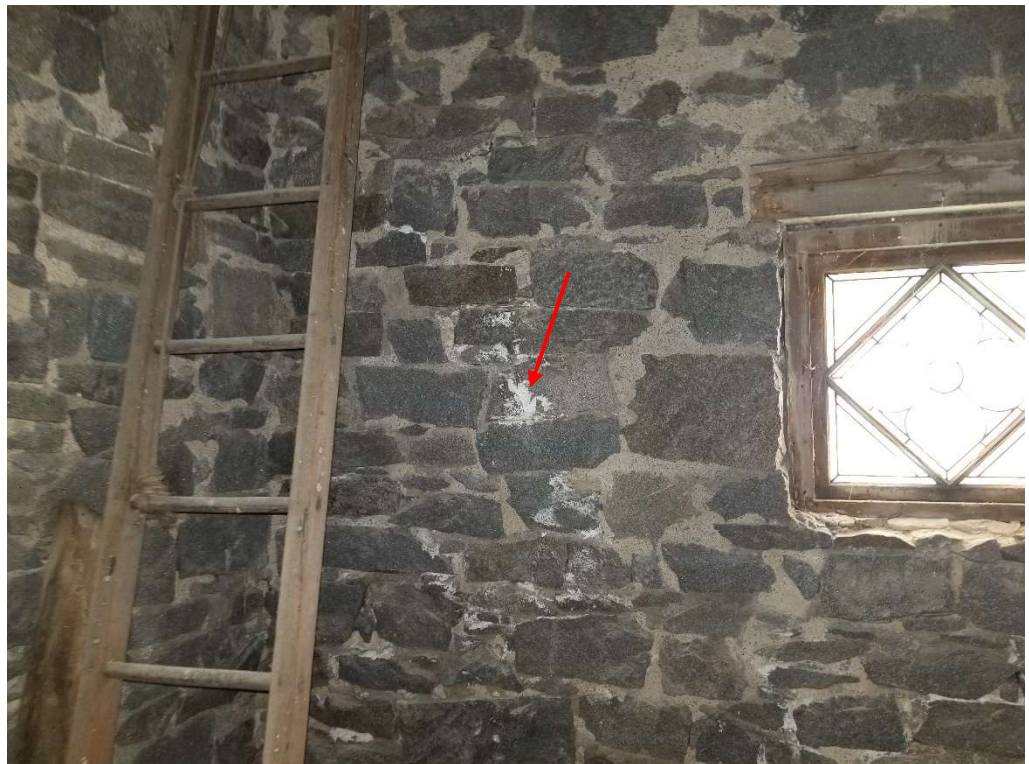
The interior of the bell tower revealed some evidence of moisture intrusion through the masonry walls in the form of efflorescence (Photo 17).

Photo 17: Efflorescence in bell tower.

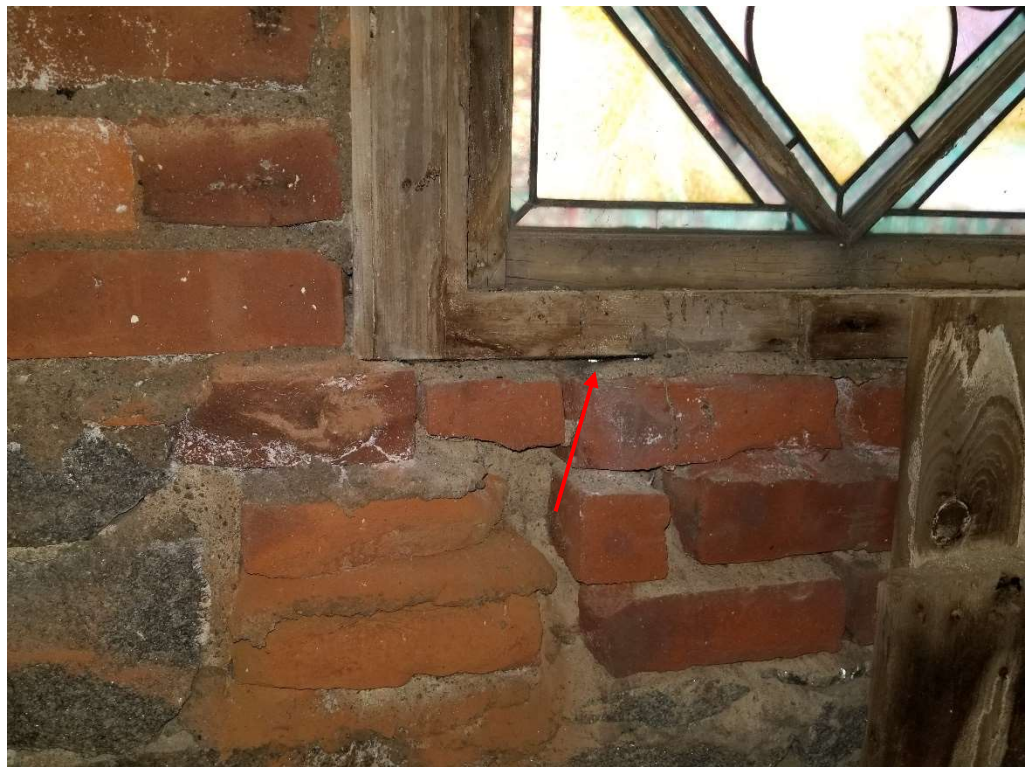
Stained glass windows are set into square openings on each side of the bell tower. From the interior, voids in the masonry at the perimeters of the windows could be seen allowing daylight through the walls (Photo 18).

Photo 18: Daylight at window perimeter.

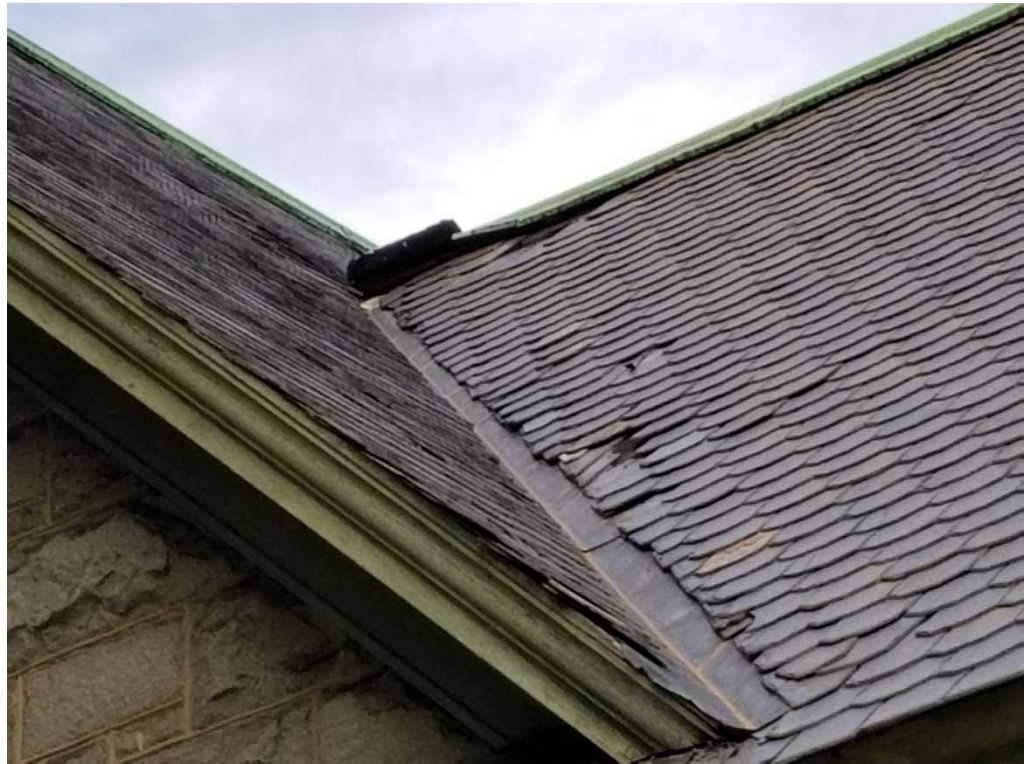
The roofs of the building are clad with slate, which is reportedly original to the building. Numerous cracked, loose, and missing slate were observed throughout the roofs (Photo 19). At the eave of the roof on the east side of the building, numerous missing slates have been replaced with asphalt shingles (Photo 20). Considerable damage and deterioration is present in the eave molding as well as the underlying roof decking (Photo 20). There are no gutters at the roof eaves.

Photo 19: Broken, missing and loose slate.

The slate roof of the church is in poor condition. Damaged flashings and cracked or missing slate tiles are commonplace. The presence of loose slates is widespread. And numerous slates have fallen off the building. Some have been replaced with asphalt shingles while others have not. These defects have directly exposed the interior of the building to moisture infiltration and has resulted in damage to the interior finishes. Typically, a slate roof can be expected to last 100 years. As this roof is reportedly original to the building, it is the opinion of Hoffmann Architects that the slate roof is beyond its useful life and should be replaced.

- Replace the slate roof and all associated flashings. This work would include the installation of gutters and rain leaders at the roof eaves to direct water away from the building foundation.

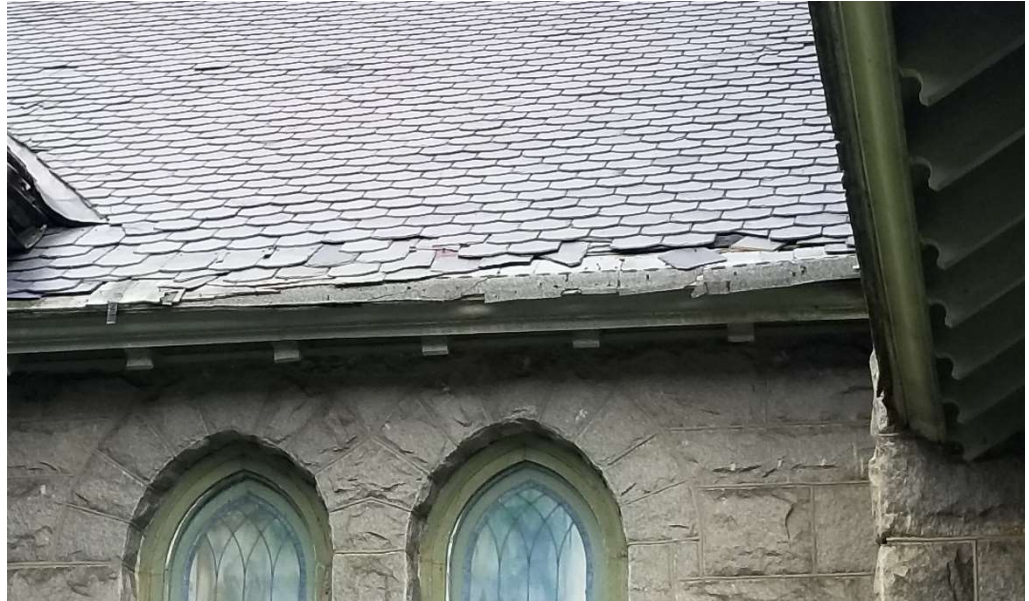
Photo 20: Missing slate at eave replaced with asphalt shingles.

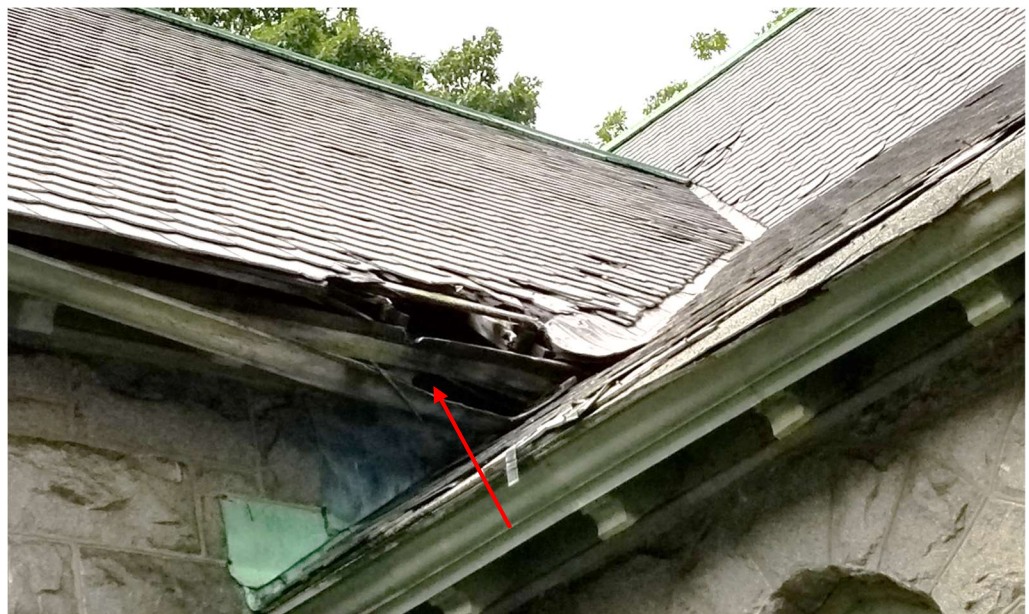
Photo 21: Damage to roof decking and eave molding. Also note, no gutters at the eaves.

are above grade remain dry. This is a clear indication that moisture is traveling through the subgrade walls and into the basement. Furthermore, the lack of gutters at the roof eaves is contributing to the amount of moisture entering the basement, as runoff is not collected and directed away from the building.

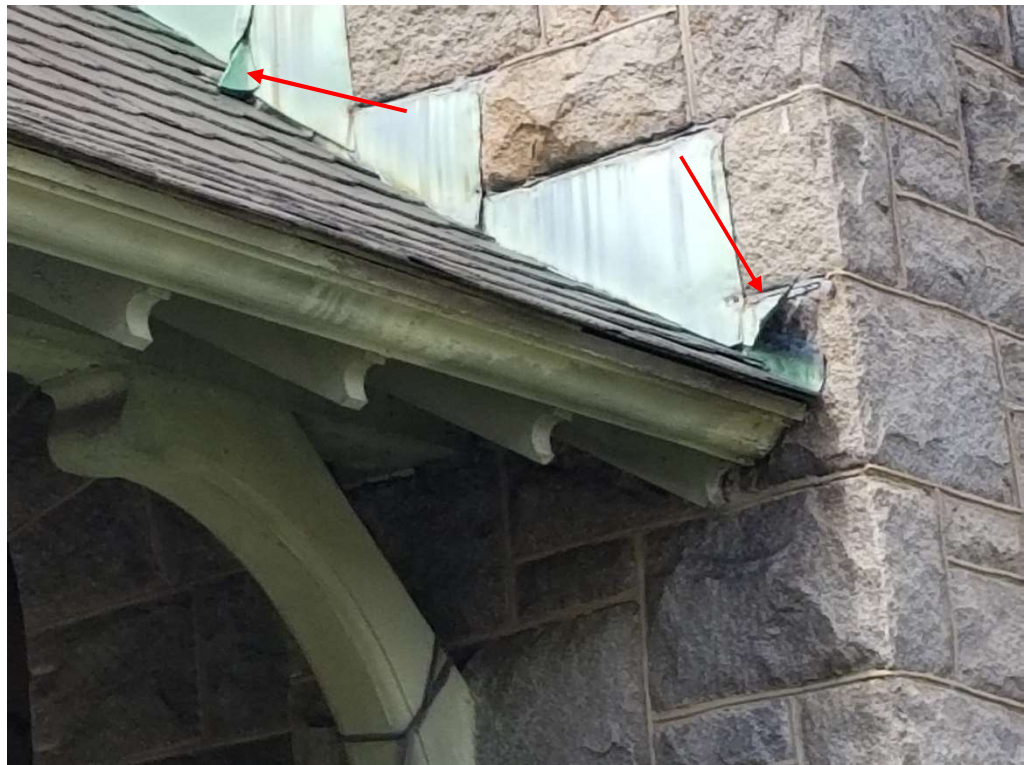
Flashings at the interface between the roof and façade elements are in varying stages of disrepair. Step flashings and counter flashings at the bell tower are bent or otherwise damaged thereby leaving gaps where water can enter the building (Photos 22 and 23). Copper ridge flashings are pulled up in many locations (Photo 24).

Photo 22: Damaged copper step flashing.

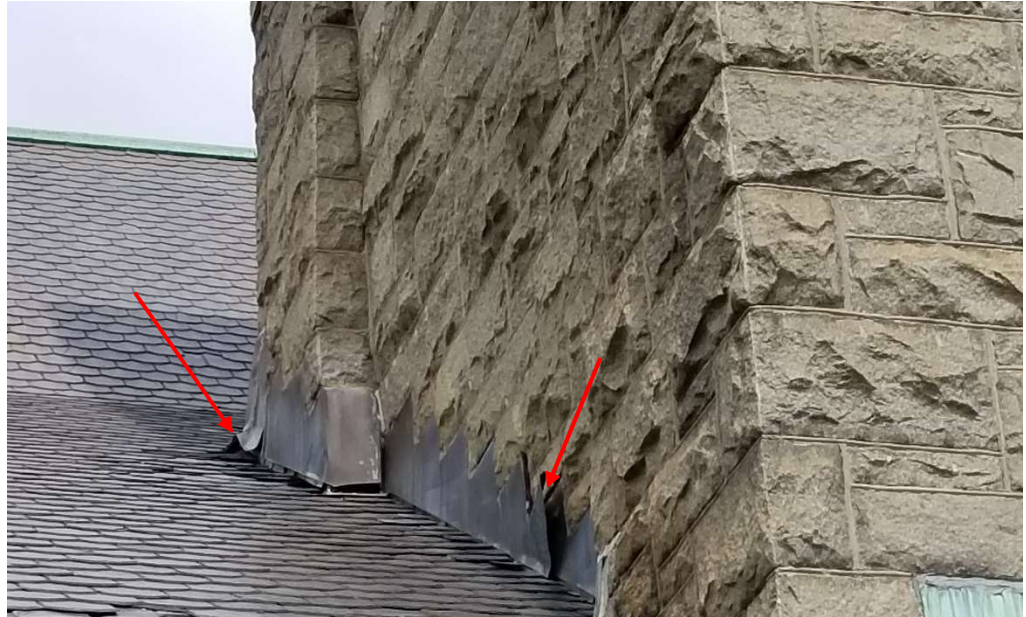
Photo 23: Damaged sawtooth counter flashing.

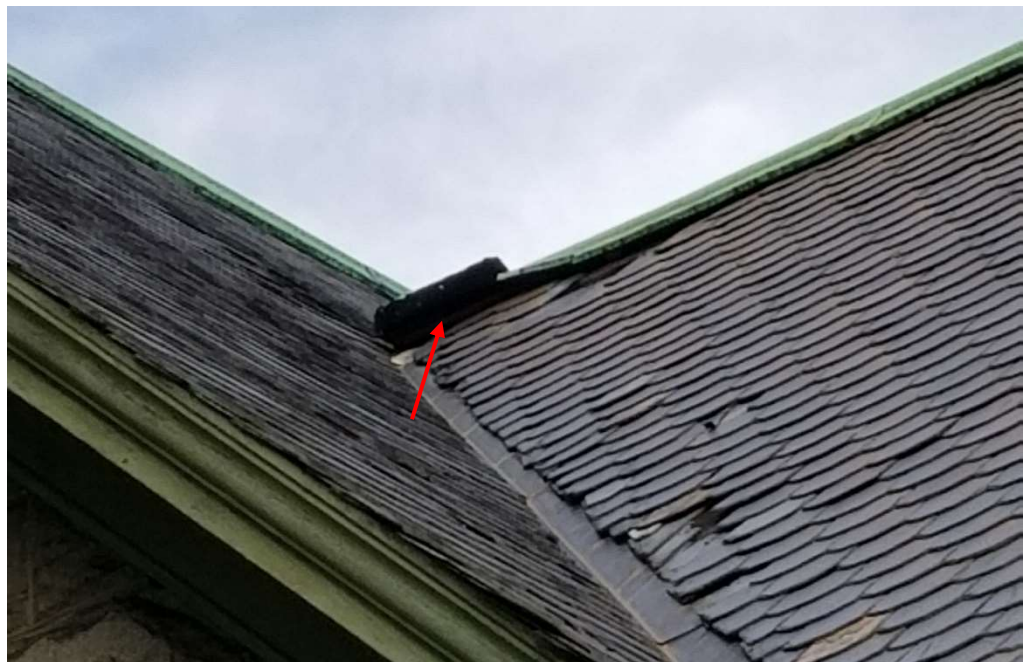
Photo 24: Damaged ridge flashing.

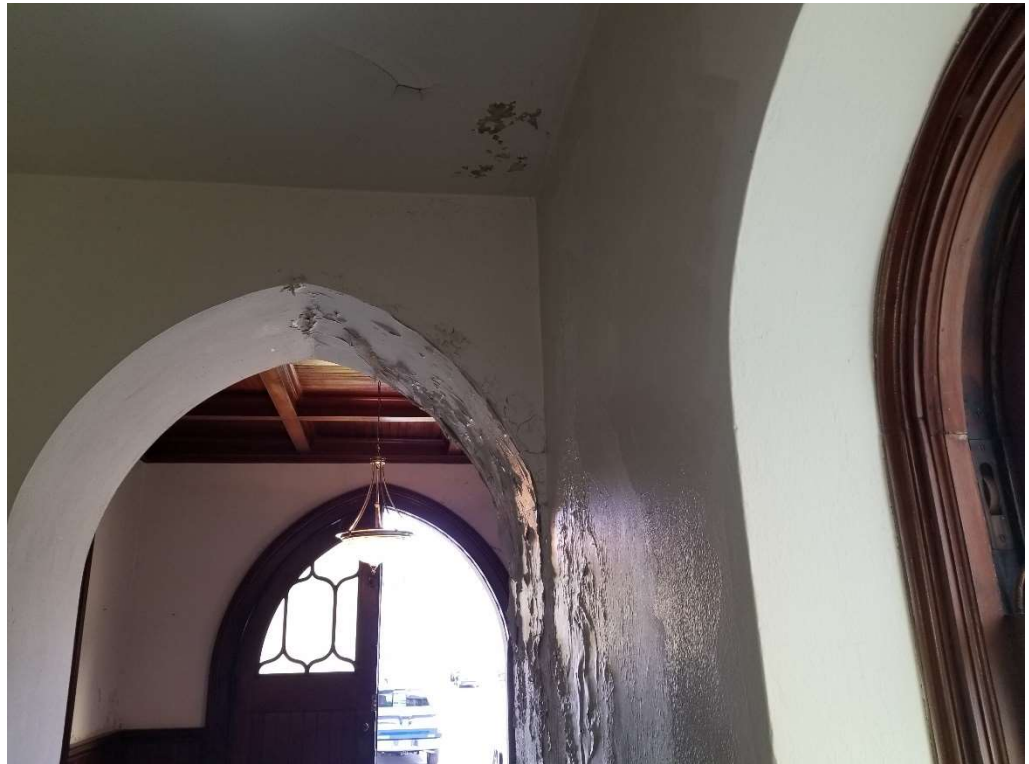
In many locations throughout the main floor as well as the basement level, considerable water damage was observed. At the entry to the nave from the narthex, water damage to the interior plaster walls is present at the archway under the bell tower (Photo 25). In the basement, severe water damage to the interior finishes is present at all exterior walls with the exception of those at the transept which are primarily above grade (Photo 26).

Photo 25: Heavy water damage to plaster walls at archway.

- Repair interior finishes.

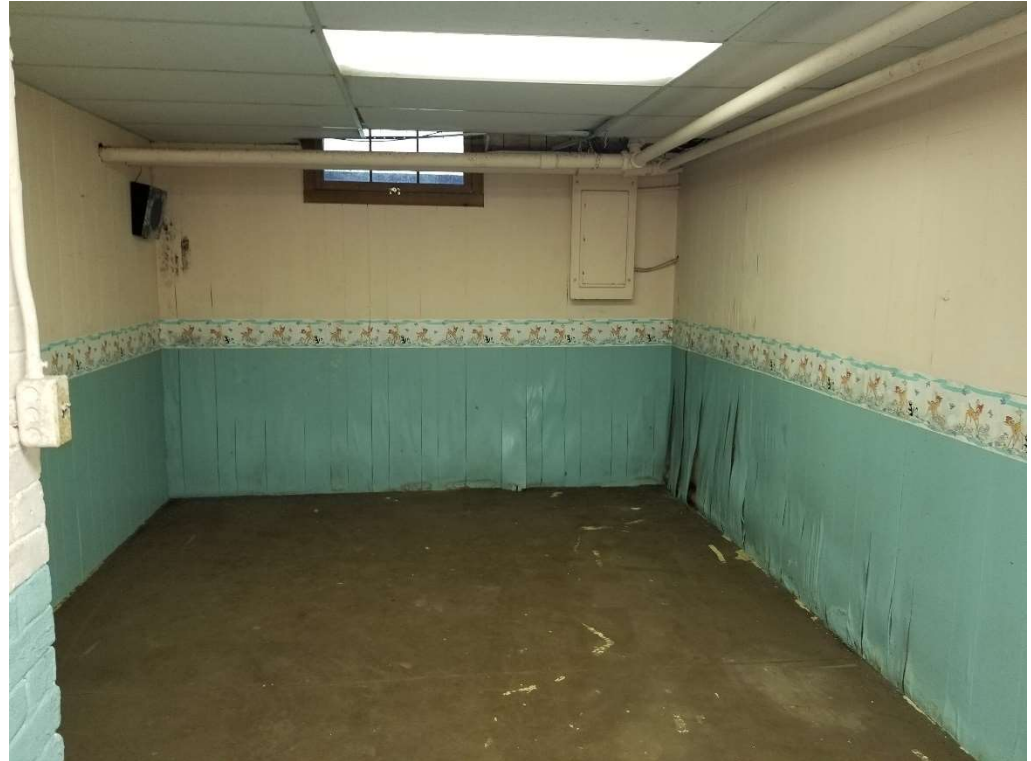
Photo 26: Water damage to interior finishes in basement.

Water infiltration into the basement of the church is severe. Damage to interior finishes occurs in all perimeter walls that are below grade, while those portions of the walls that

It is unknown if any means of dampproofing of the foundation walls of the church was employed during construction in 1901. Typically, at that time, basements were not meant as living space and therefore extensive waterproofing was not common or needed. Masonry foundations would allow water to seep into the basement in wet conditions where it flowed to a floor drain or seeped into an unfinished (dirt) floor. When the basement of the former Georgetown Bible Church was converted into living space, it was likely not properly waterproofed nor were any drainage improvements to the foundation installed.
