## GRANITE CHURCH

GEORGETOWN, CT

### CONDITIONS ASSESSMENT REPORT

November 17, 2023

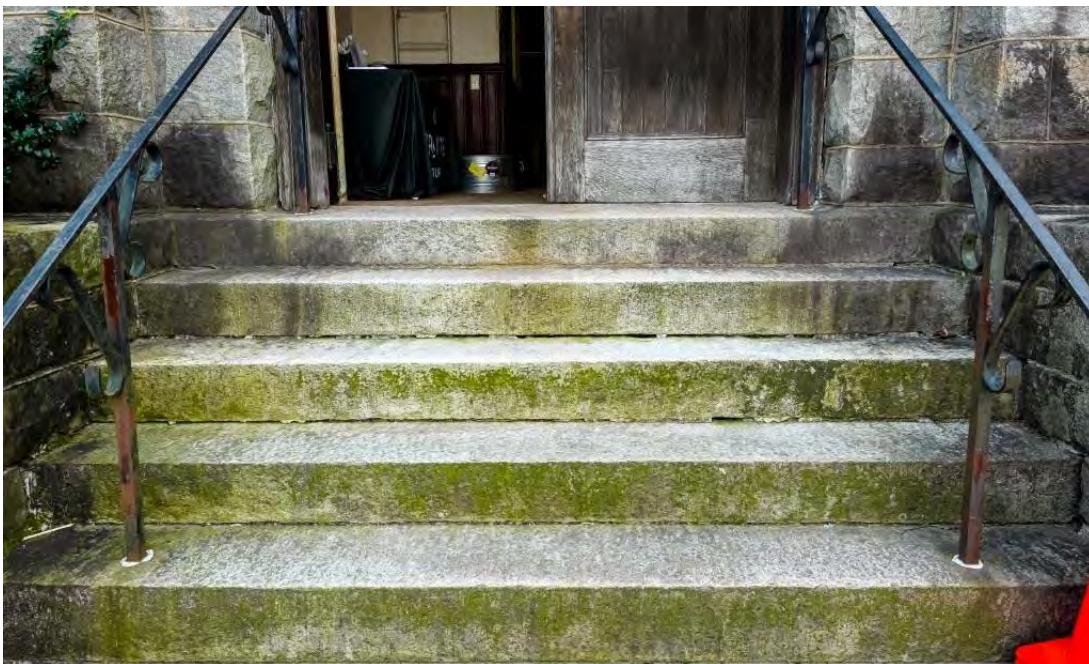
Granite Church – Existing Conditions – Exterior Masonry  
North, Main Entrance Steps – Open Joints in Steps

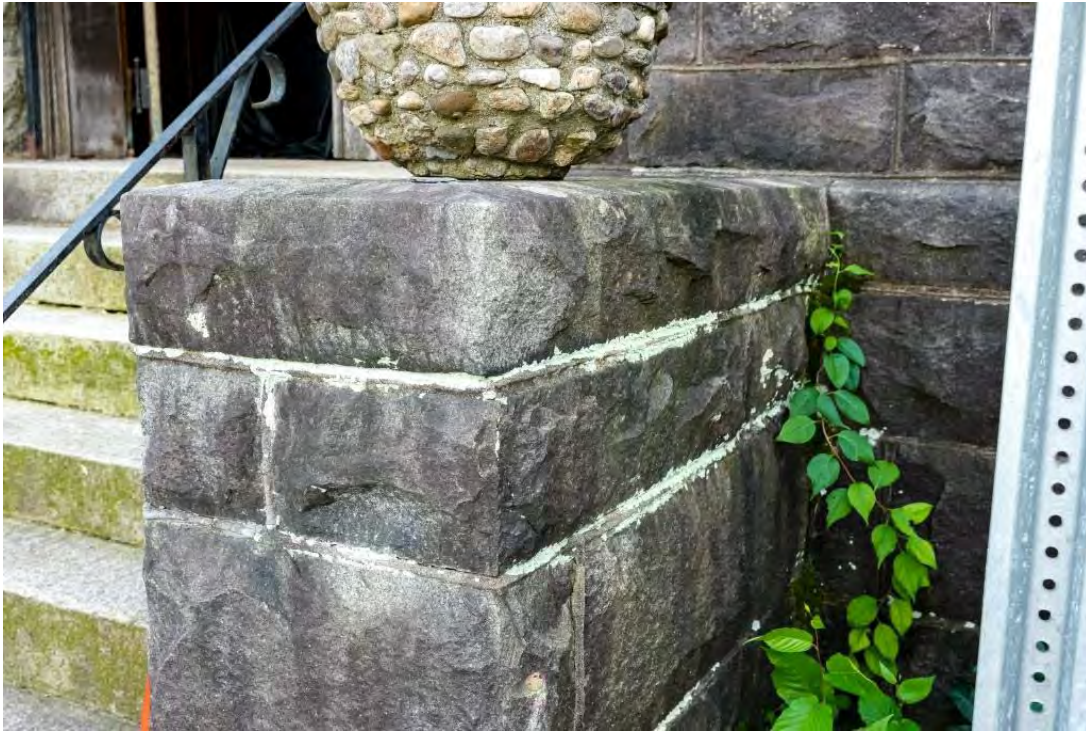
Granite Church – Existing Conditions – Exterior Masonry  
North, Main Entrance Steps – Staining of in Stone at Sidewalls

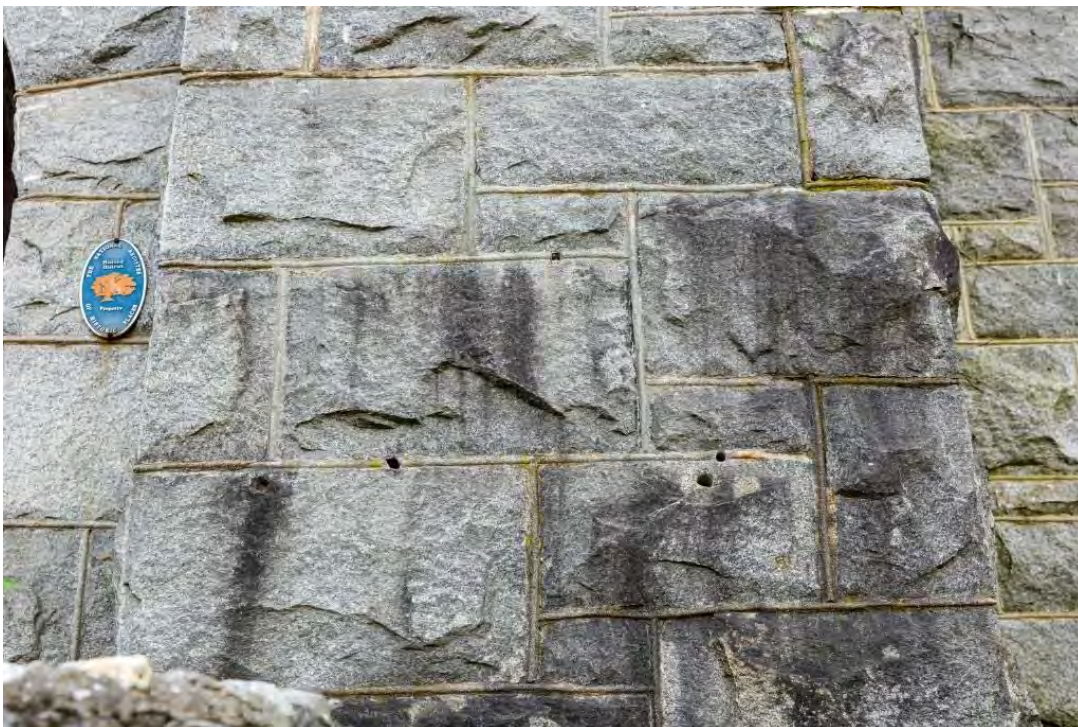
Granite Church – Existing Conditions – Exterior Masonry  
North Wall West of Main Entrance – Holes in Stonework at Removed Plaque

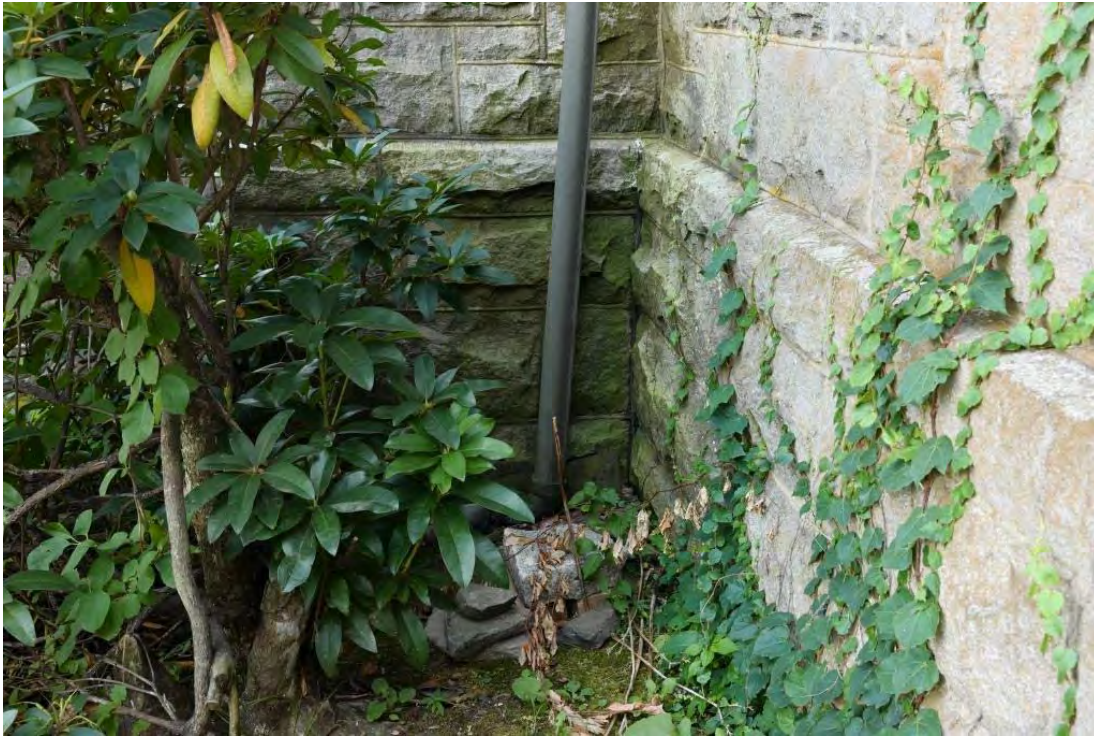
Granite Church – Existing Conditions – Exterior Masonry  
North Elevation – Northwest Inside Corner beside Tower  
Vegetation on Stonework – Drainage Issues at Base of Leader – Staining at Base of Wall

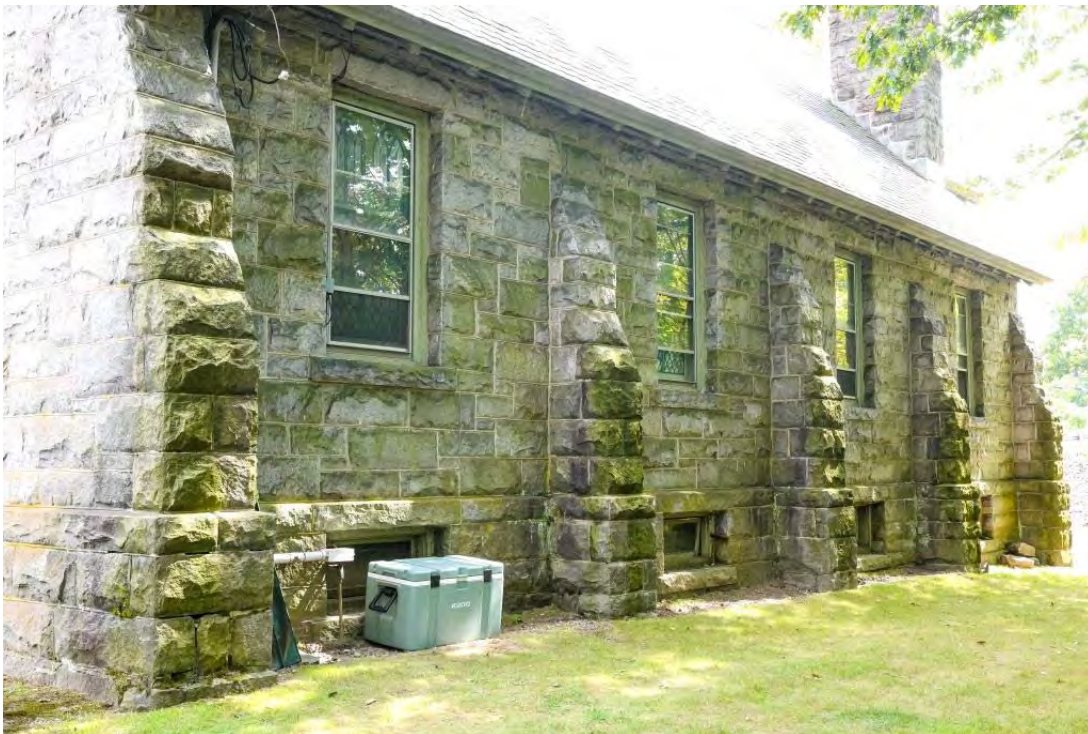
Granite Church – Existing Conditions – Exterior Masonry  
West Elevation – Overall – Open Joints and Staining

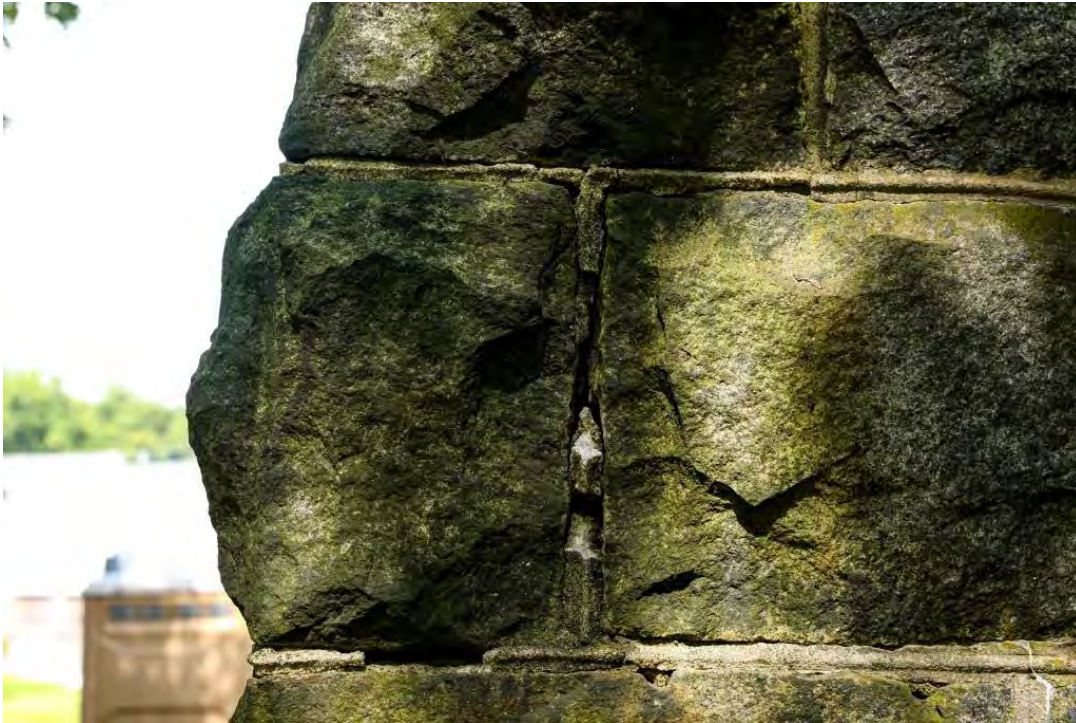
Granite Church – Existing Conditions – Exterior Masonry  
West Elevation – North Buttress – South Face – Open Joints and Staining

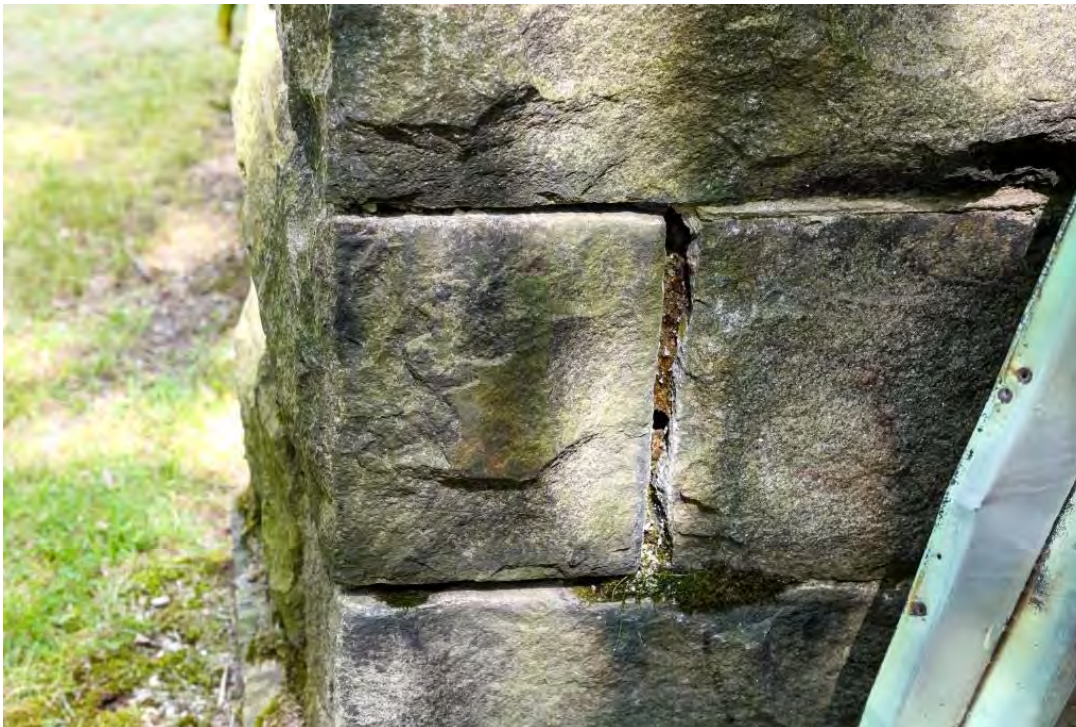
Granite Church – Existing Conditions – Exterior Masonry  
West Elevation – North Buttress – South Face – Open Joints and Staining

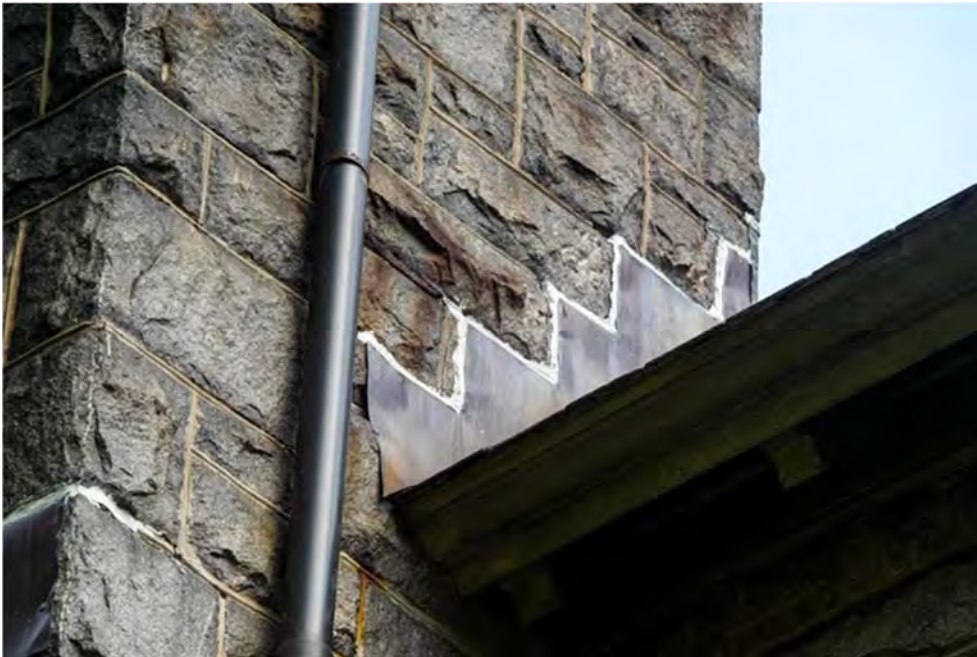
Granite Church – Existing Conditions – Exterior Masonry  
Chimney at Southwest Corner – South Face – Improper Pointing (Sealant) Staining

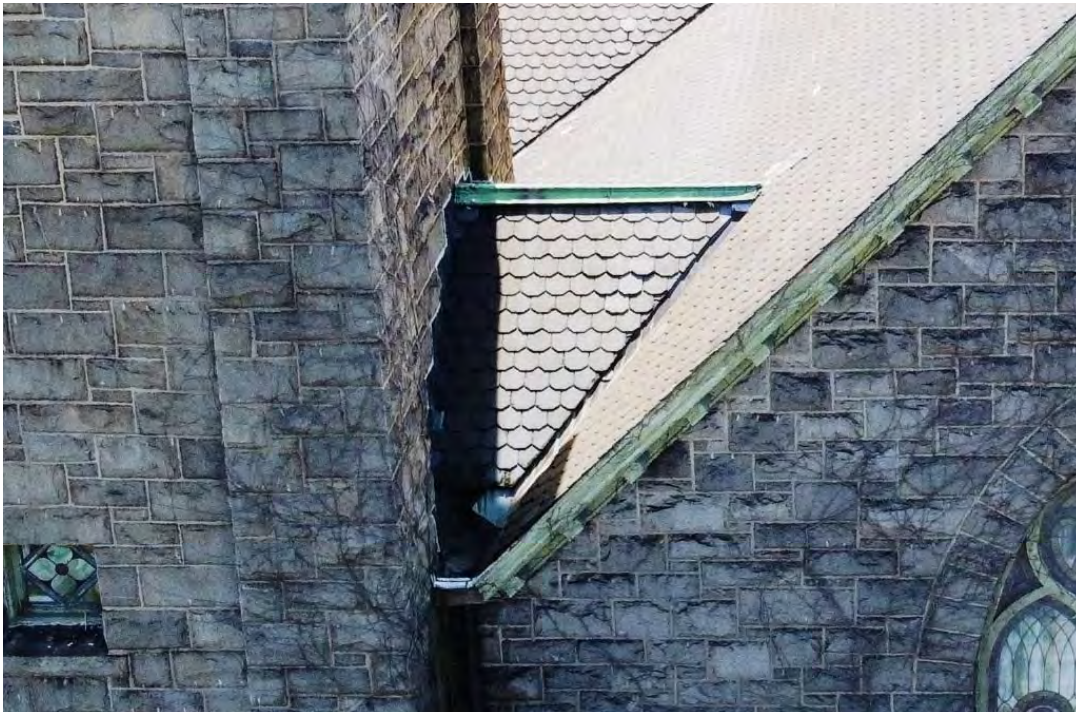
Granite Church – Existing Conditions – Roof and Drainage  
Cricket on North Side of Tower – Previous Leaks were an Issue at this Location  
Roof/Flashing has been Temporarily Repaired

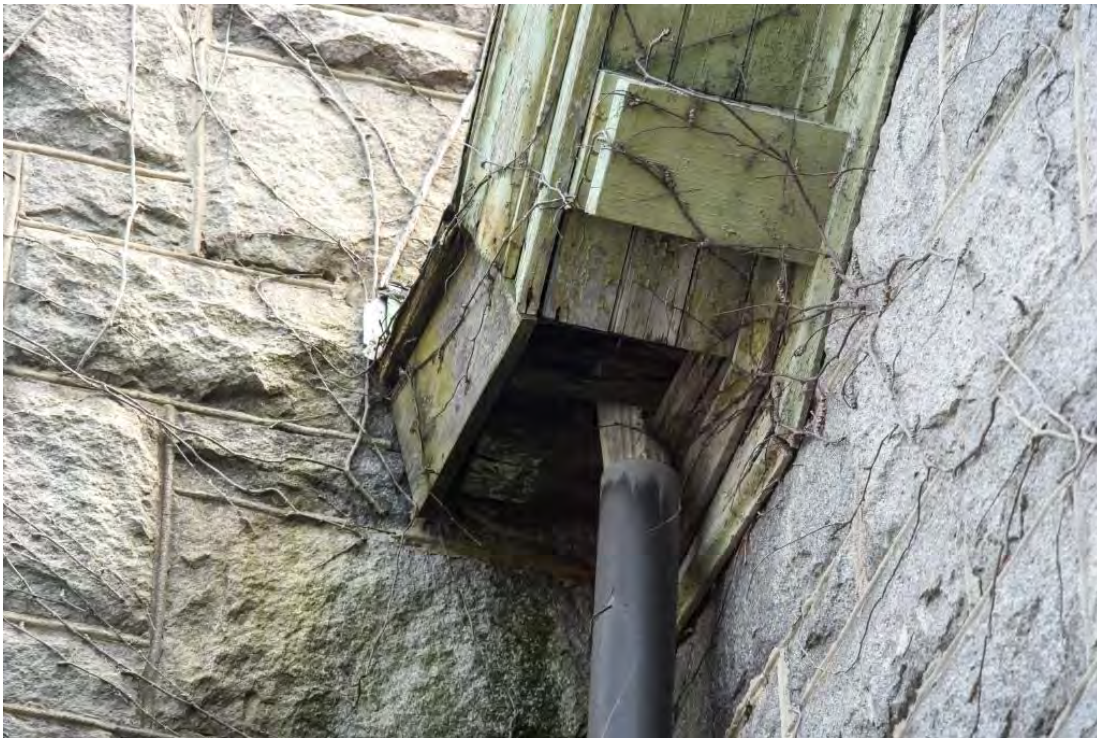
Granite Church – Existing Conditions – Roof and Drainage  
Drain and Downspout from Main Roof at Intersection with North Side of Tower – Wood Fascia and Soffit Missing -

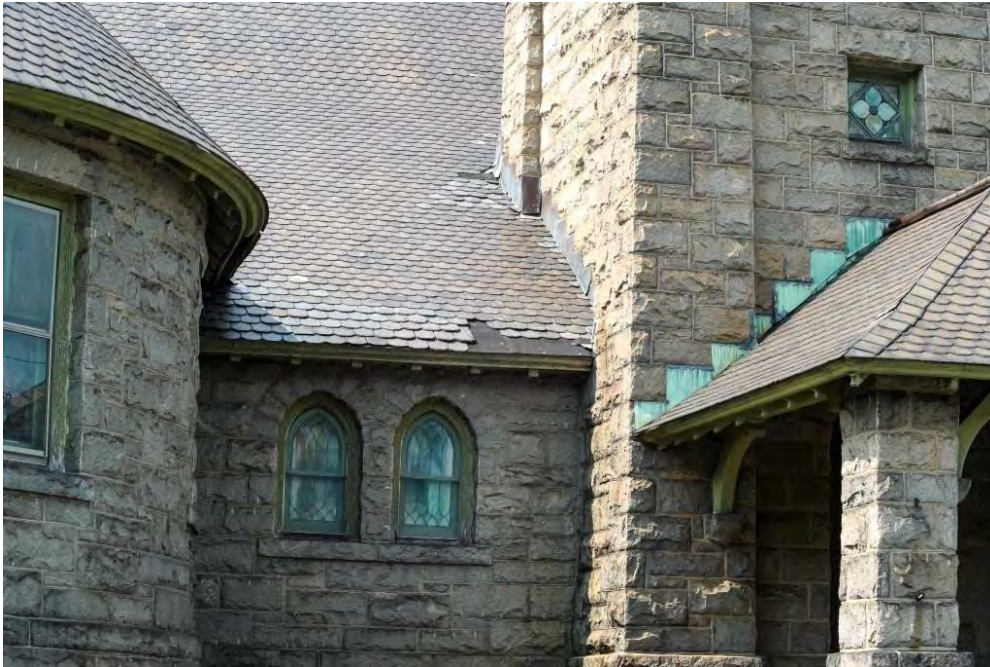
Granite Church – Existing Conditions – Roof and Drainage  
East Slope of Main Roof - Previous Leaks were an Issue at this Location – Slates Missing – Flashing Damaged  
Roof/Flashing has been Temporarily Repaired

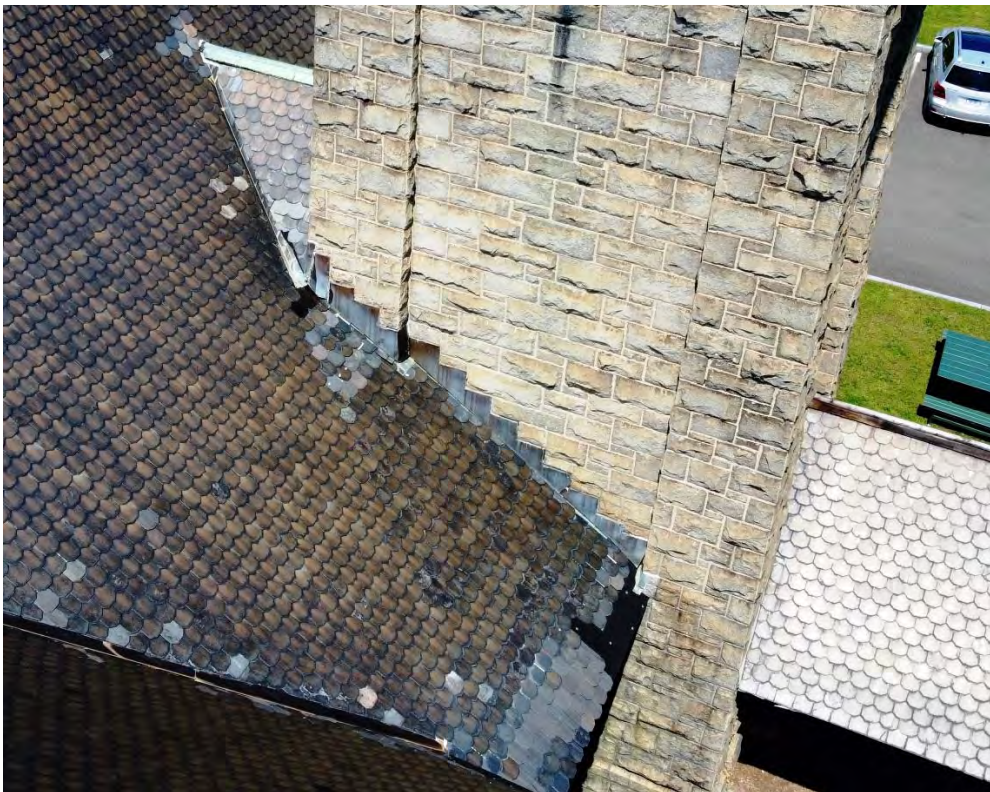
Granite Church – Existing Conditions – Roof and Drainage  
East Slope of Main Roof - Previous Leaks were an Issue at this Location – Slates Missing – Flashing Damaged  
Roof/Flashing has been Temporarily Repaired

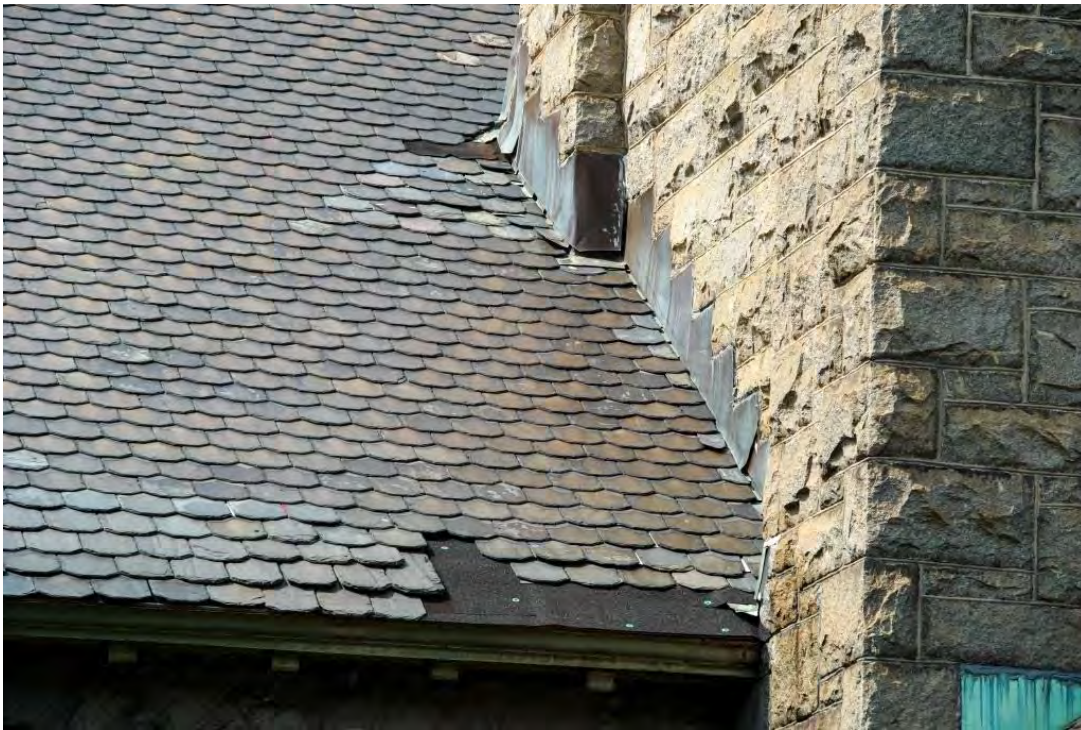
Granite Church – Existing Conditions – Roof and Drainage  
East Slope of Main Roof – Detail - Previous Leaks were an Issue at this Location - Slates Missing – Flashing Damaged  
Roof/Flashing has been Temporarily Repaired

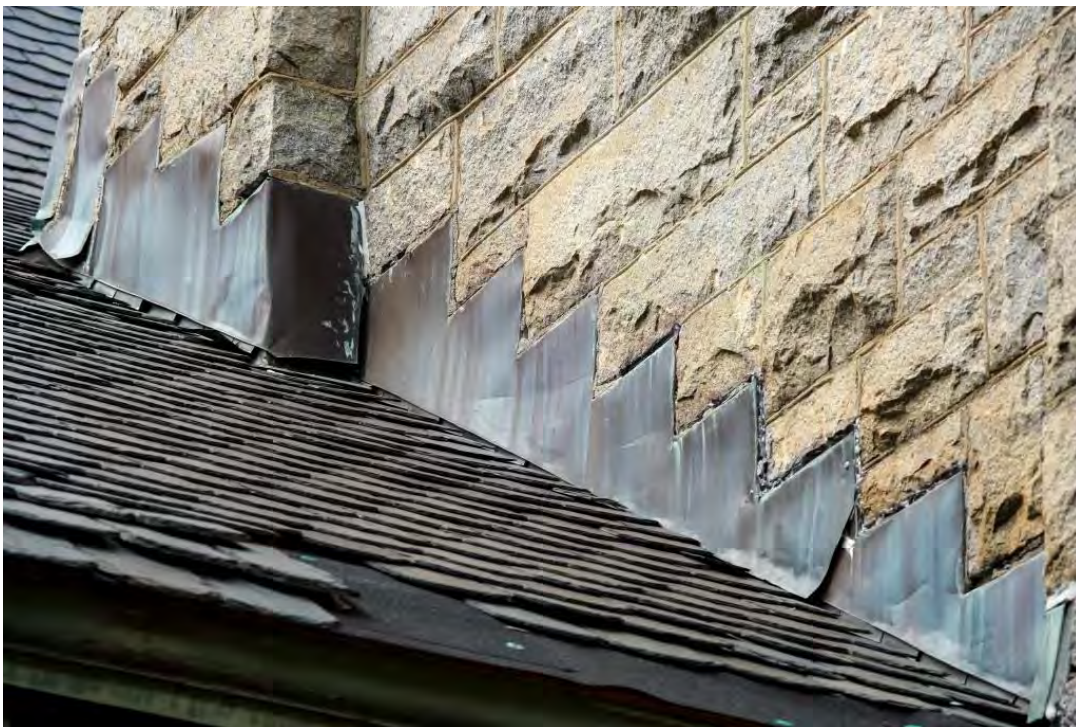
Granite Church – Existing Conditions – Roof and Drainage  
East Slope of Main Roof – Detail - Previous Leaks were an Issue at this Location - Slates Missing – Flashing Damaged  
Roof/Flashing has been Temporarily Repaired

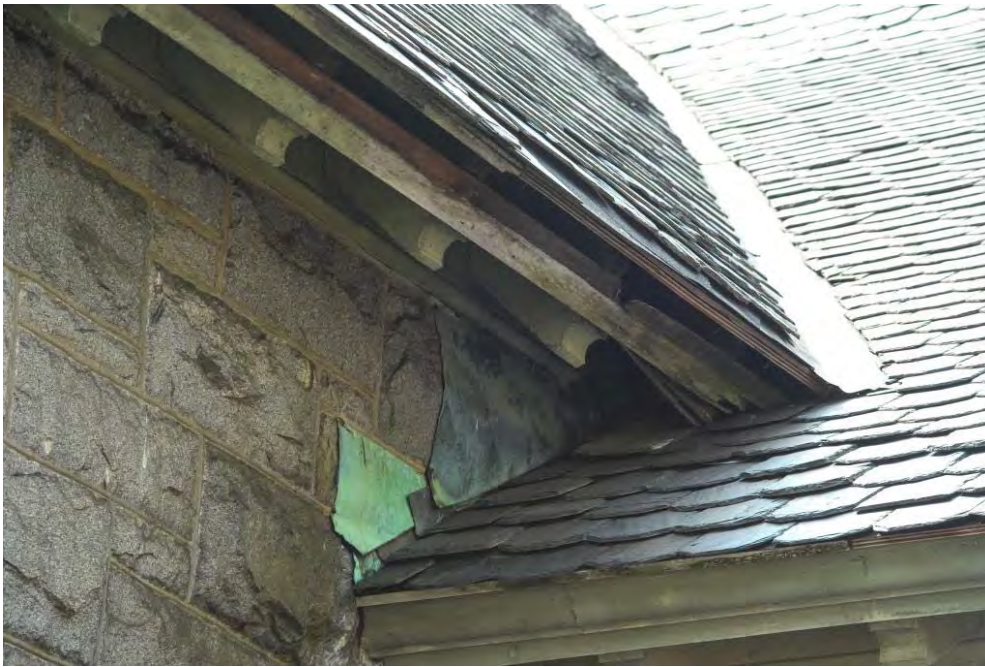
Granite Church – Existing Conditions – Roof and Drainage  
East Slope of Main Roof – At Juncture with North Wall of Semi-Circular East Wing  
Slates Missing – Flashing Damaged – Gutter Missing - Wood Elements Damaged and Lacking Paint  
Roof/Flashing has been Temporarily Repaired

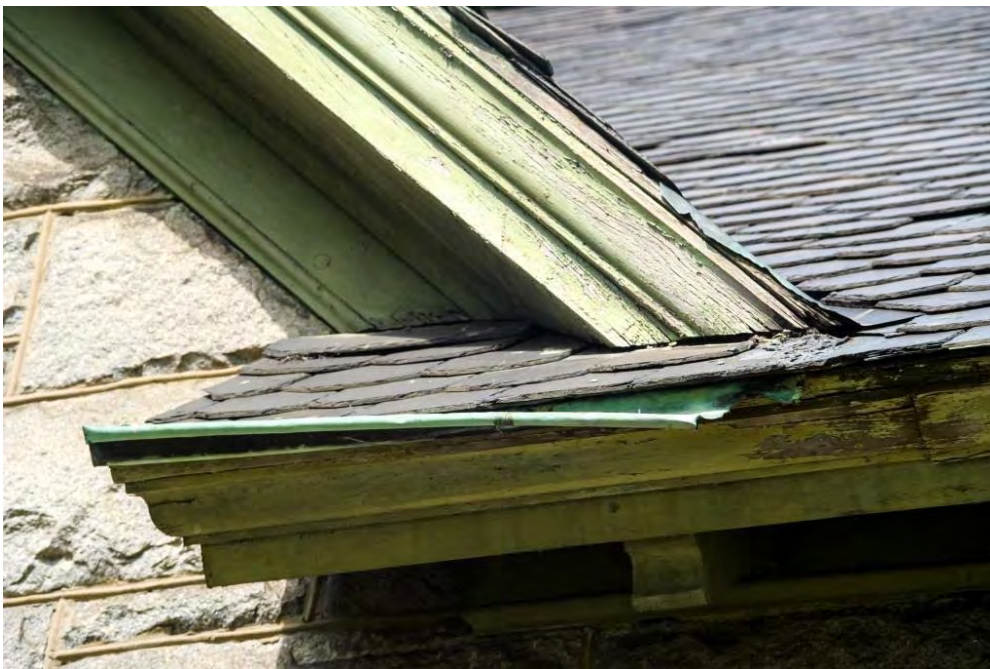
Granite Church – Existing Conditions – Roof and Drainage  
South Elevation – At Juncture with Semi-Circular East Wing  
Slates Damaged & Missing – Gutter Missing – Wood Elements Damaged and Lacking Paint

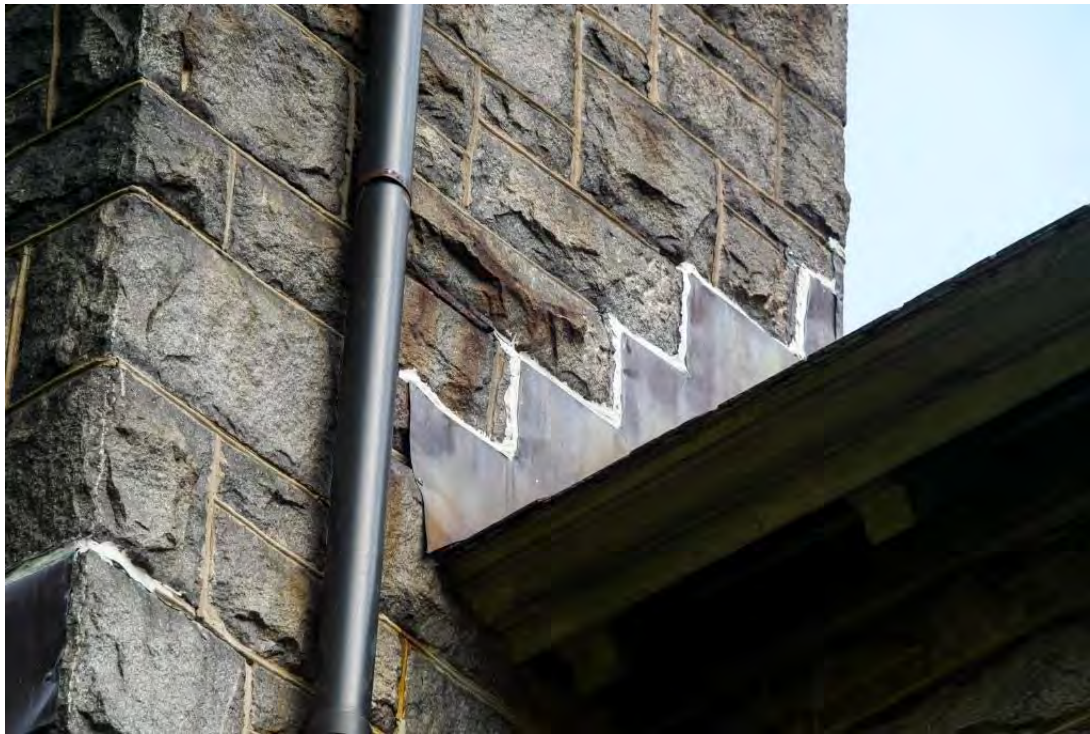
Granite Church – Existing Conditions – Exterior Masonry  
West Elevation – Chimney at Southwest Corner – South Face – Step Flashing at Chimney to Roof Juncture  
Appears to be in Good Condition - Improper installation of sealant

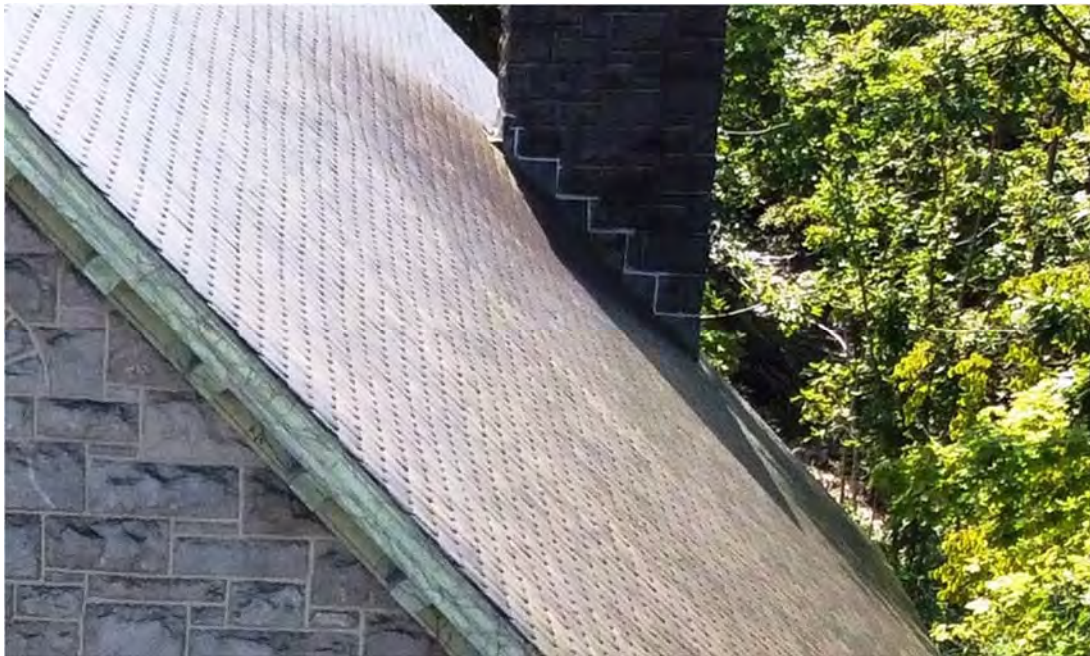
Granite Church – Existing Conditions – Exterior Masonry  
Chimney at Southwest Corner – North Face – Step Flashing at Chimney to Roof Juncture  
Appears to be in Good Condition; No Cricket at East Face of Chimney

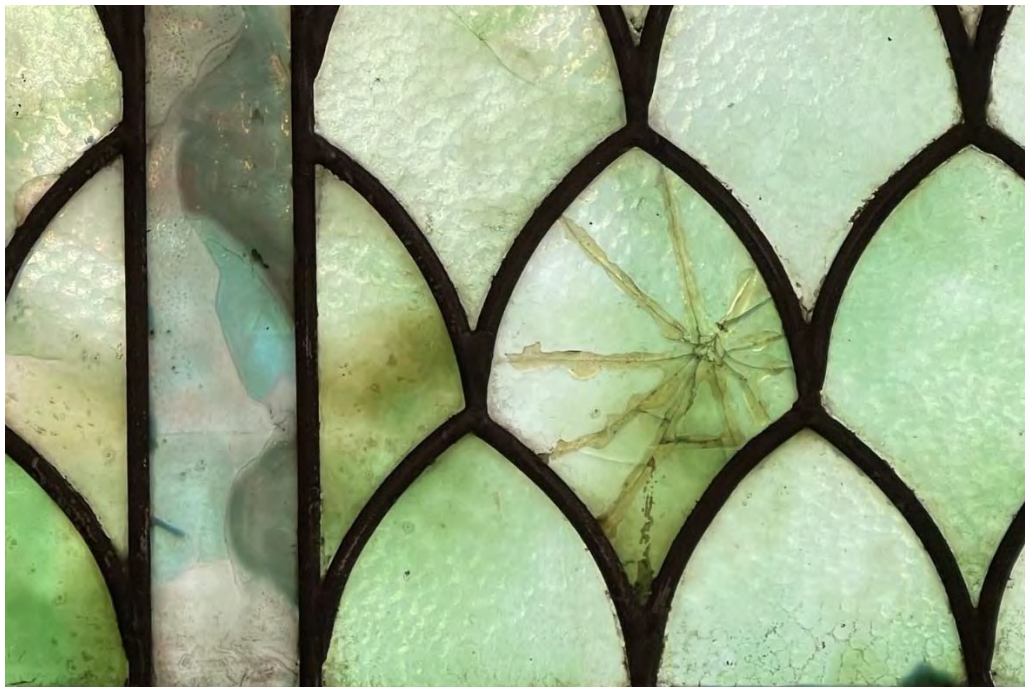
Granite Church – Existing Conditions – Doors and Windows  
First Floor - Typical Double-Hung Stained-Glass Window on West Wall in Sanctuary  
Typical Example of Cracked Glass

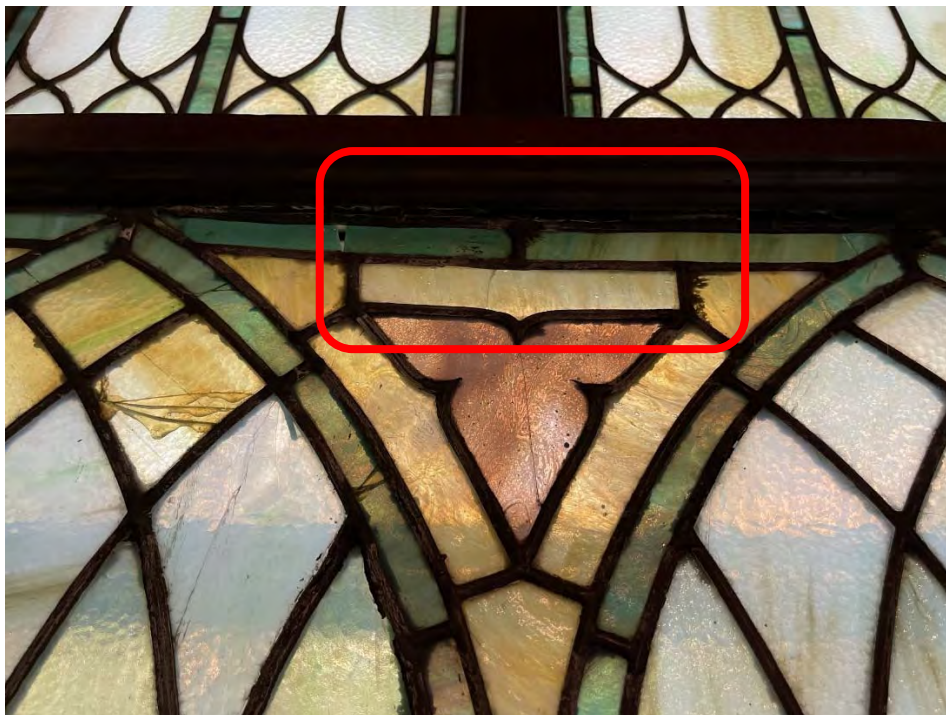
Granite Church – Existing Conditions – Doors and Windows  
First Floor – Double-Hung Stained-Glass Window on West Wall in Sanctuary – Window Second from South  
Separation of Window from Frame at top of Bottom Sash

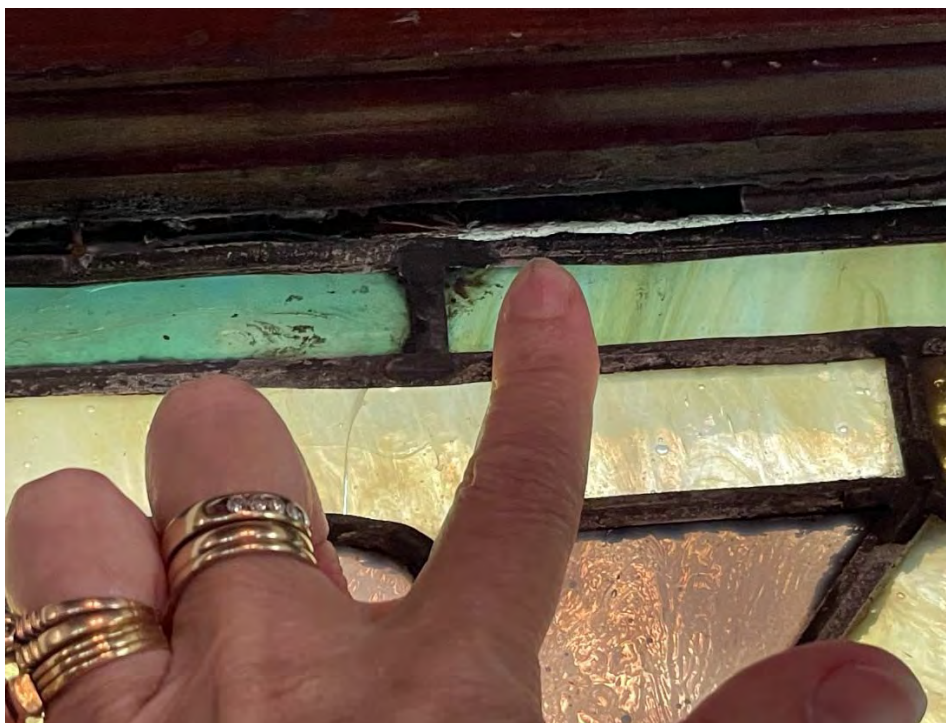
Granite Church – Existing Conditions – Doors and Windows  
First Floor – Double-Hung Stained-Glass Window on West Wall in Sanctuary – Window Second from South  
Separation of Window from Frame at top of Bottom Sash

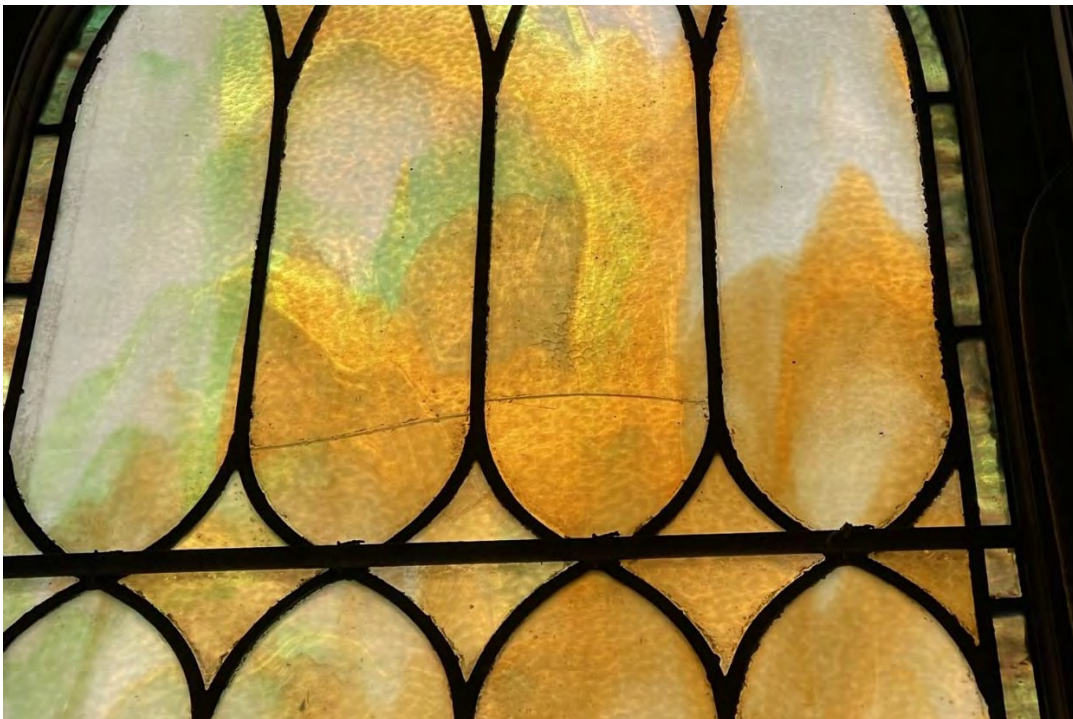
First Floor – Double-Hung Stained-Glass Chancel Window - Typical Example of Cracked Glass

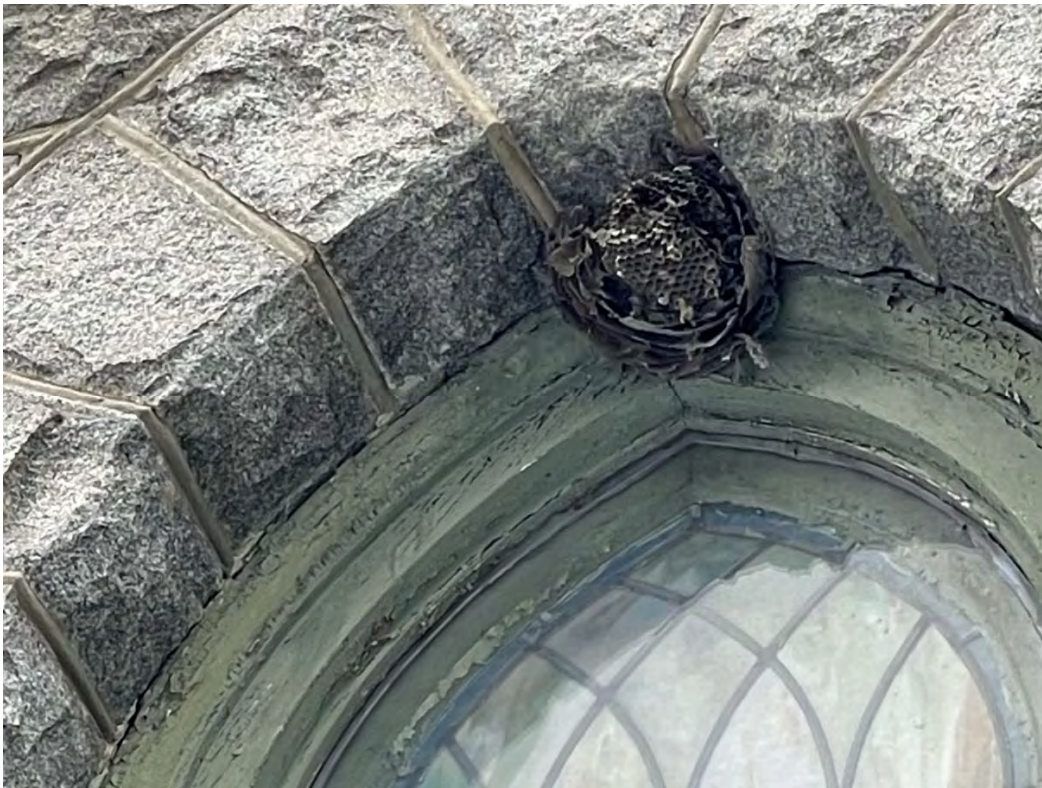
Granite Church – Existing Conditions – Doors and Windows  
First Floor - Double-Hung Stained-Glass Chancel Window - East-most Chancel Window on South Elevation  
Insect Nest; Acrylic Sheeting on Exterior of Window Could Cause Heat Build-up and Damage to Window

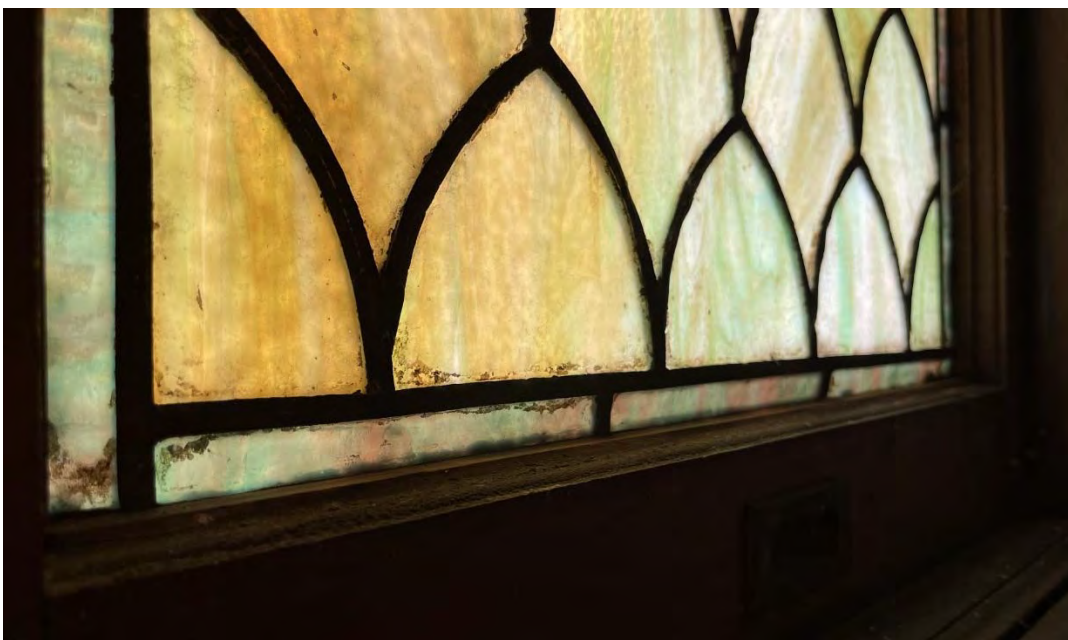
Granite Church – Existing Conditions – Doors and Windows  
Typical Double-Hung Stained-Glass Chancel Window  
First Floor - Deflection of Lead Comes and Glass at Base of Window

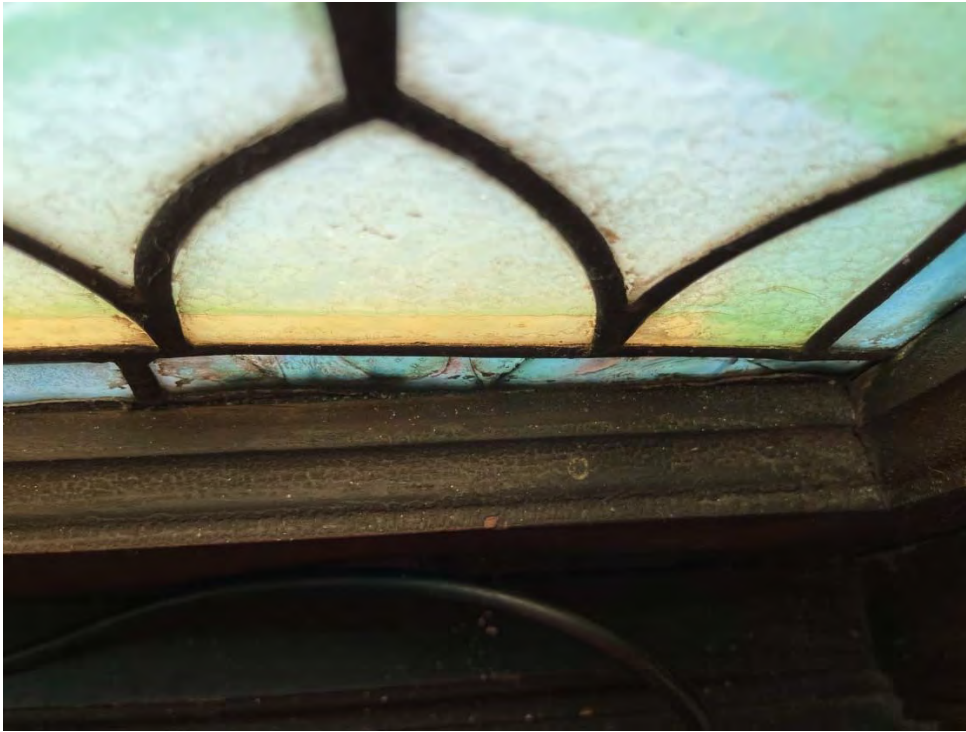
Granite Church – Existing Conditions – Doors and Windows  
First Floor – Double-Hung Stained-Glass Window in East Meeting Room – East-most Window  
Deflection of Lead Comes and Glass at Base of Window

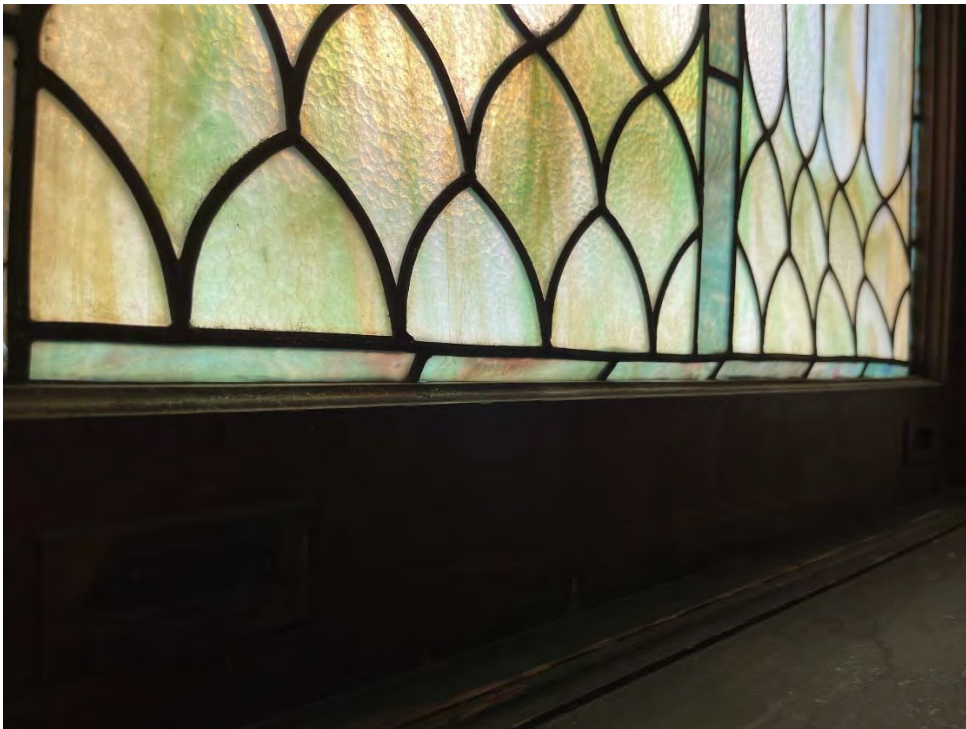
Granite Church – Existing Conditions – Doors and Windows  
First Floor – Double-Hung Stained-Glass Window in East Meeting Room – East-most Window  
Deflection of Lead Comes and Glass at Base of Window

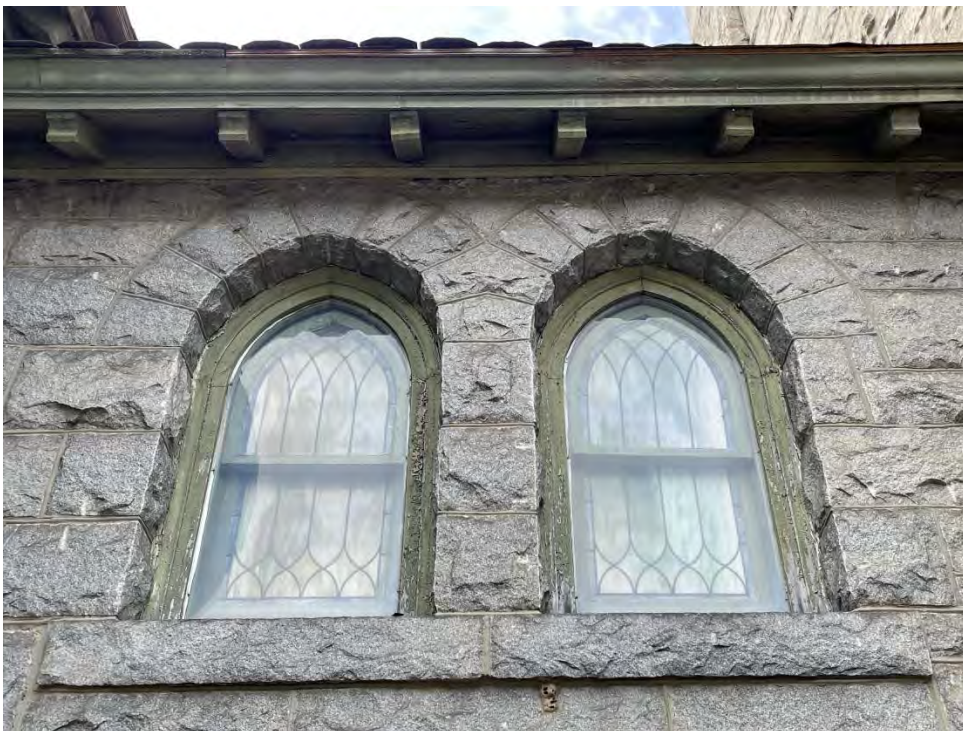
Granite Church – Existing Conditions – Doors and Windows  
First Floor – Double-Hung Stained-Glass Windows in Stair Hall  
Exterior View – Frames in Need of Painting

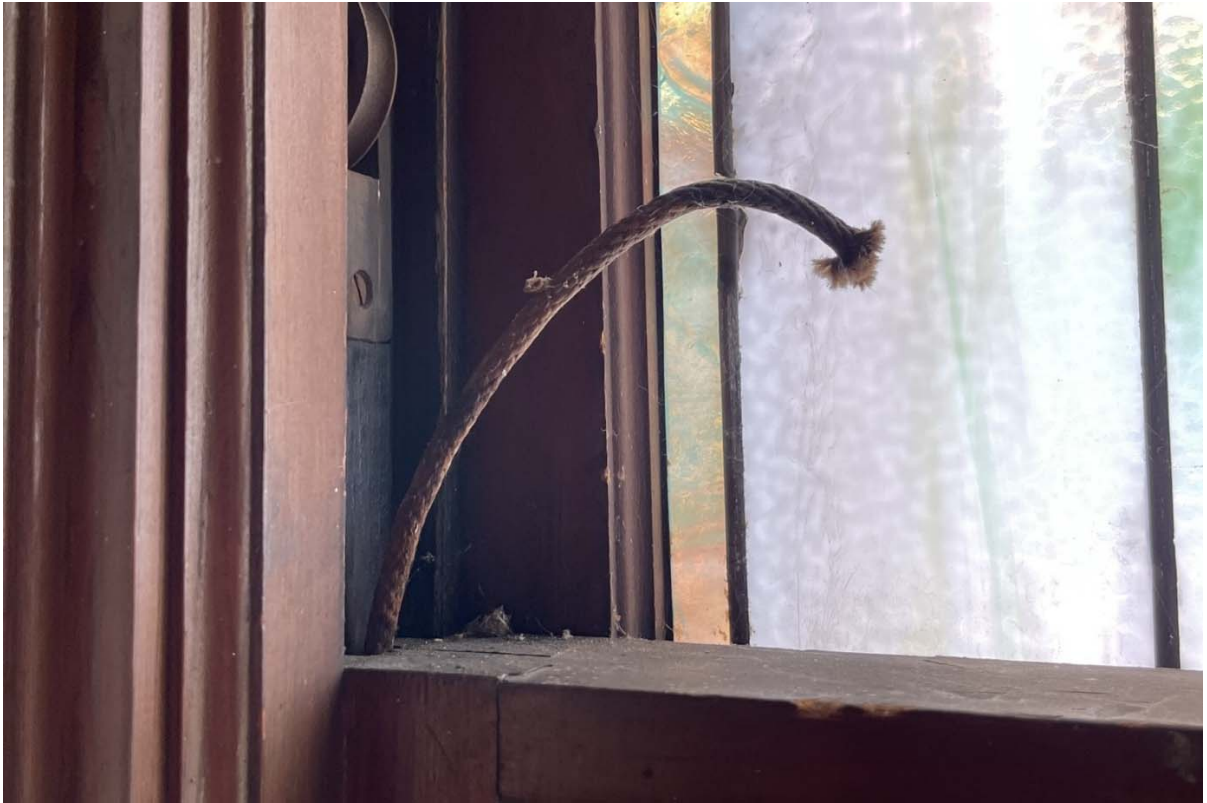
Granite Church – Existing Conditions – Doors and Windows  
First Floor – Double-Hung Stained-Glass Windows in Stair Hall  
Broken Window Cord
