## GRANITE CHURCH

GEORGETOWN, CT

### CONDITIONS ASSESSMENT REPORT

November 17, 2023

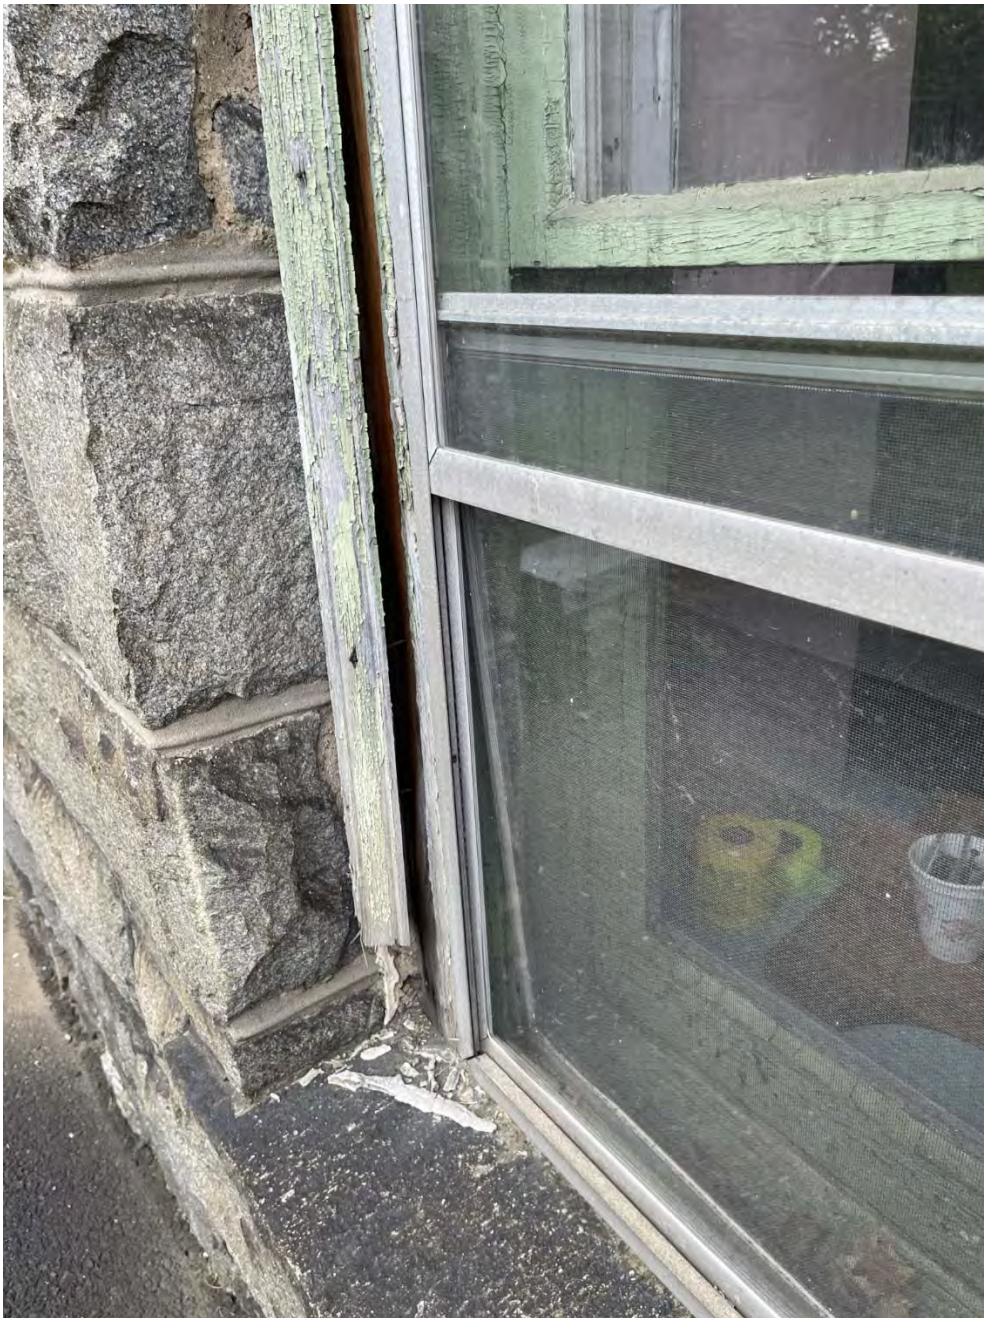
Granite Church – Existing Conditions – Doors and Windows  
Basement – Double-Hung Window in East Meeting Room - West-most Window on South Wall  
Damaged Wood Trim, Windows in Need of Paint, Damaged Storm Window

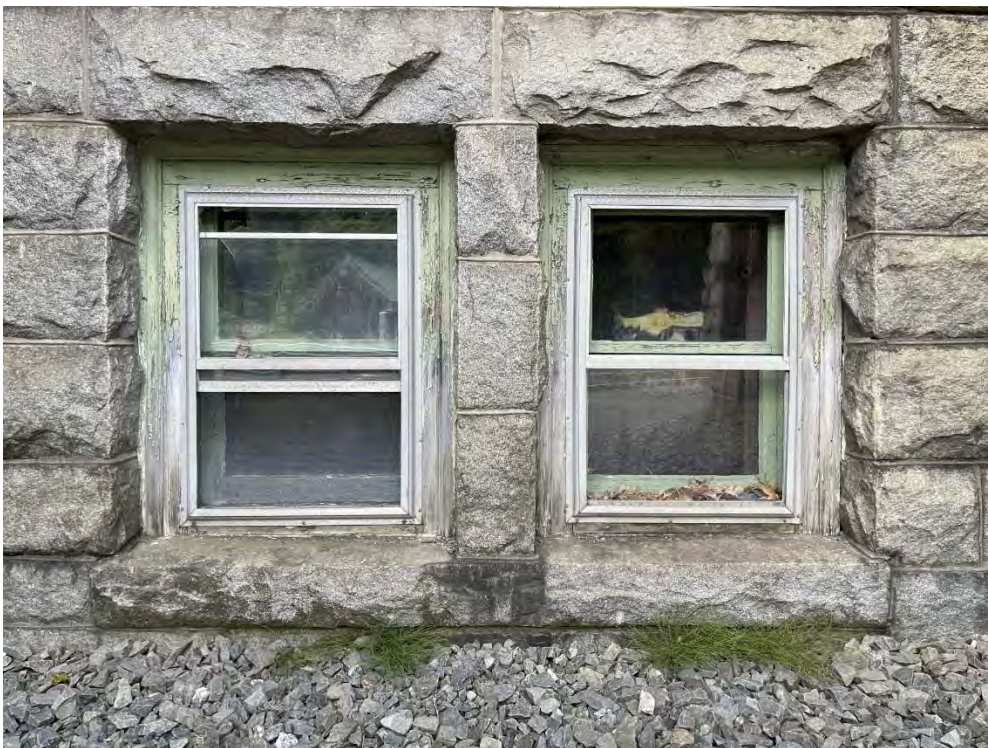
Granite Church – Existing Conditions – Doors and Windows  
Basement – Double-Hung Windows in Stair Hall  
Exterior View – Wood Frame in Need of Painting

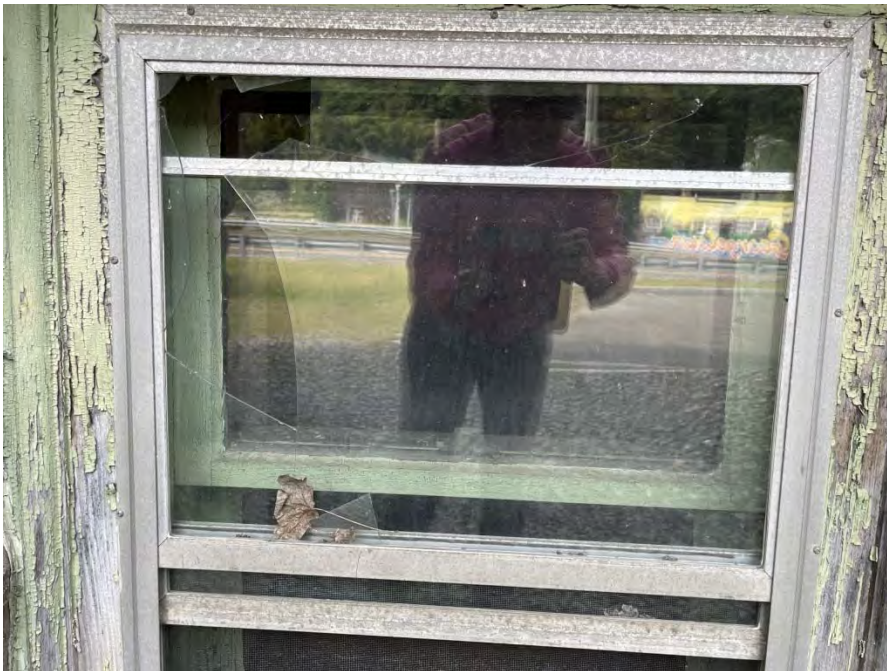
Granite Church – Existing Conditions – Doors and Windows  
Basement – Double-hung Window in Stair Hall  
Broken Glass in Storm Window – Wood Frame in Need of Painting

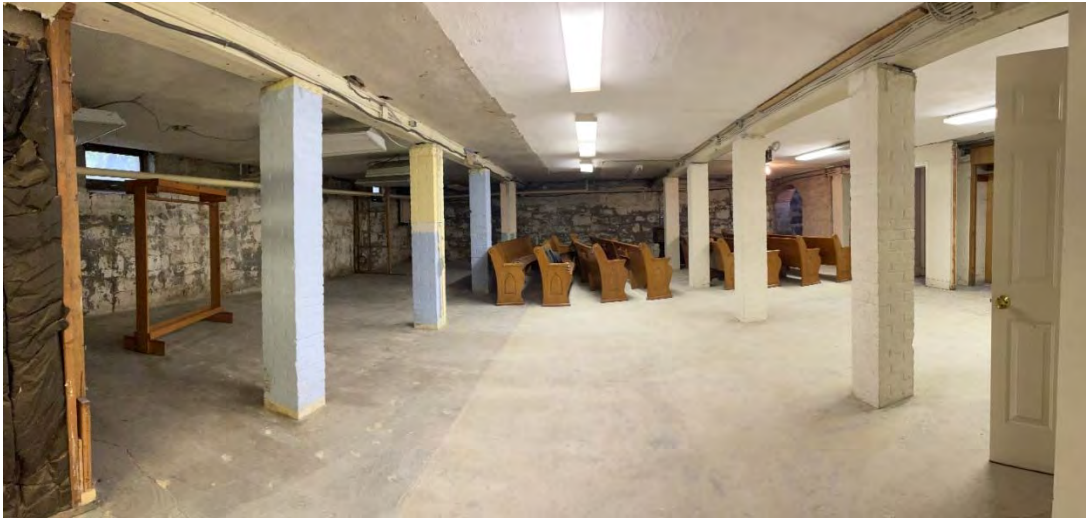
Granite Church – Existing Conditions – Interior Overall Views  
Basement – Main Space Under Sanctuary Looking North  
Partition Walls Have Been Removed; Hazardous Materials have been Removed

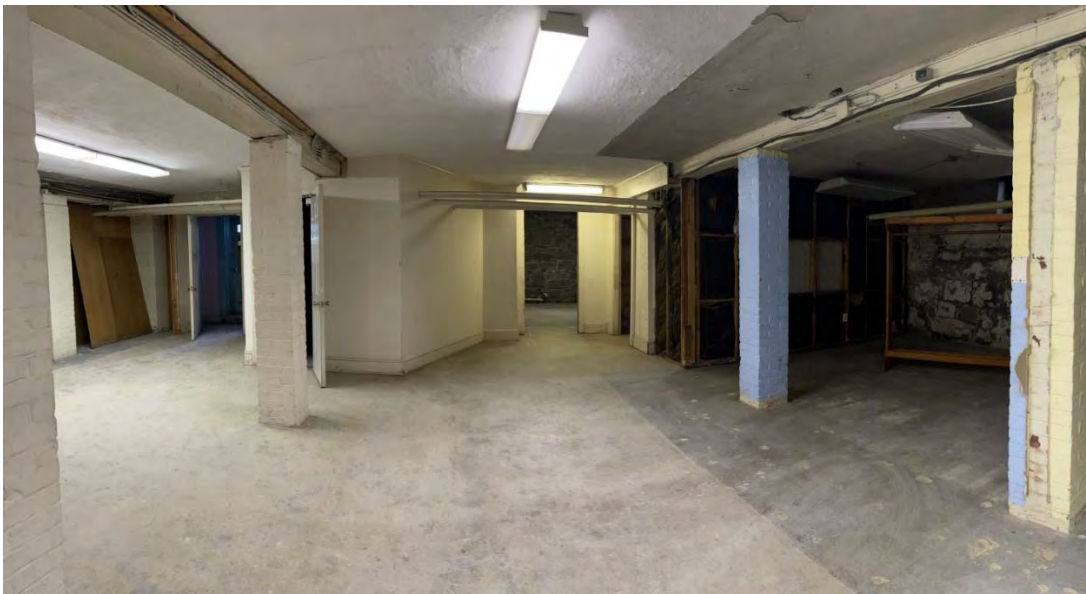
Granite Church – Existing Conditions – Interior Overall Views  
Basement – Main Space Under Sanctuary Looking South  
Partition Walls Have Been Removed; Hazardous Materials have been Removed

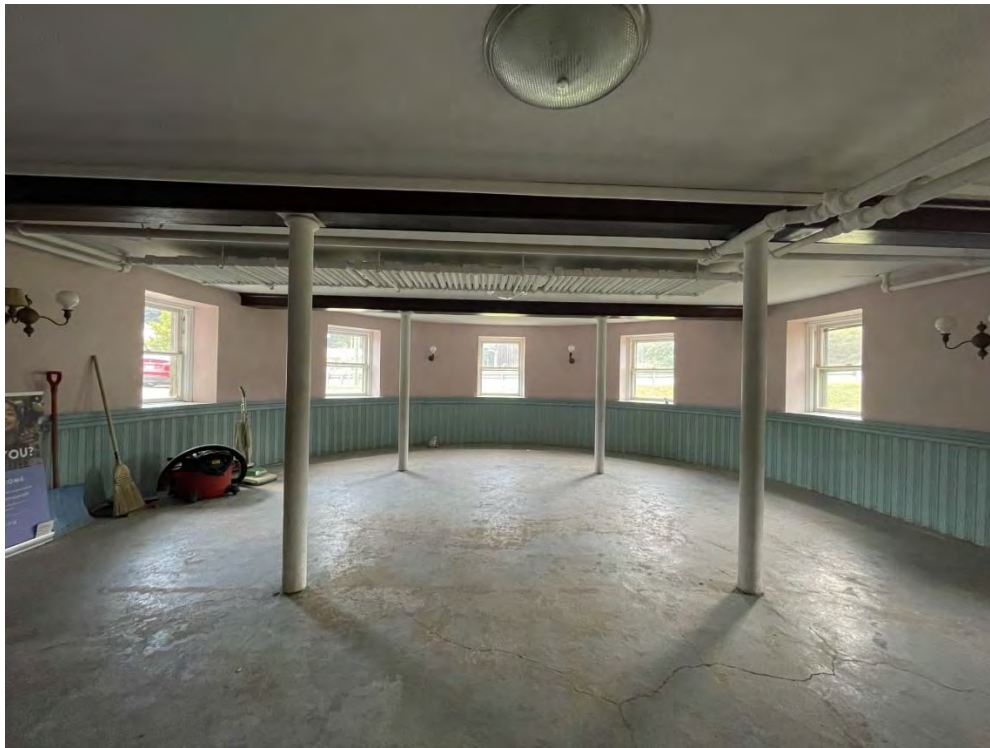
Granite Church – Existing Conditions – Interior Overall Views  
Basement – East Meeting Room Looking East  
Finishes Generally in Good Condition; Floor Needs New Surfacing

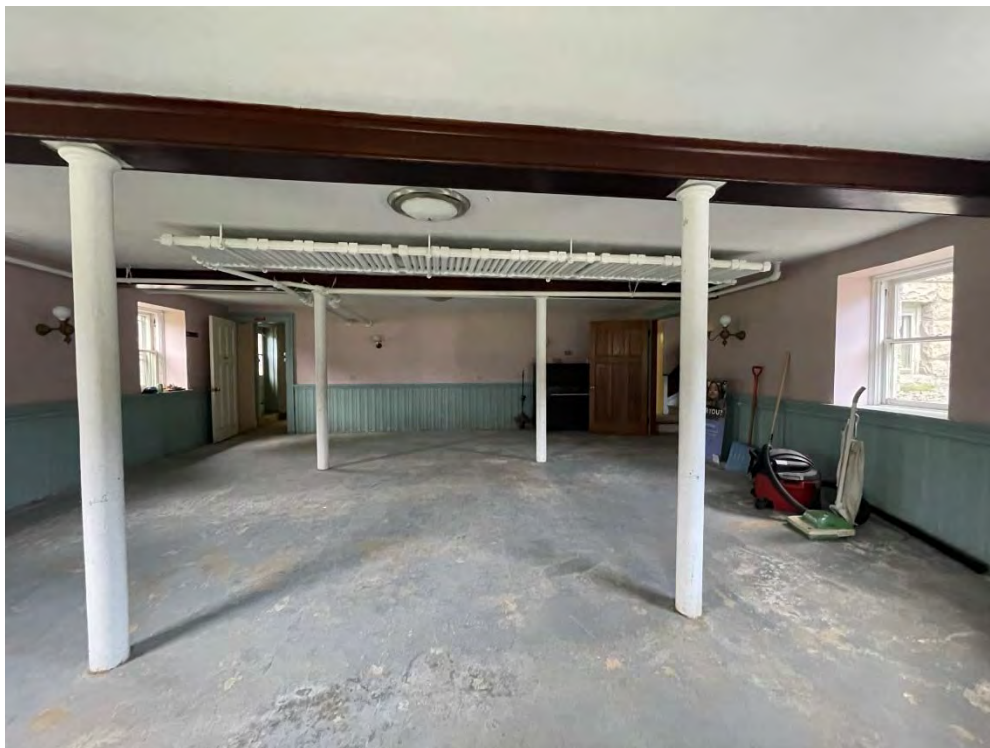
Granite Church – Existing Conditions – Interior Overall Views  
Basement – East Meeting Room Looking West  
Finishes Generally in Good Condition; Floor Needs New Surfacing

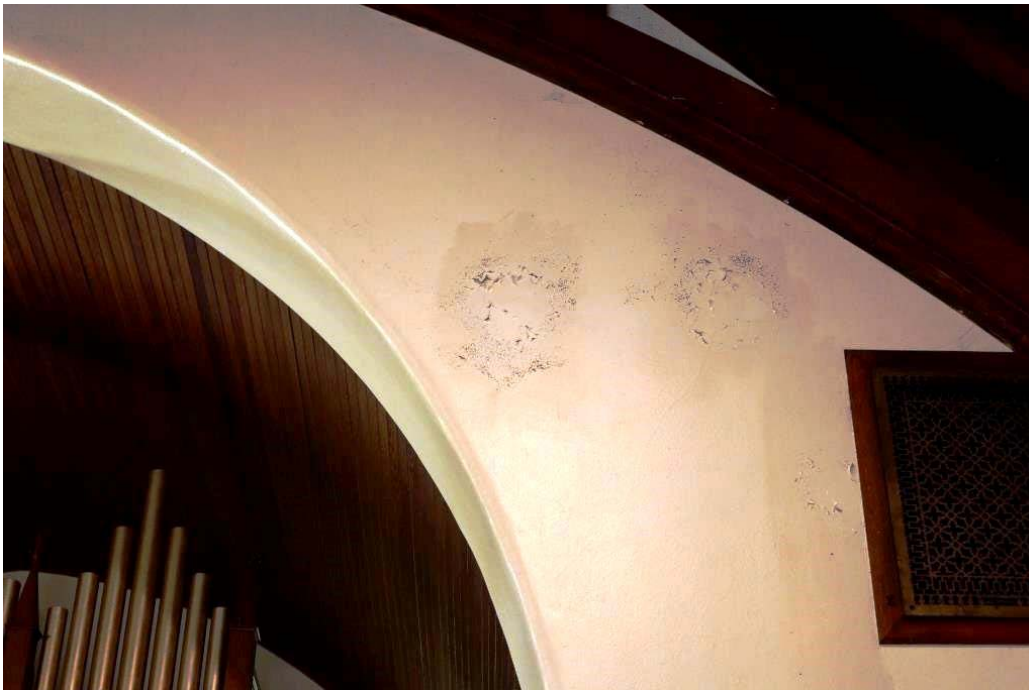
Granite Church – Existing Conditions – Interior  
South Wall in Sanctuary  
Damaged Plaster and Paint due to Previous Roof Leaks (Chimney Flashing?)

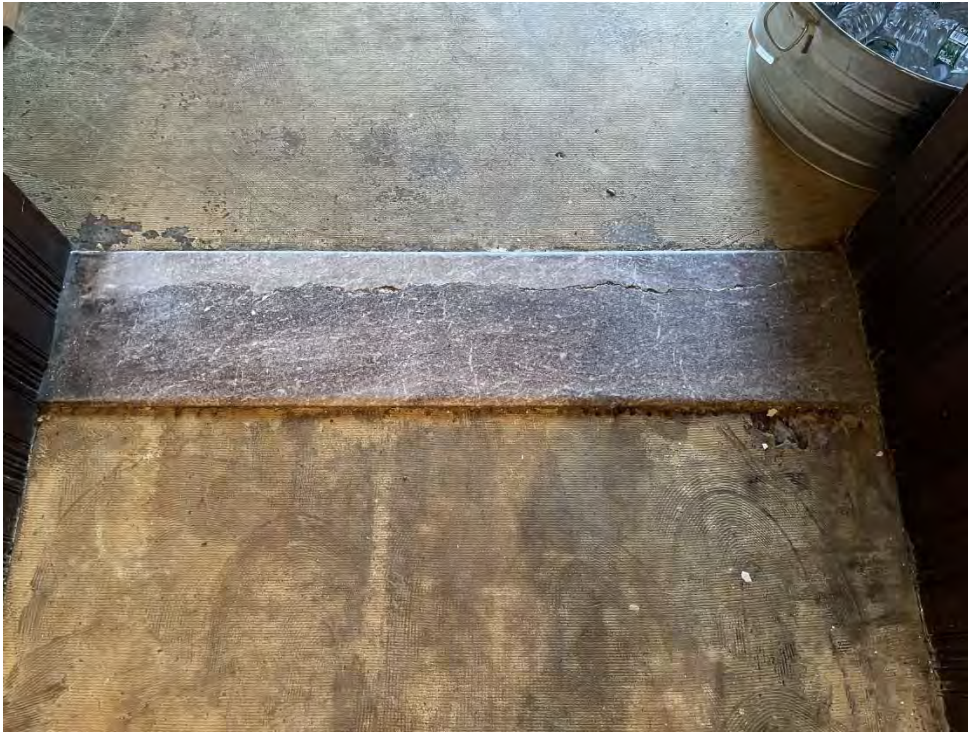
Granite Church – Existing Conditions – Interior  
First Floor - Stone Threshold Between Entrance Vestibule and Stair Hall  
Stone is Cracked Longitudinally

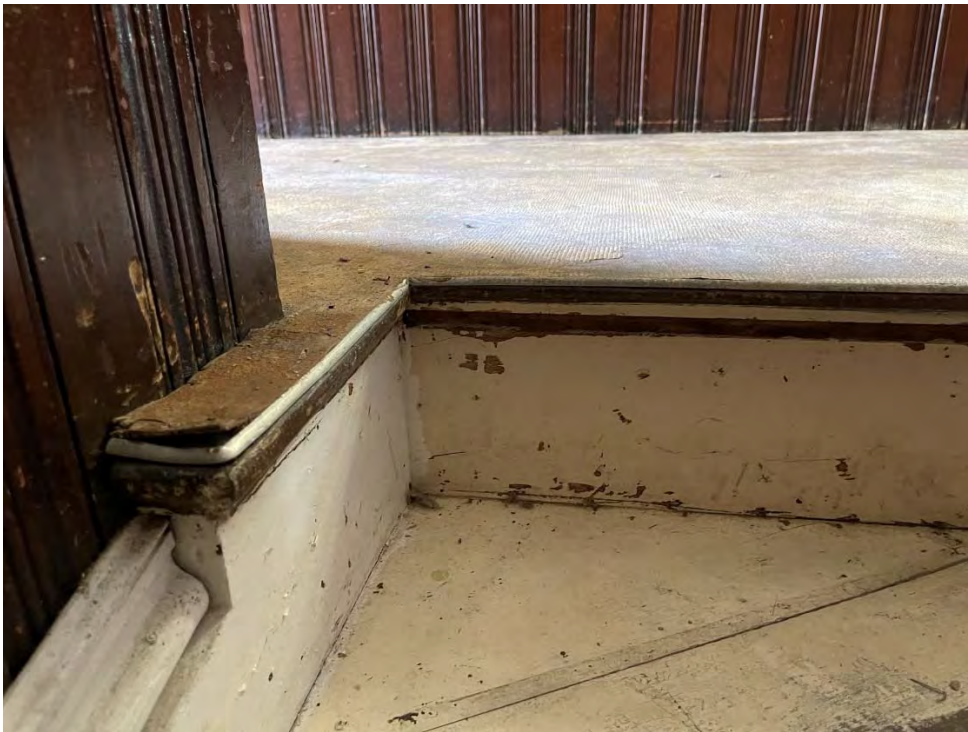
Granite Church – Existing Conditions – Interior  
First Floor - Stair Hall  
Original Wood Floor covered by Fiberboard Subfloor; Vinyl Tile has been Removed

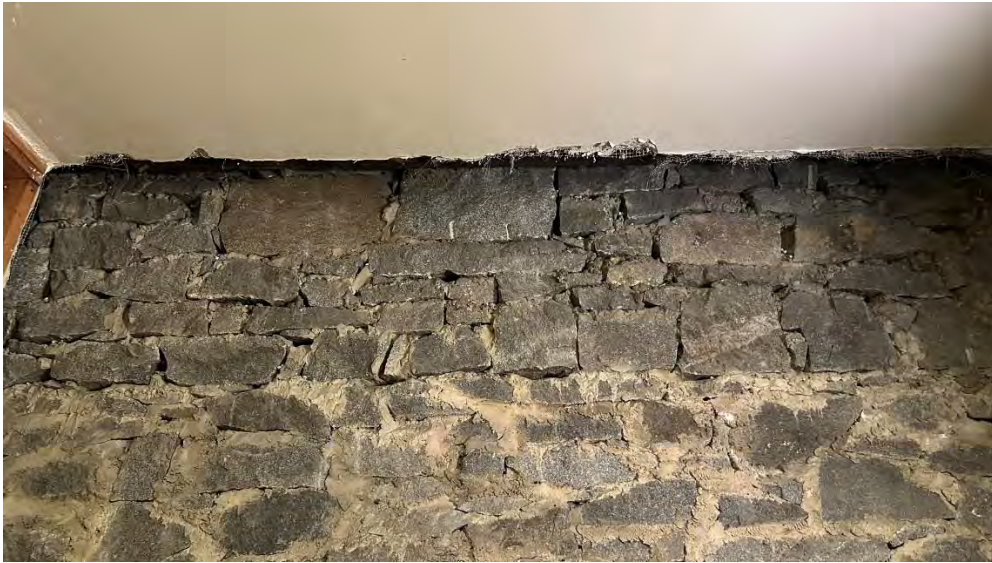
Granite Church – Existing Conditions – Interior  
Basement – West Room Under Chancel – South Wall  
Open Joints in Stonework

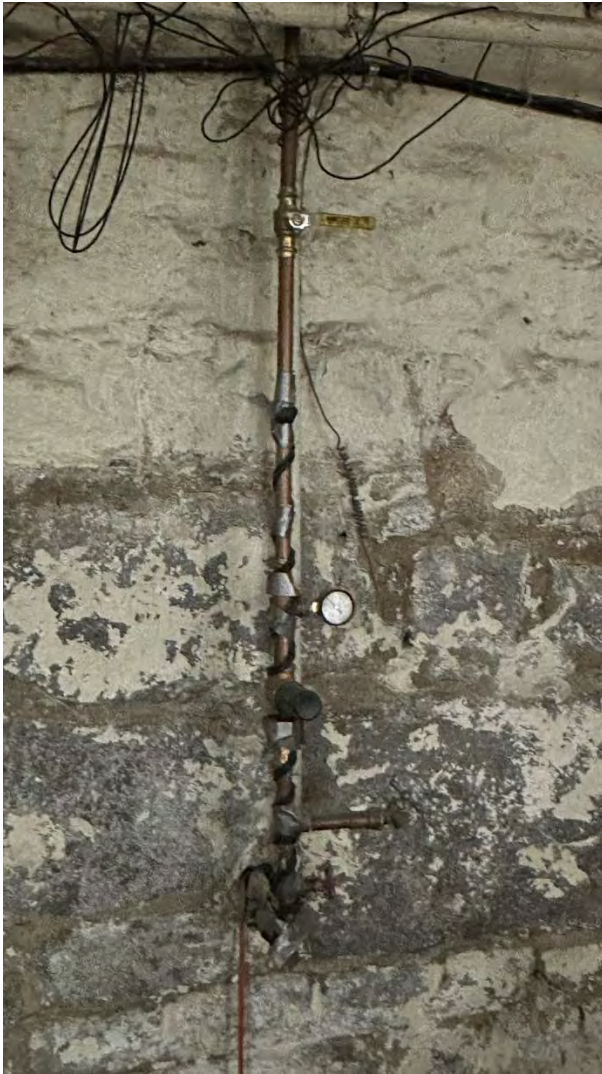
Granite Church – Existing Conditions – MEP  
Basement – Main Water Service Entrance  
Water supply currently turned off

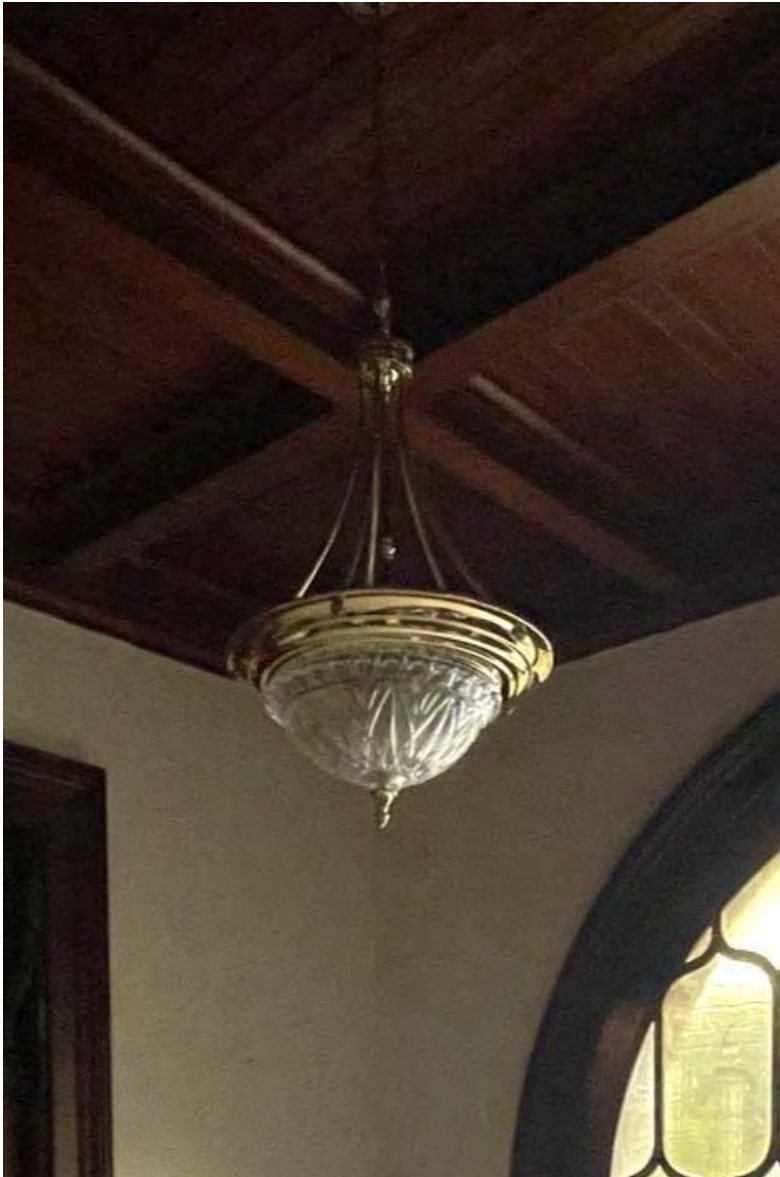
Granite Church – Existing Conditions – Lighting  
First Floor – Entrance Vestibule – Ceiling Pendant  
Replacement - In Good Condition but Inappropriate

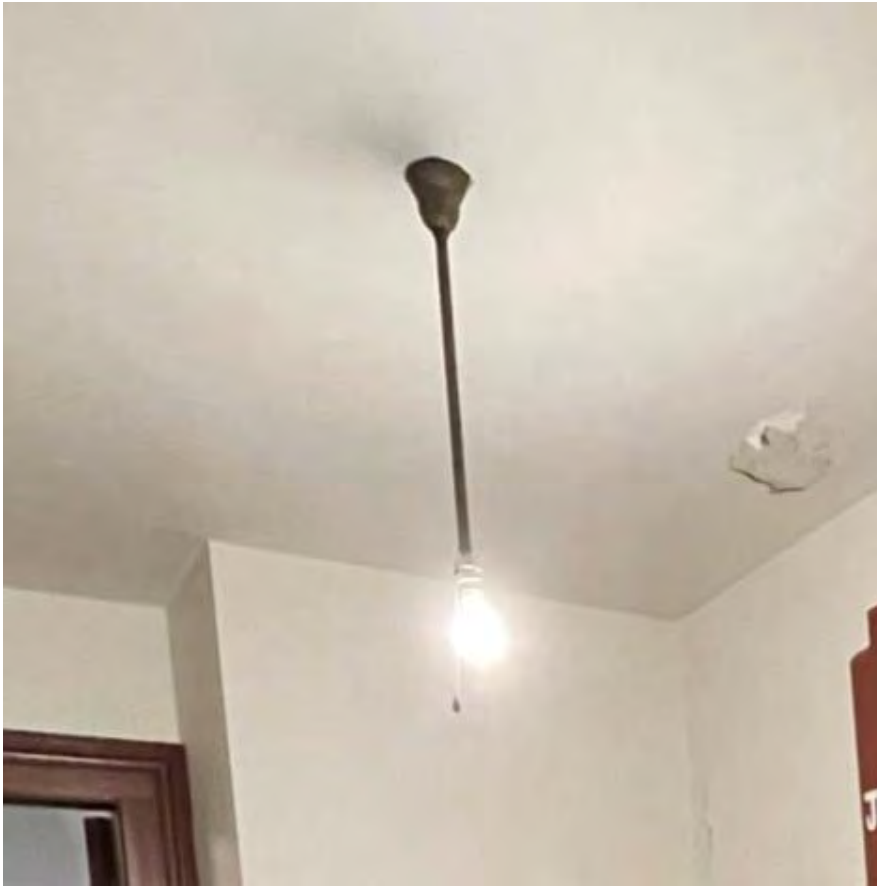
Granite Church – Existing Conditions – Lighting  
First Floor – East Meeting Room - Chandelier  
Original - In Good Condition but not Appropriate for the Space

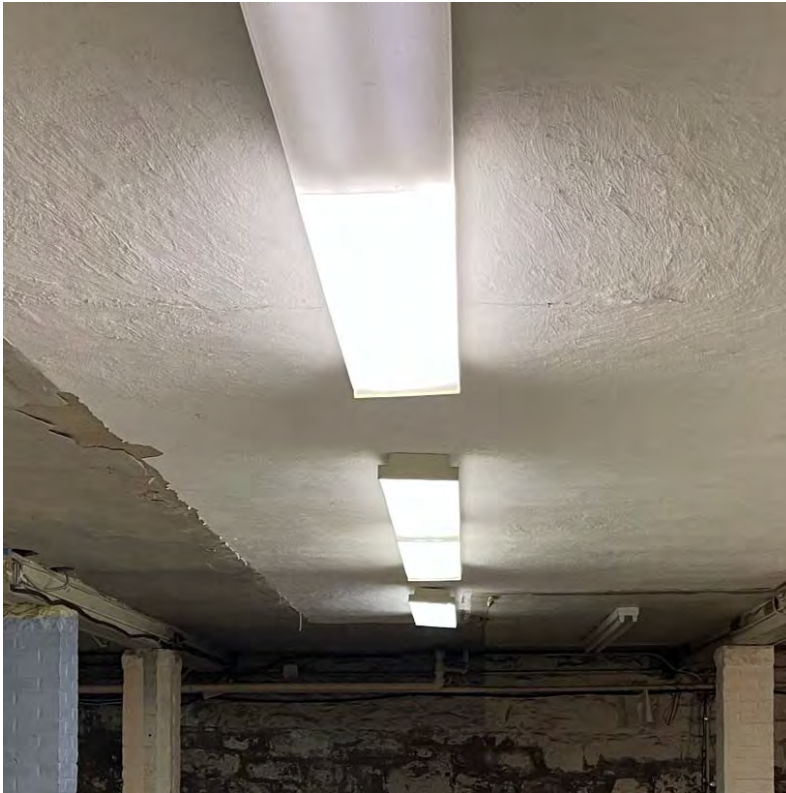
Granite Church – Existing Conditions – Lighting  
Basement – Main Space below Sanctuary – Fluorescent Strip Fixtures  
Replacement - In Good Condition but Inappropriate
