## GRANITE CHURCH

GEORGETOWN, CT

### CONDITIONS ASSESSMENT REPORT

November 17, 2023

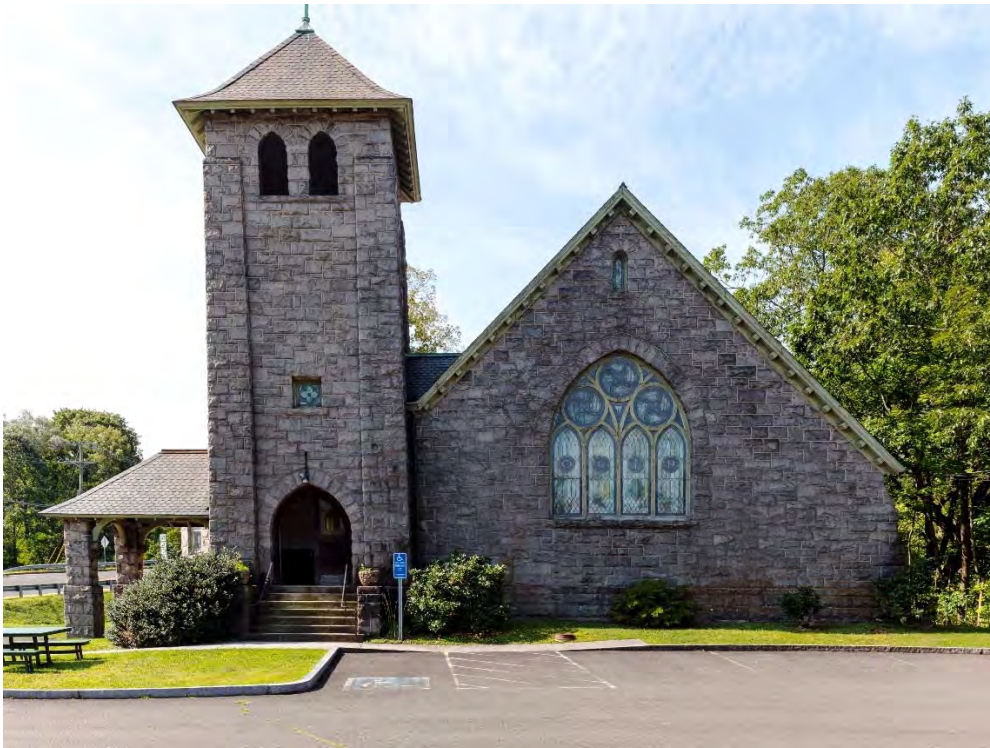
Granite Church – Existing Conditions  
North Elevation - Overall

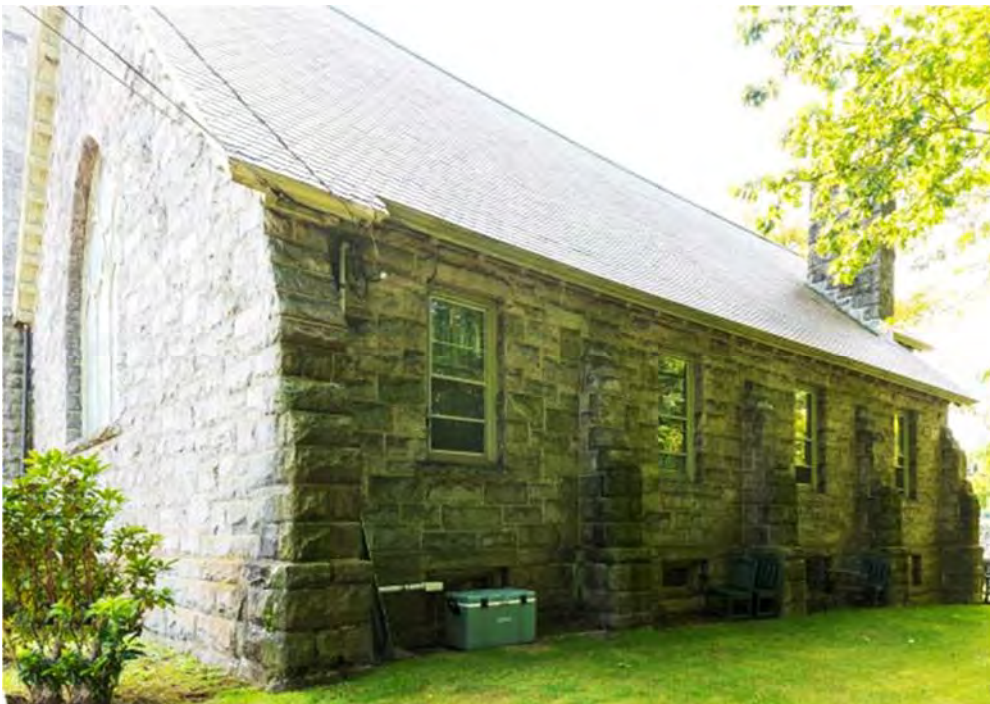
Granite Church – Existing Conditions  
West Elevation - Overall

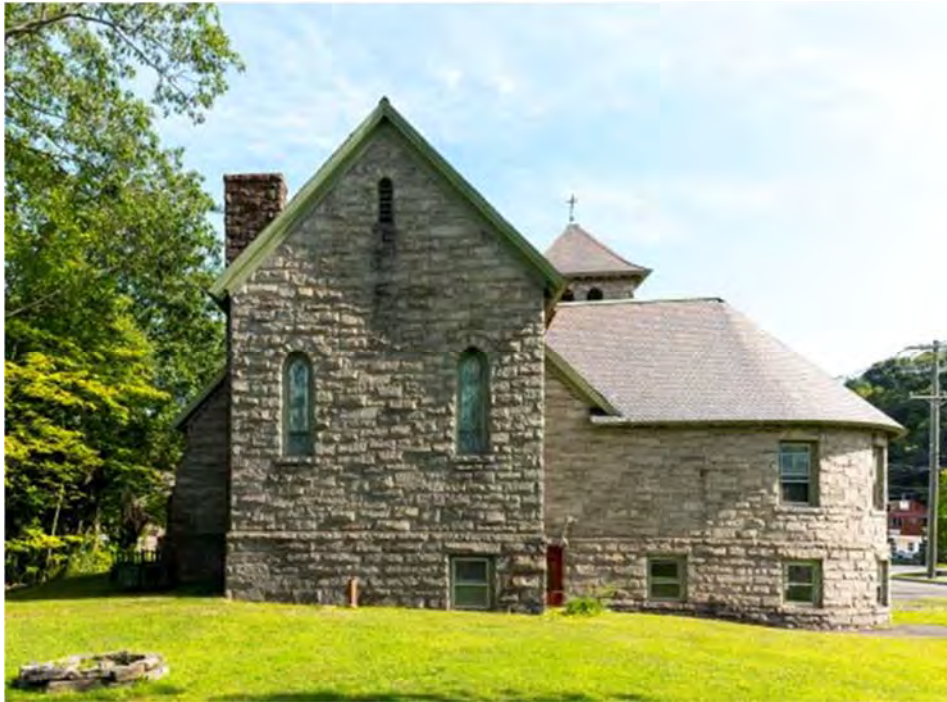
Granite Church – Existing Conditions  
South Elevation – Overall

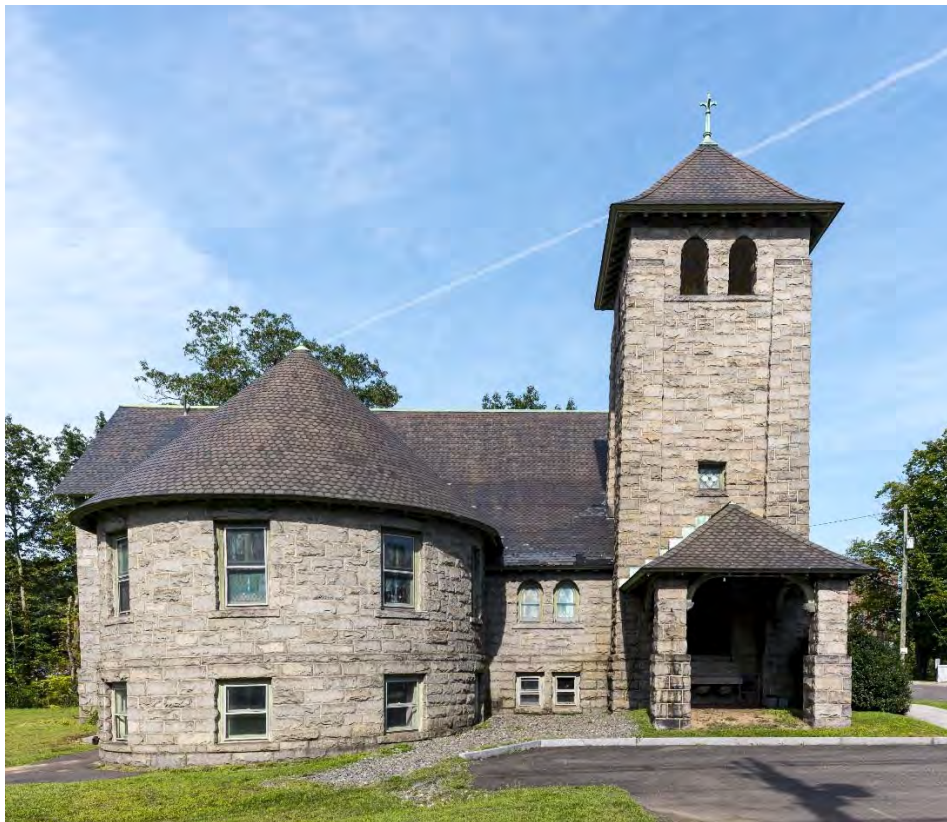
Granite Church – Existing Conditions  
East Elevation - Overall

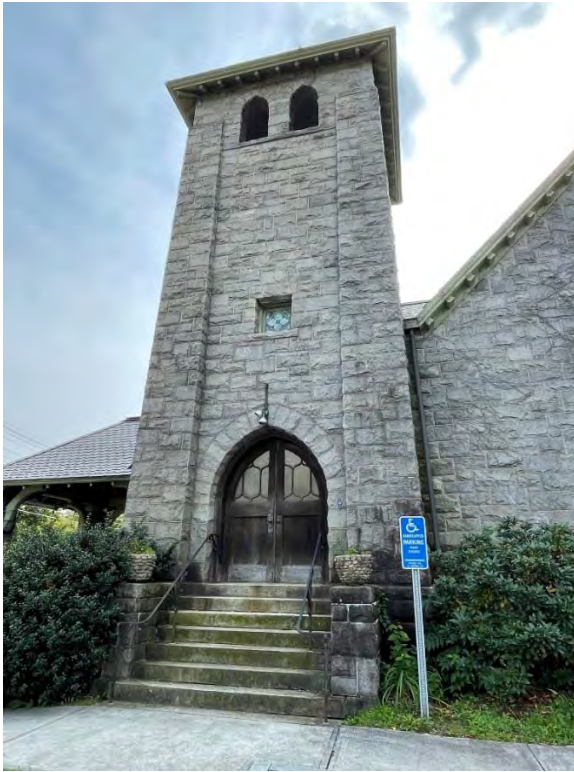
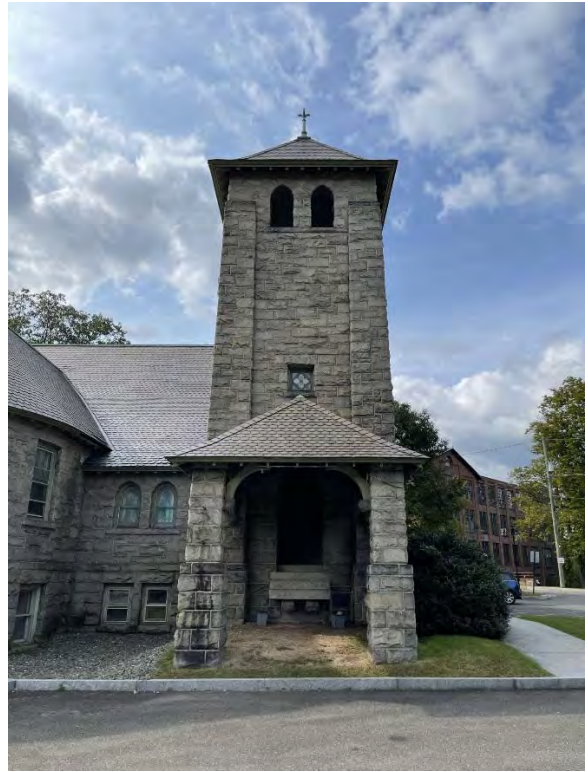
Granite Church – Existing Conditions  
North and East Tower Elevations - Overall

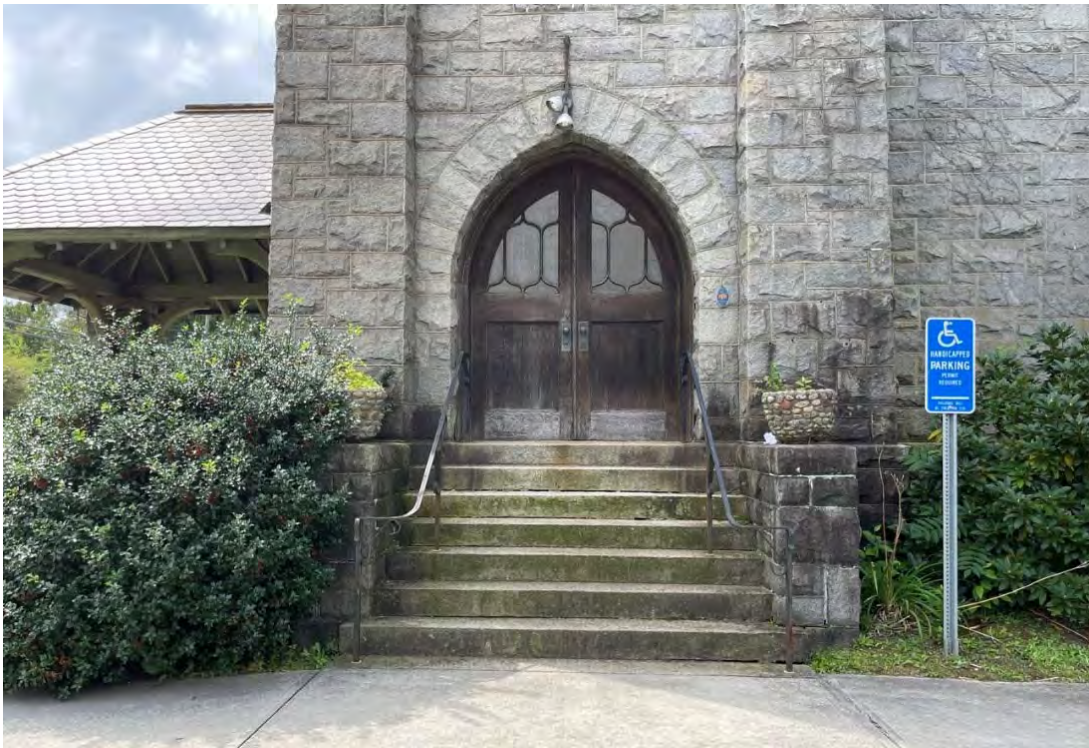
Granite Church – Existing Conditions – Exterior Masonry  
North, Main Entrance - Overall

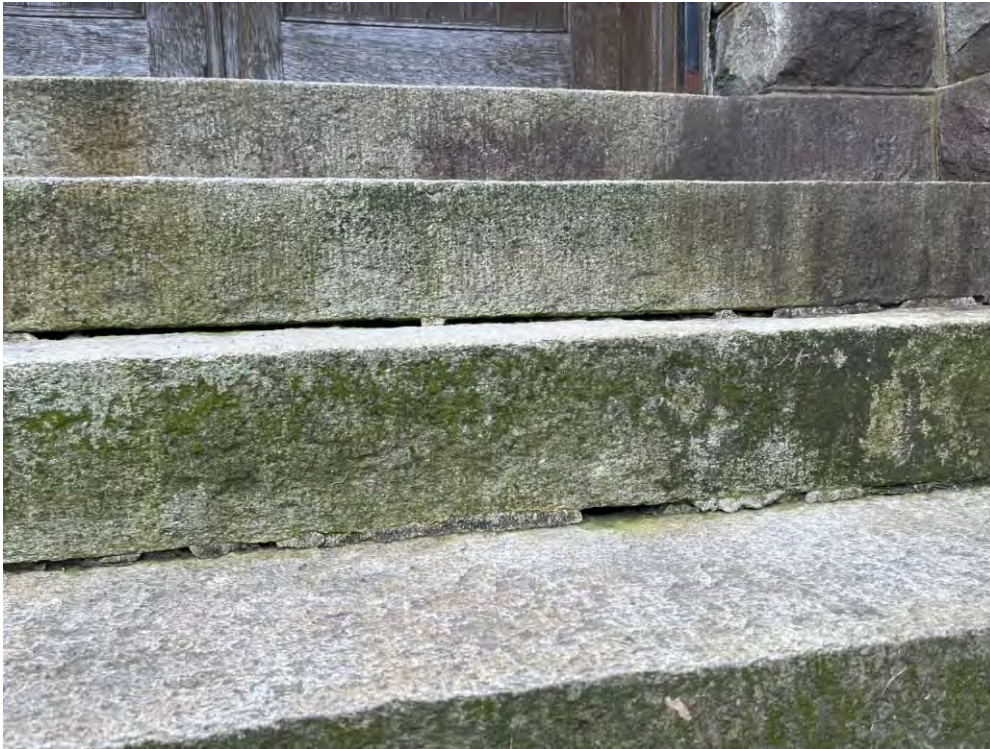
Granite Church – Existing Conditions – Exterior Masonry  
North, Main Entrance Steps – Open Joints in Steps

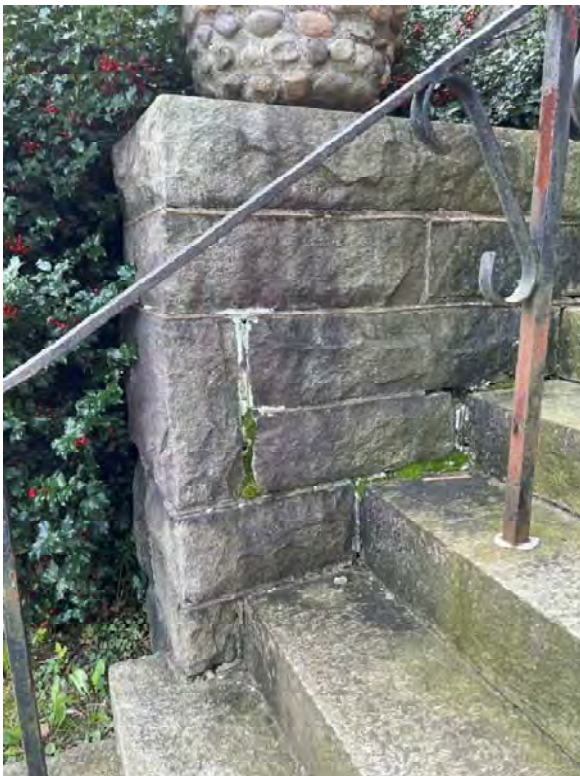
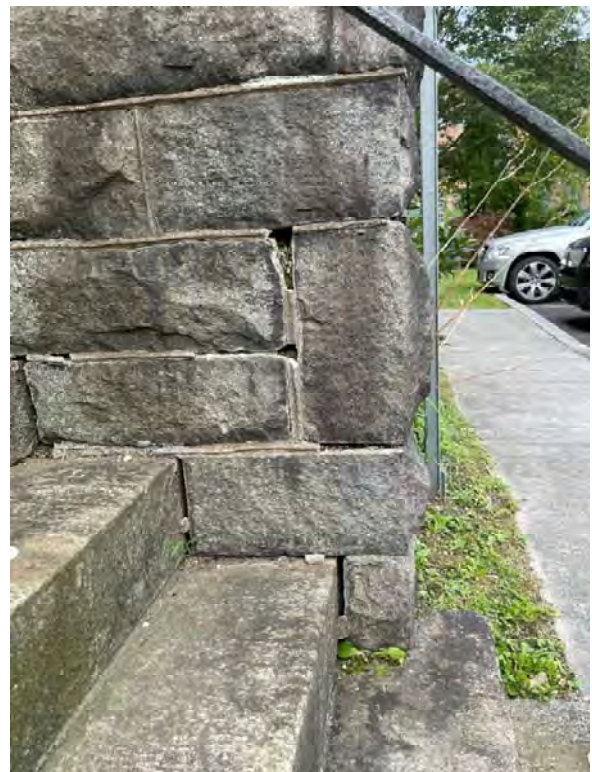
Granite Church – Existing Conditions – Exterior Masonry  
North, Main Entrance Steps – Open Joints in Stone at Sidewalls

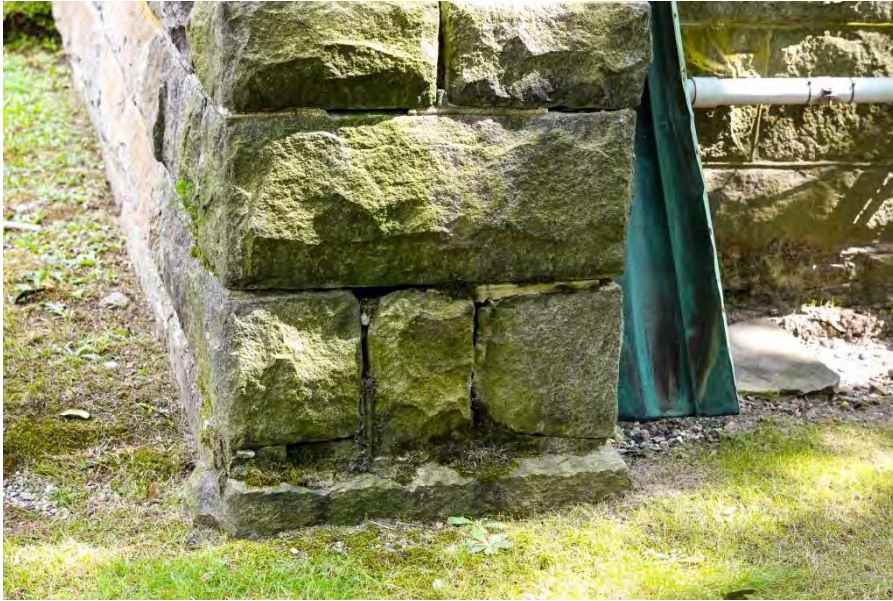
Granite Church – Existing Conditions – Exterior Masonry  
West Elevation – North Buttress – West Face - Open Joints and Staining

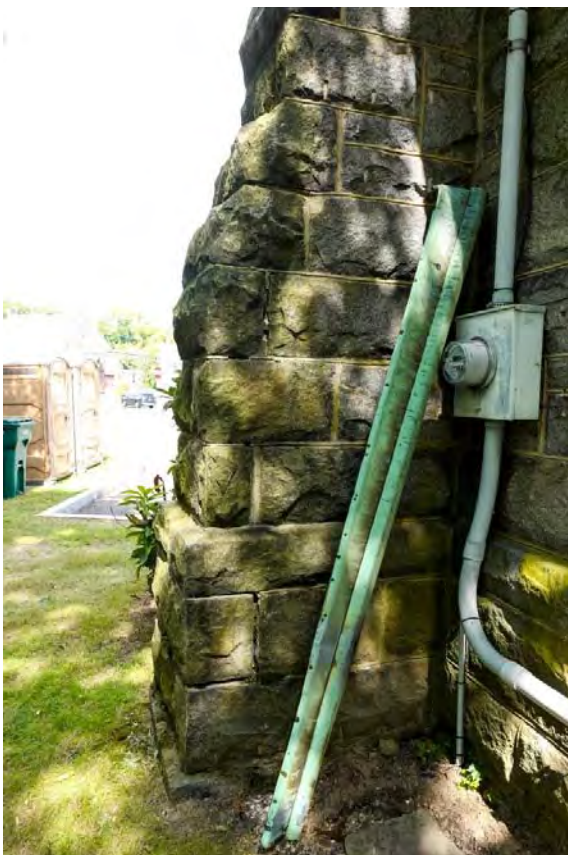
Granite Church – Existing Conditions – Exterior Masonry  
West Elevation – North Buttress – South Face – Open Joints and Staining

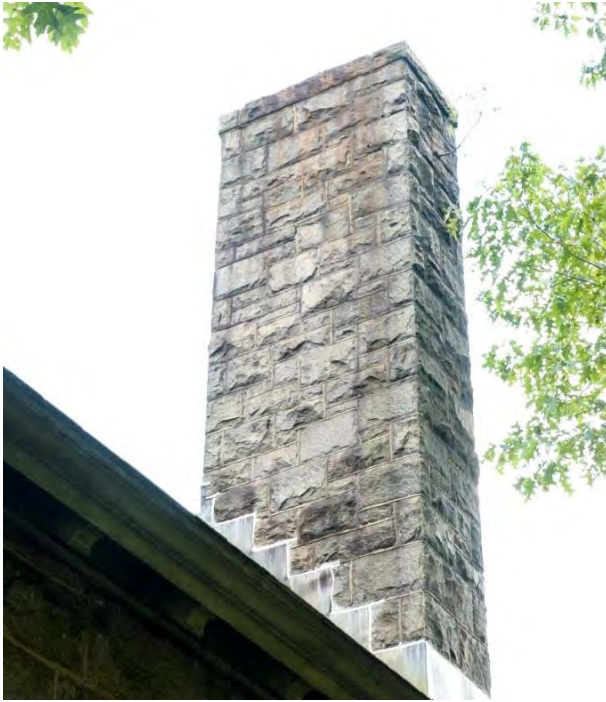
Granite Church – Existing Conditions – Exterior Masonry  
West Elevation – Chimney at Southwest Corner – North and West Faces - Staining

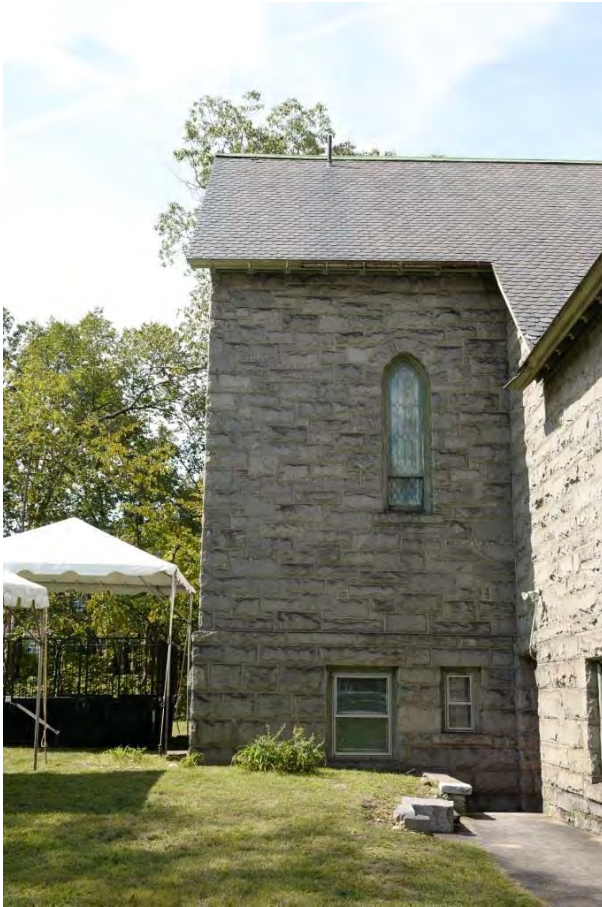
Granite Church – Existing Conditions – Exterior Masonry  
East Elevation – East Wall of Chancel

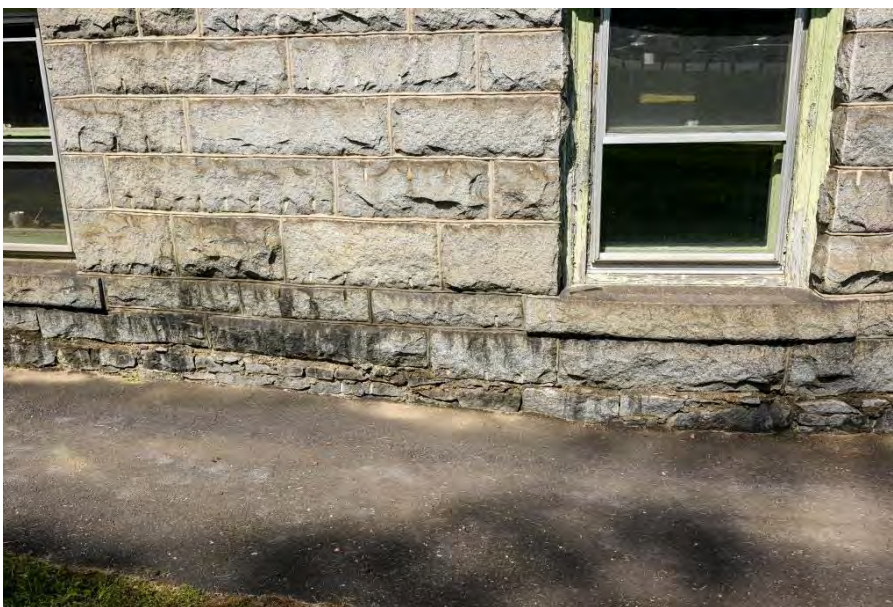
Granite Church – Existing Conditions – Exterior Masonry  
East Elevation – East Wall of Chancel – Staining at Base of Wall

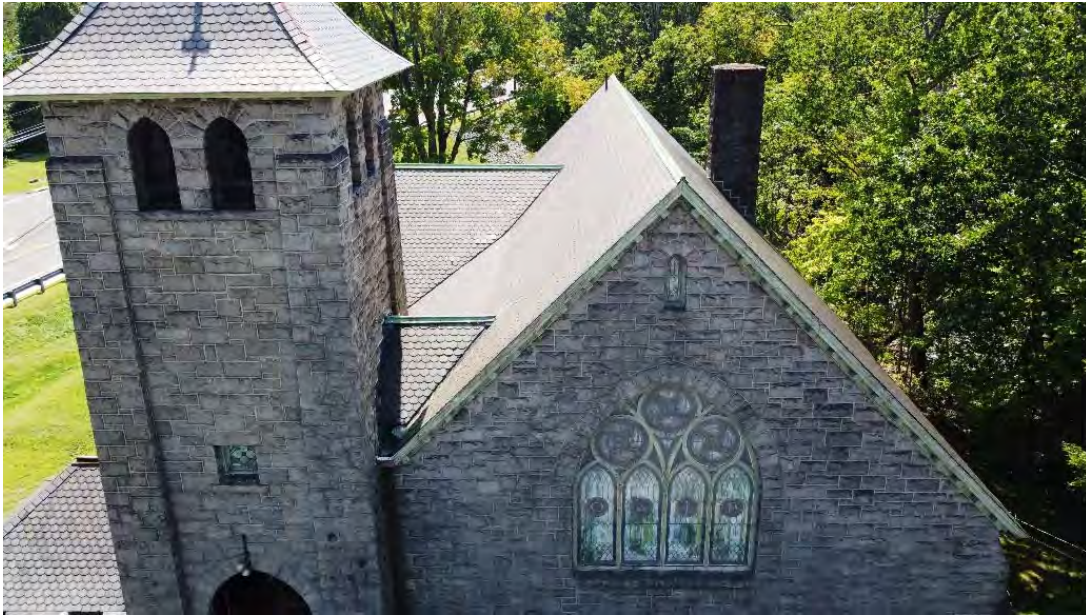
Granite Church – Existing Conditions – Roof and Drainage  
Overall Aerial View from North

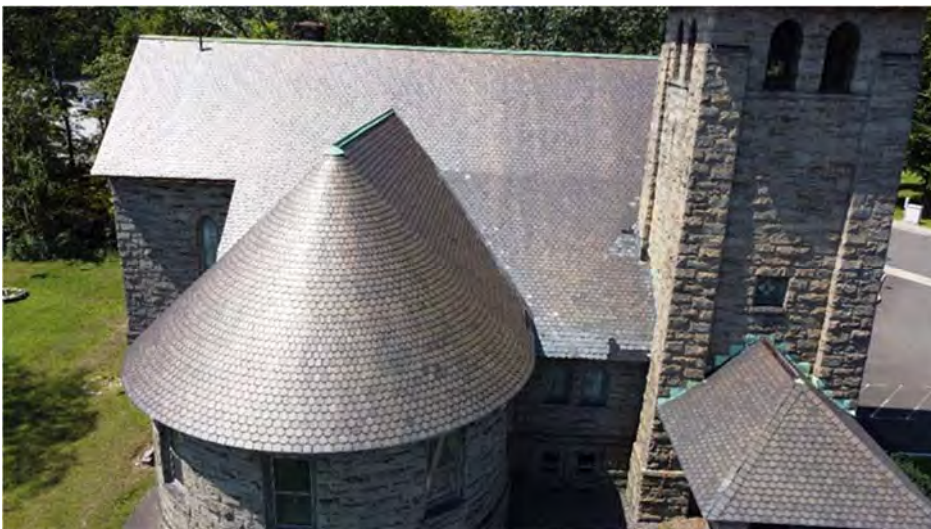
Granite Church – Existing Conditions – Roof and Drainage  
Overall Aerial View from East

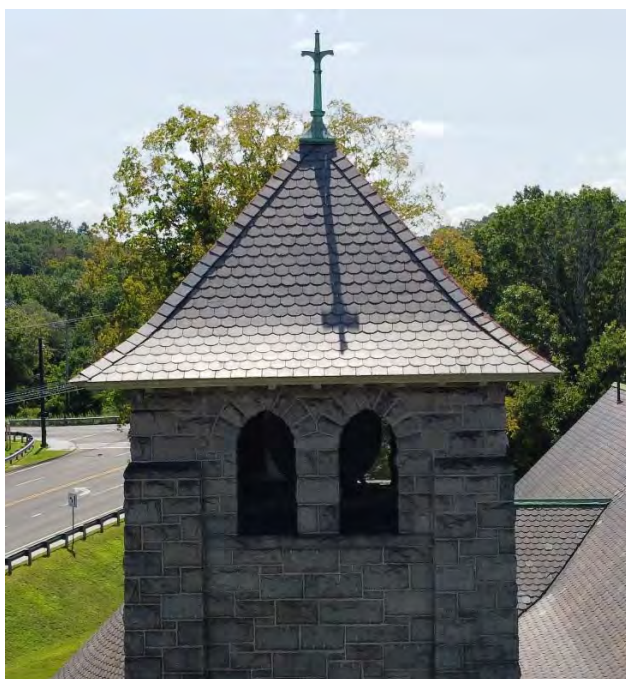
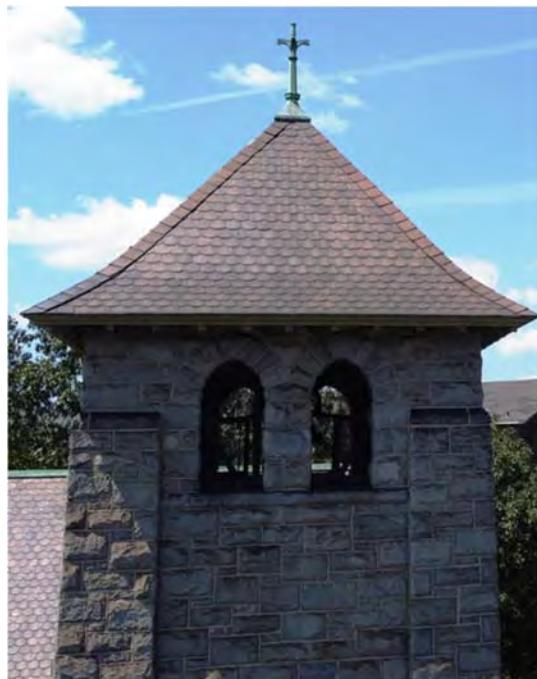
Granite Church – Existing Conditions – Roof and Drainage  
Tower Roof – Left: Overall Aerial View from North; Right; Overall Aerial View from East  
Roof Appears to be in Good Condition

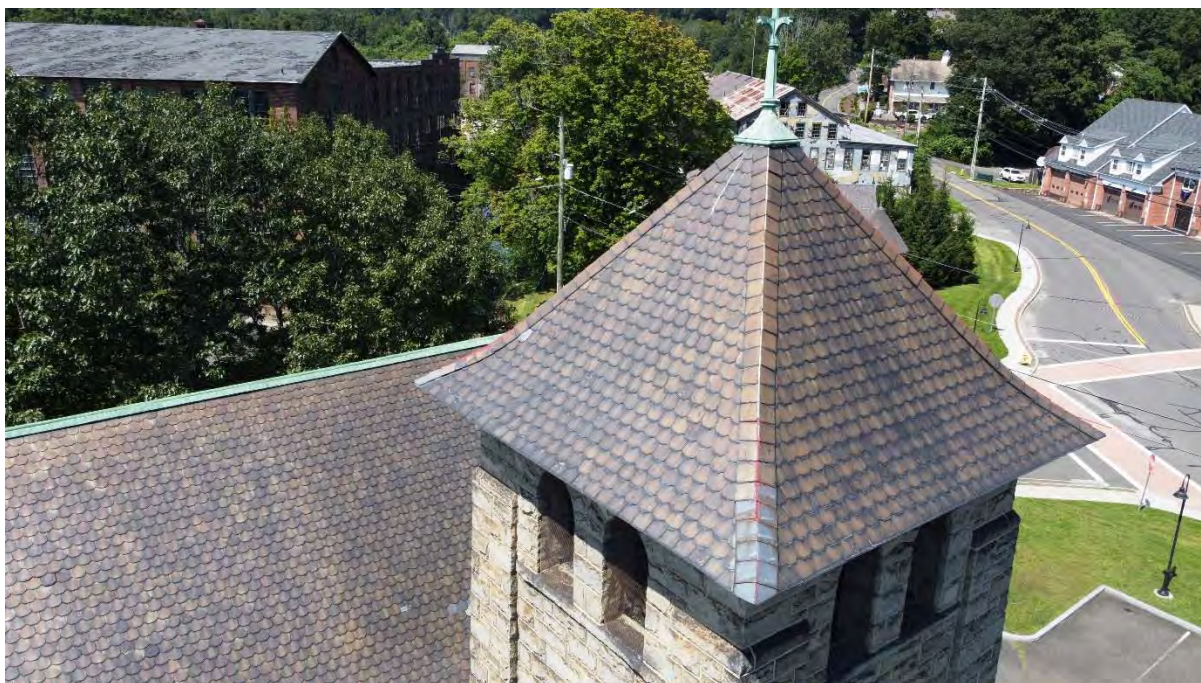
Granite Church – Existing Conditions – Roof and Drainage  
Tower Roof – Overall Aerial View from Southwest  
Roof Appears to be in Good Condition

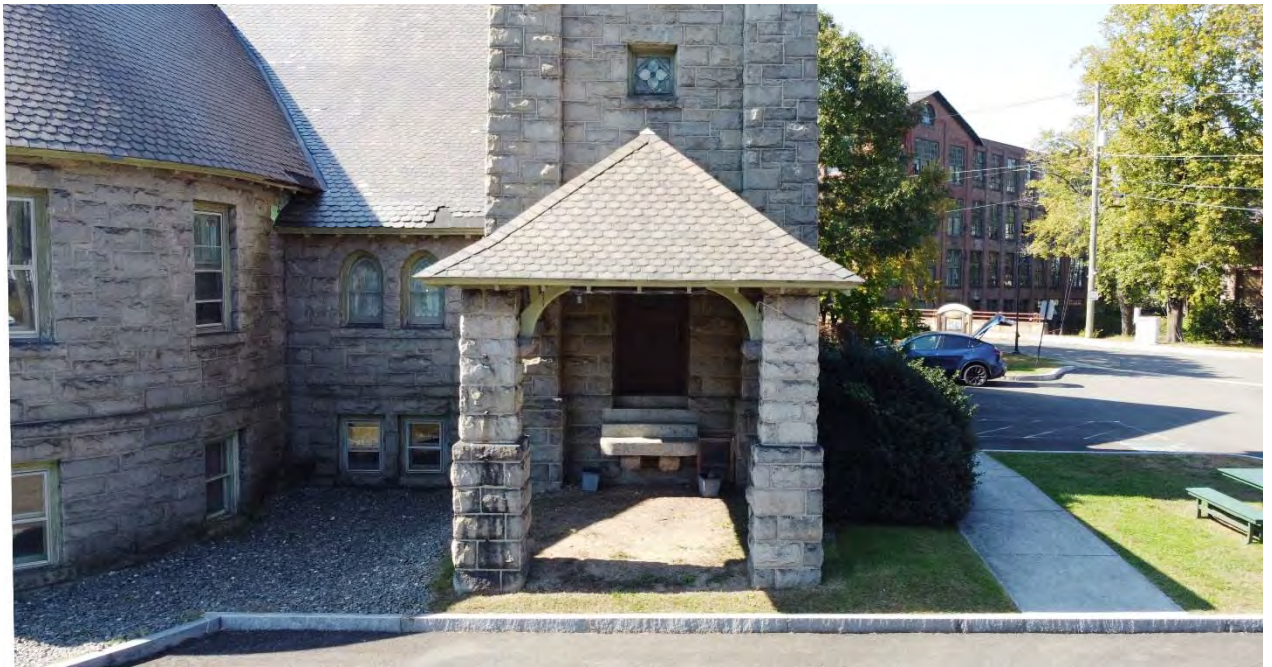
Granite Church – Existing Conditions – Roof and Drainage  
Porte Cochere/Carriage Entrance Roof – Overall View from East  
Roof Appears to be in Good Condition

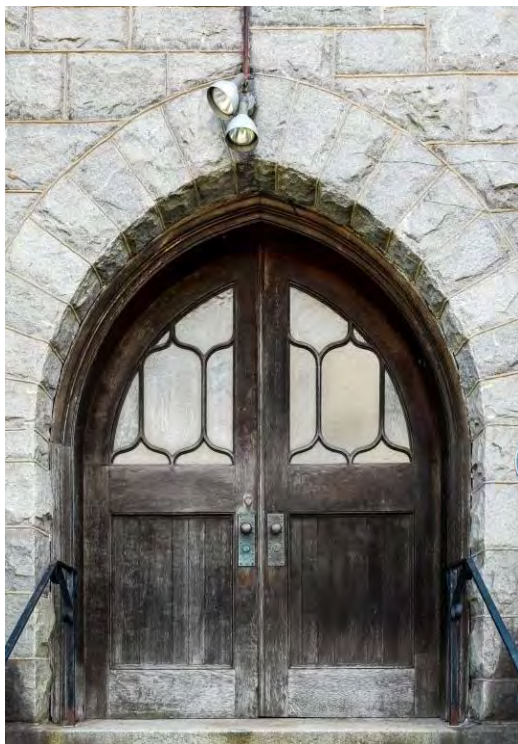
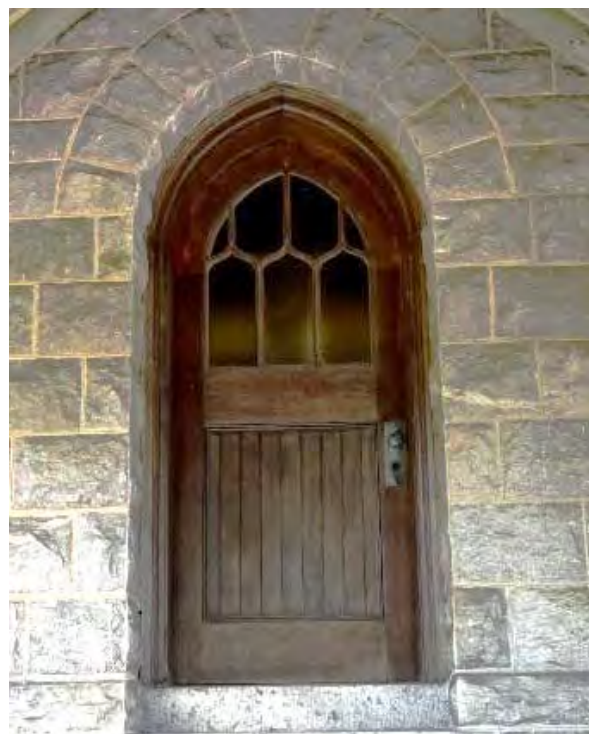
Granite Church – Existing Conditions– Doors and Windows

Left: Main, North, Main Entrance Doors; Right: East Door at Porte Cochere Carriage Entrance

Doors Exhibit Wear and surface deterioration from Exposure to Elements

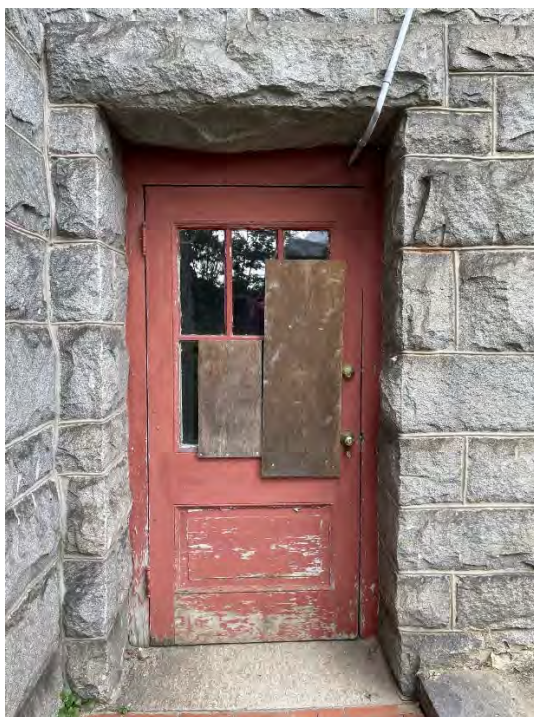
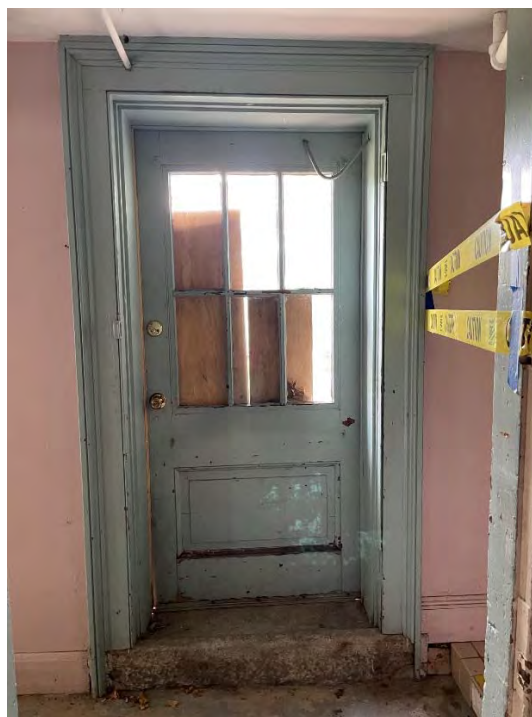
Granite Church – Existing Conditions – Doors and Windows

Basement Entrance Door on South Elevation - Left: Exterior View; Right: Interior View

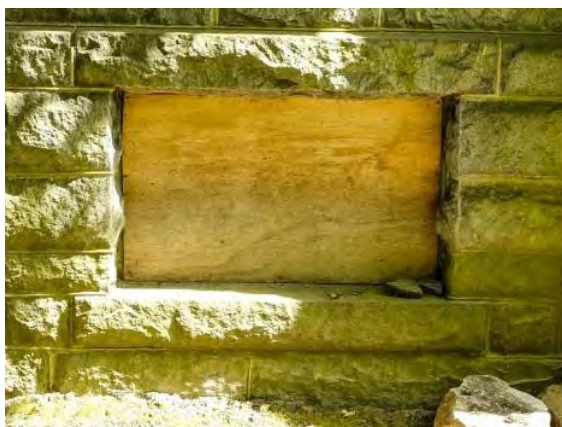
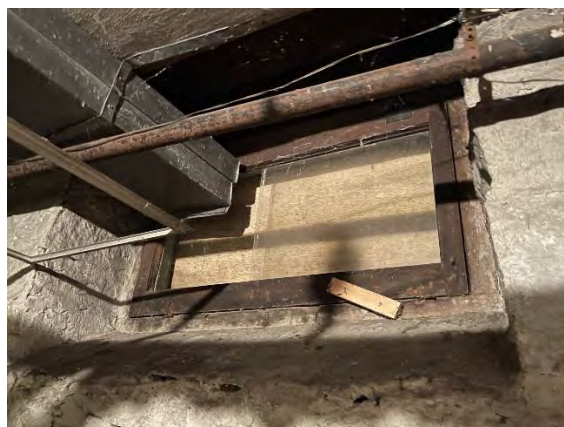
Typical West Wall Basement Window - Left: Exterior View; Right: Interior View

Minor Repairs Necessary for Window Frame and Trim; Window Frame is Worn and in Need of Painting

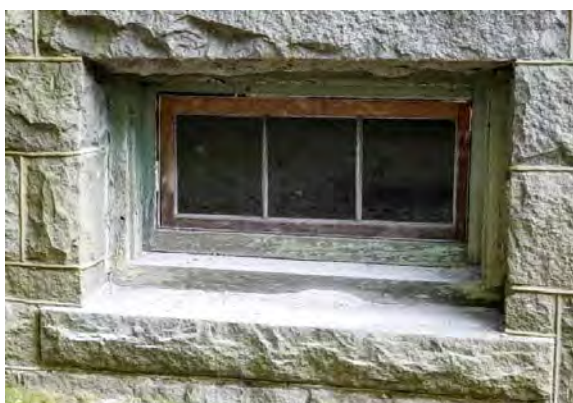
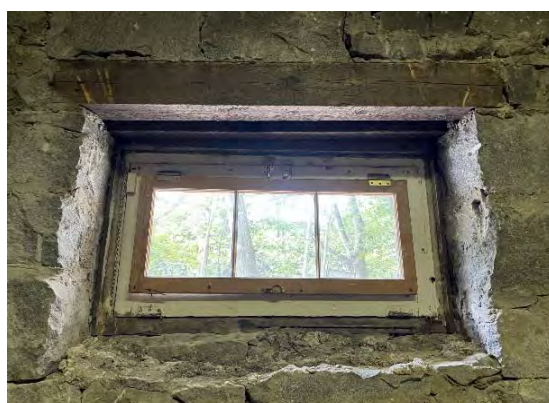
West Wall Basement Window at Boiler Room - Left: Exterior View; Right: Interior View

Window Sealed and Altered for Venting of Boiler; Minor Repairs Necessary for Window Frame and Trim; Frame is Worn and in Need of Painting

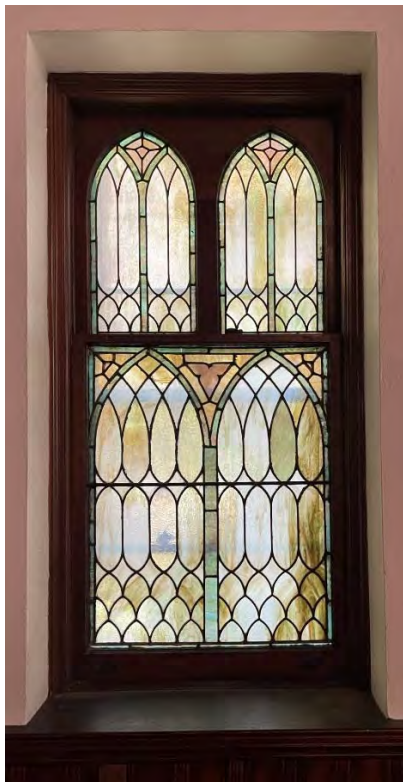
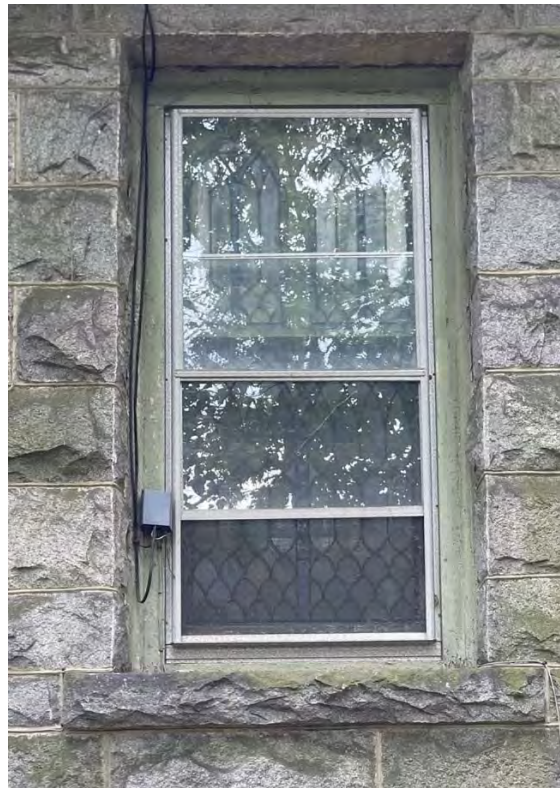
First Floor - Small Stained-Glass Window on North Wall of Sanctuary (Above Large Stained-Glass Window)

Window Appears to be in Good Condition; Wood Frame is Worn and in Need of Painting

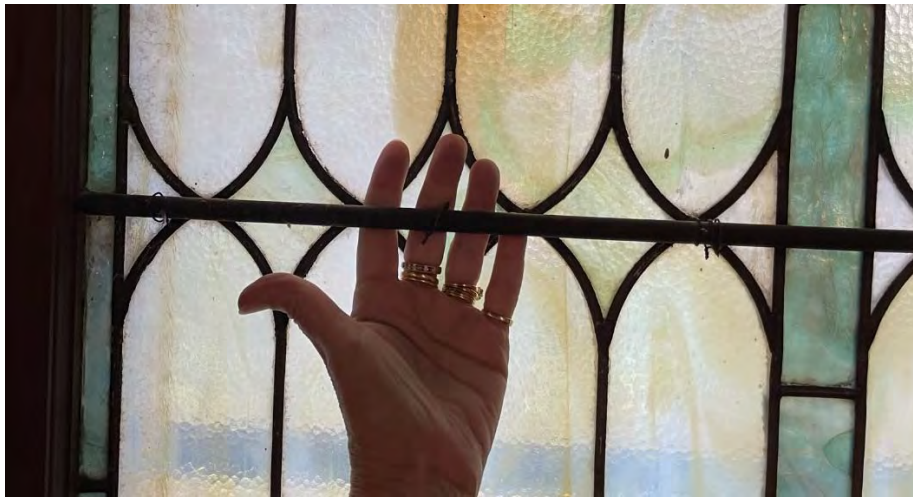
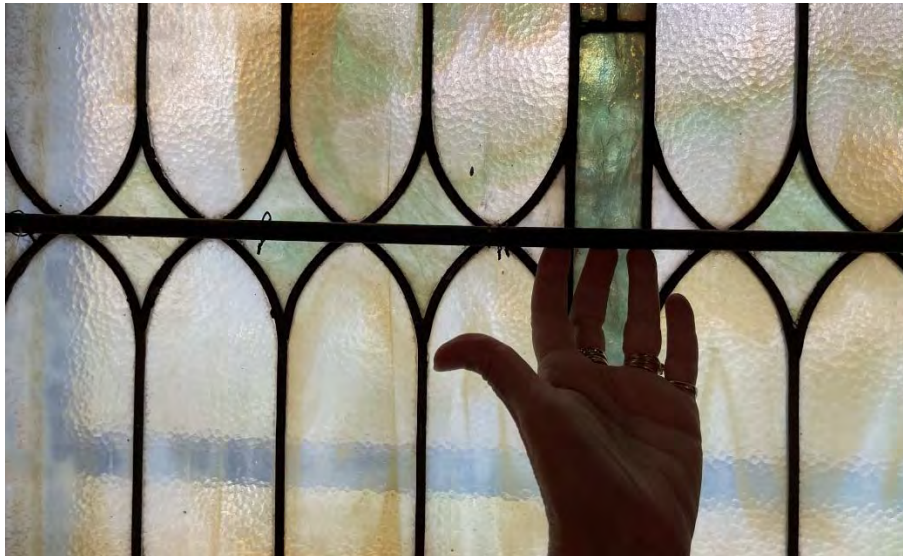
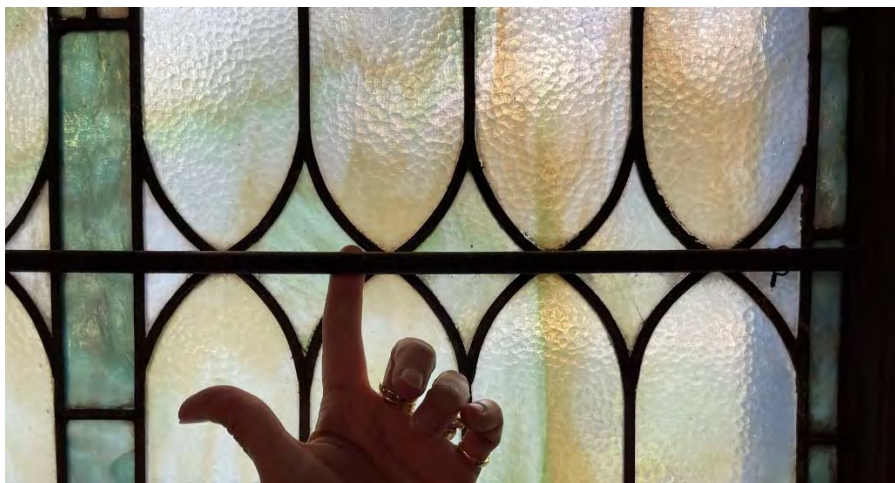
Granite Church – Existing Conditions – Doors and Windows  
First Floor - Typical Double-Hung Stained-Glass Window on West Wall in Sanctuary  
Typical Example of Cracked Glass

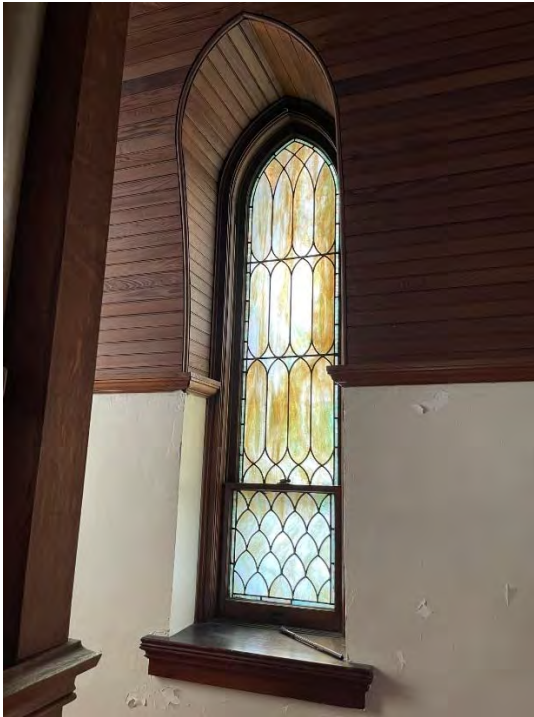
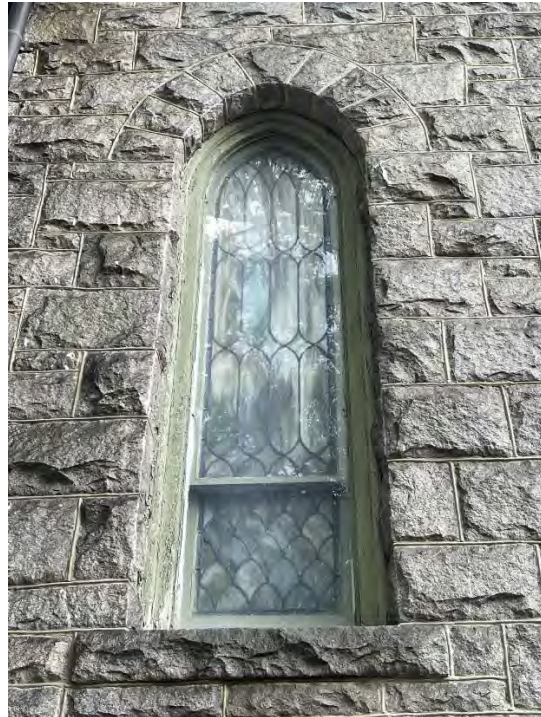
Granite Church – Existing Conditions – Doors and Windows  
First Floor – Double-Hung Stained-Glass Window on West Wall in Sanctuary – Window Second from South  
Separation of Window from Frame at top of Bottom Sash

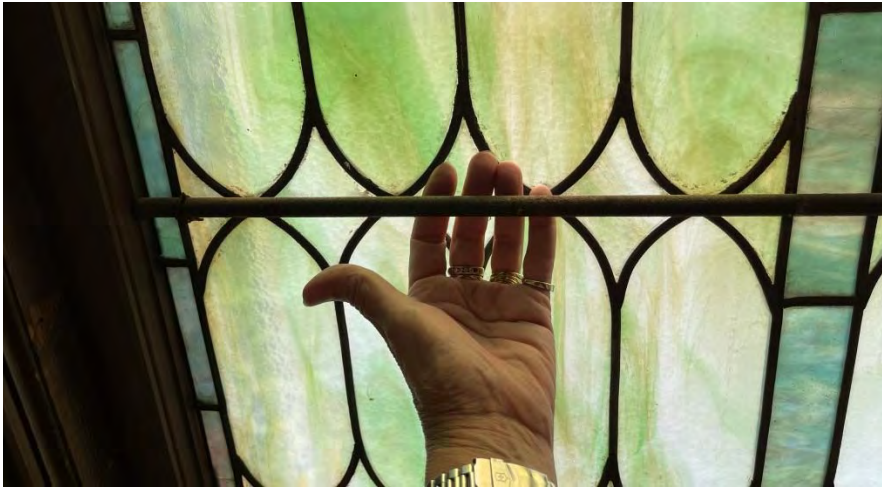
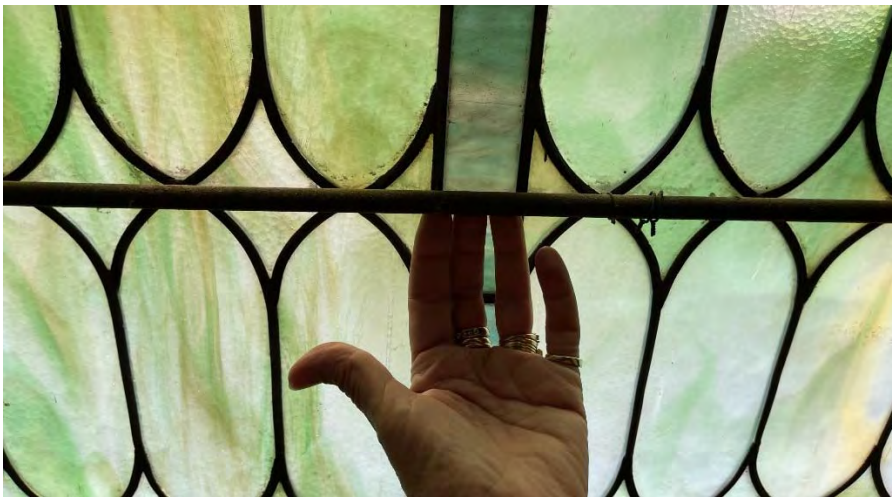
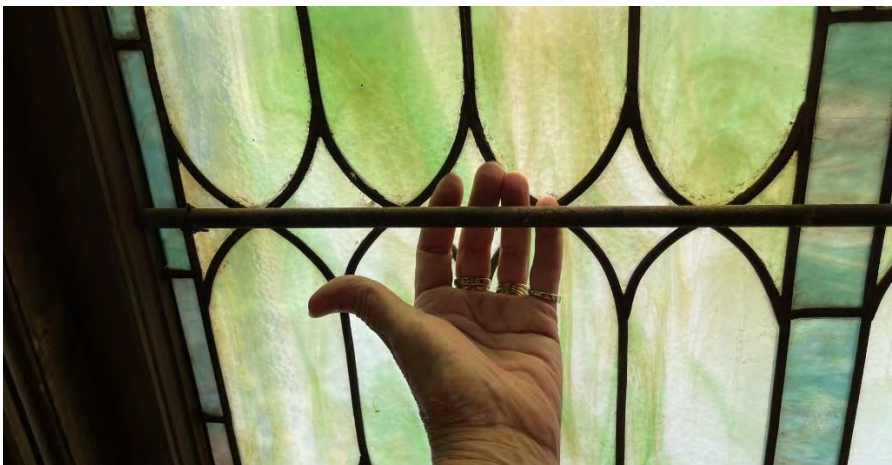
Granite Church – Existing Conditions – Doors and Windows  
First Floor – Double-Hung Stained-Glass Window in East Meeting Room – East-most Window  
Deflection of Lead Comes and Glass at Base of Window

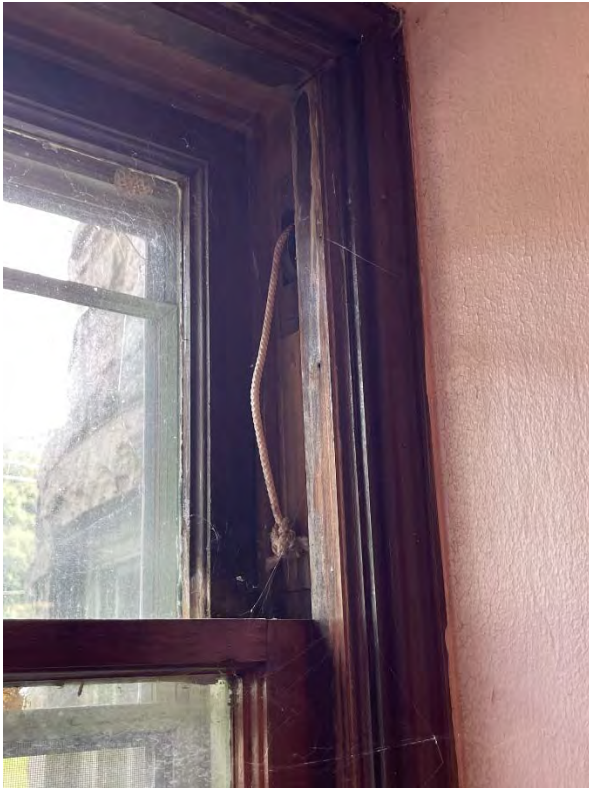
Granite Church – Existing Conditions – Doors and Windows  
Basement – Double-Hung Windows in Stair Hall  
Exterior View – Wood Frame in Need of Painting

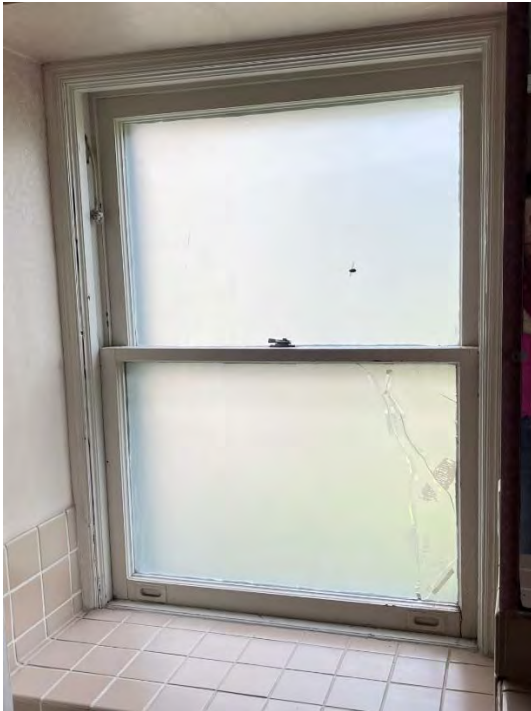
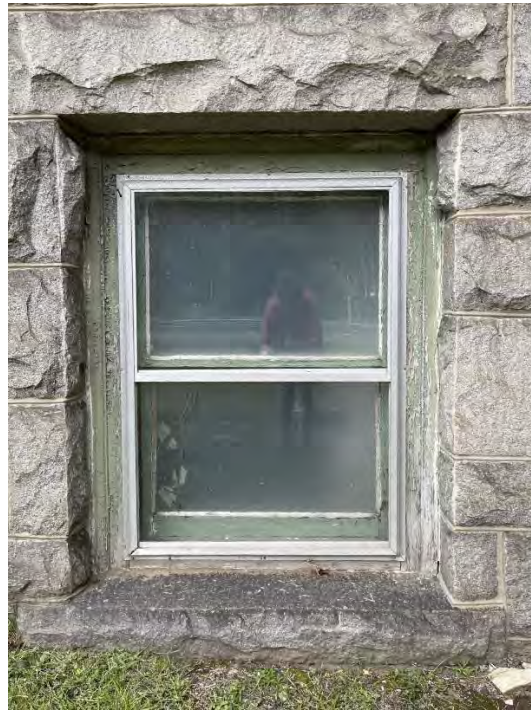
Granite Church – Existing Conditions – Doors and Windows  
Basement – Double-hung Window in Stair Hall  
Broken Glass in Storm Window – Wood Frame in Need of Painting

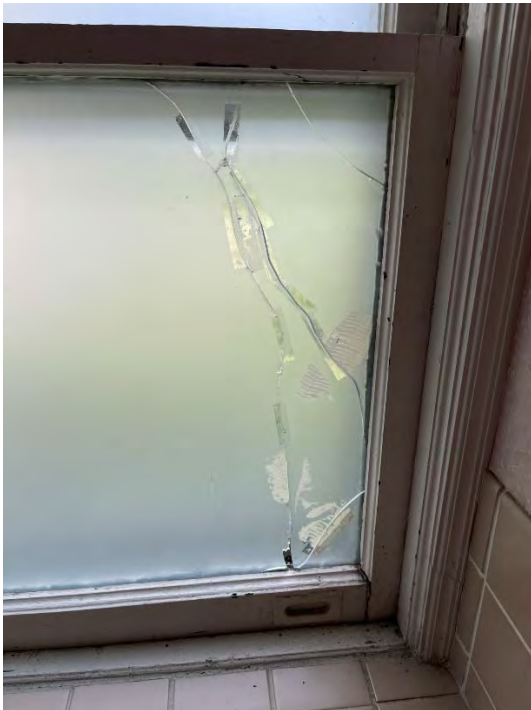
Granite Church – Existing Conditions – Doors and Windows  
Basement – Typical Double-Hung Window in Women's Toilet  
Left: Interior View; Right: Exterior View – Wood Frame in Need of Painting, Inappropriate Storms Generally in Good Condition

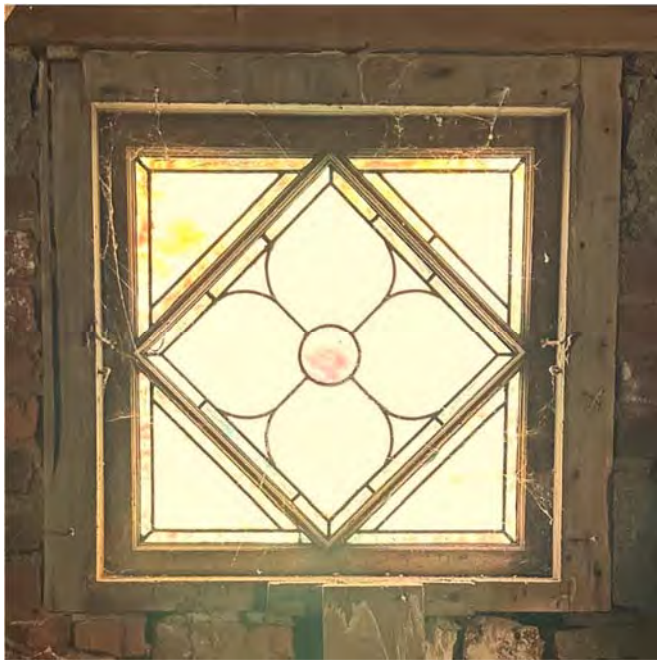
Granite Church – Existing Conditions – Doors and Windows  
Basement – Double-Hung Window in Women's Toilet  
Cracked Glass

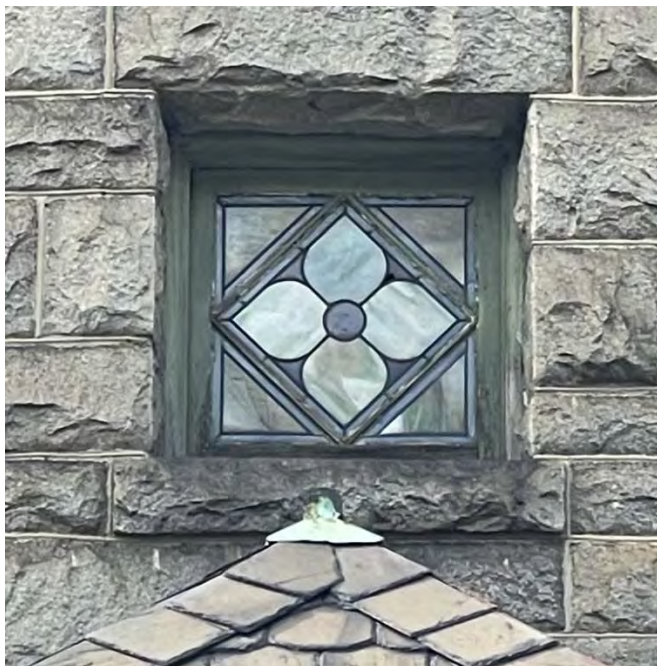
Granite Church – Existing Conditions – Doors and Windows  
Tower - Typical Fixed Stained-Glass Window  
Interior View - Generally in Good Condition
