## GRANITE CHURCH

GEORGETOWN, CT

### CONDITIONS ASSESSMENT REPORT

November 17, 2023

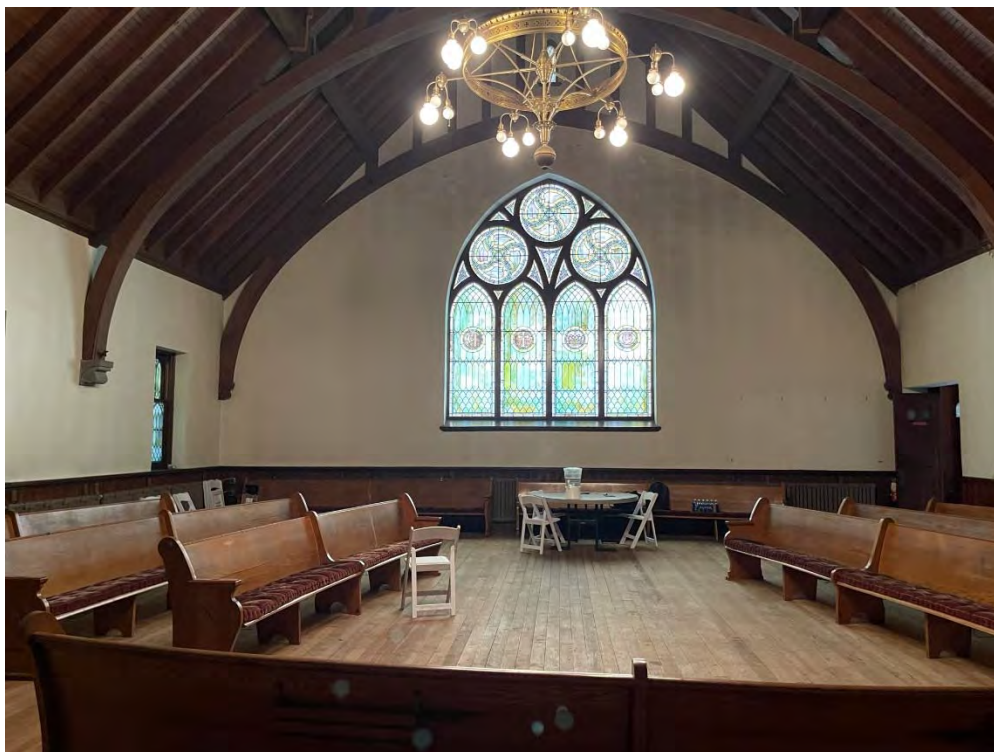
First Floor - Sanctuary Looking South

Finishes Generally in Good Condition with Some Areas of Plaster/Paint Damage from Previous Leaks

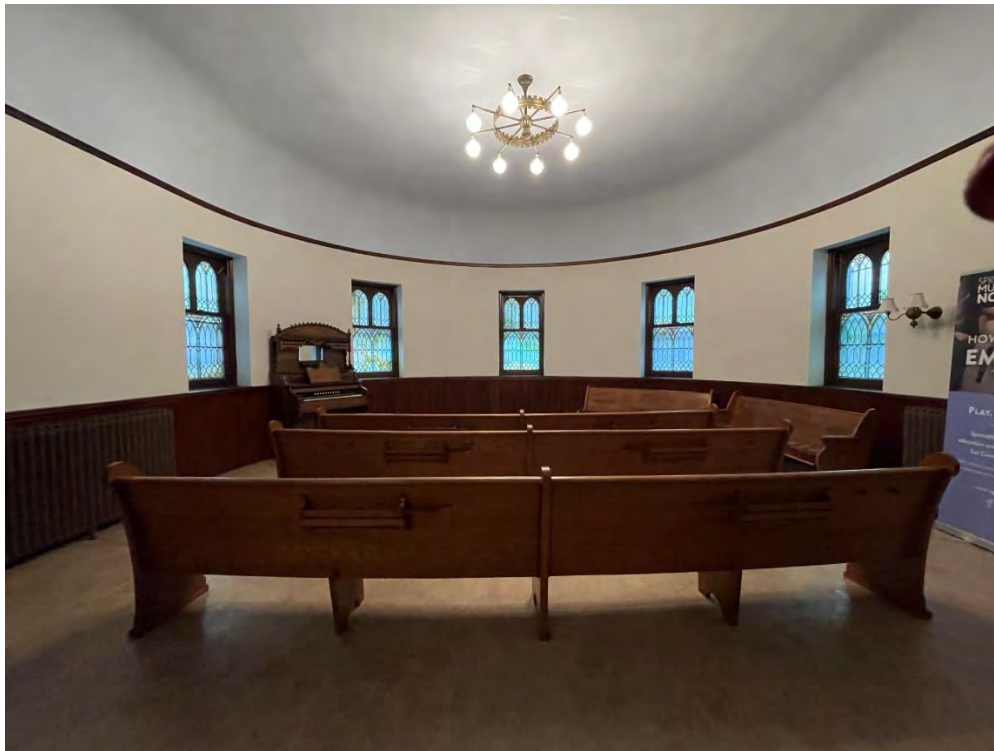
Granite Church – Existing Conditions – Interior Overall Views  
First Floor – South Meeting Room Looking East  
Finishes Generally in Good Condition

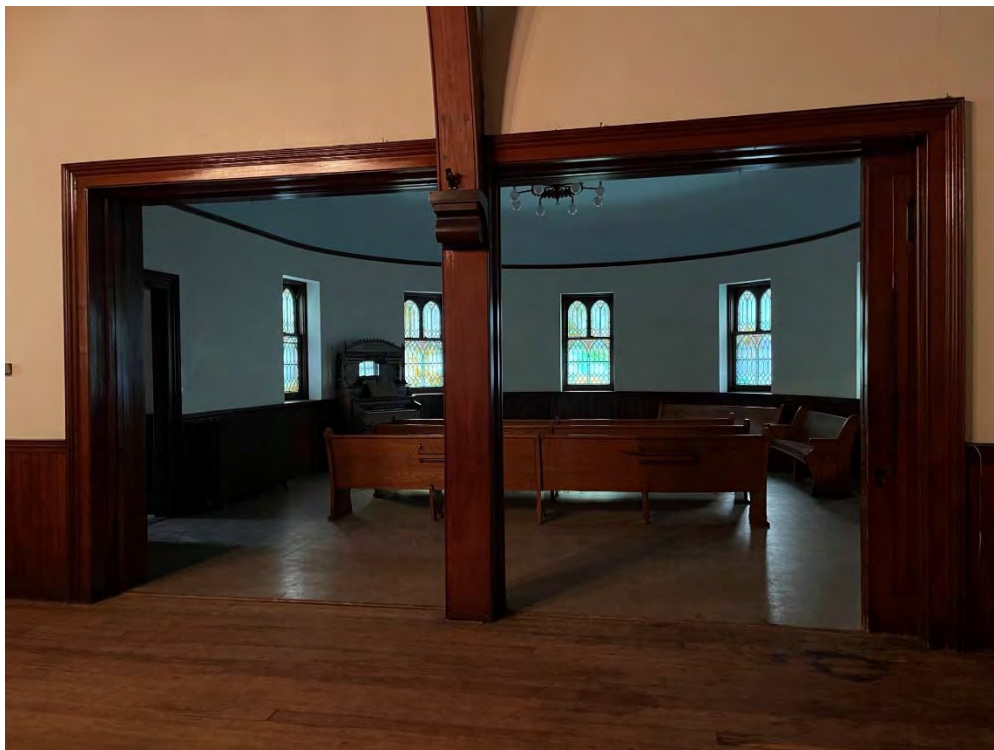
Granite Church – Existing Conditions – Interior Overall Views  
First Floor – South Meeting Room Looking West  
Finishes Generally in Good Condition

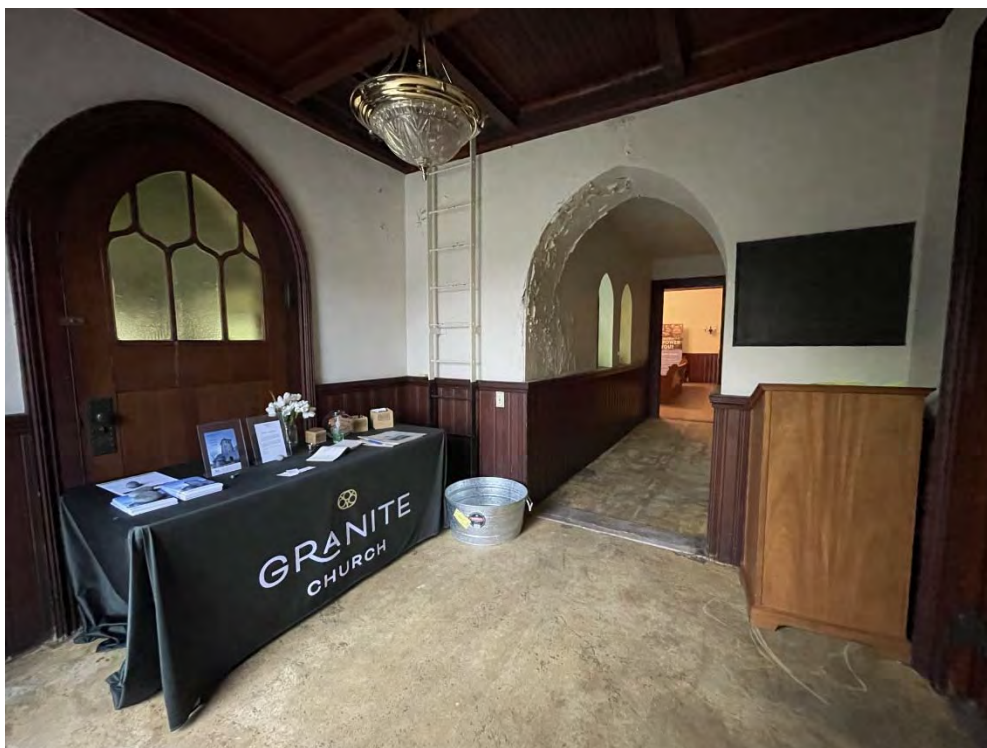
First Floor – Entrance Vestibule Looking Southeast

Finishes Generally in Good Condition with Areas of Plaster/Paint Damage from Previous Leaks

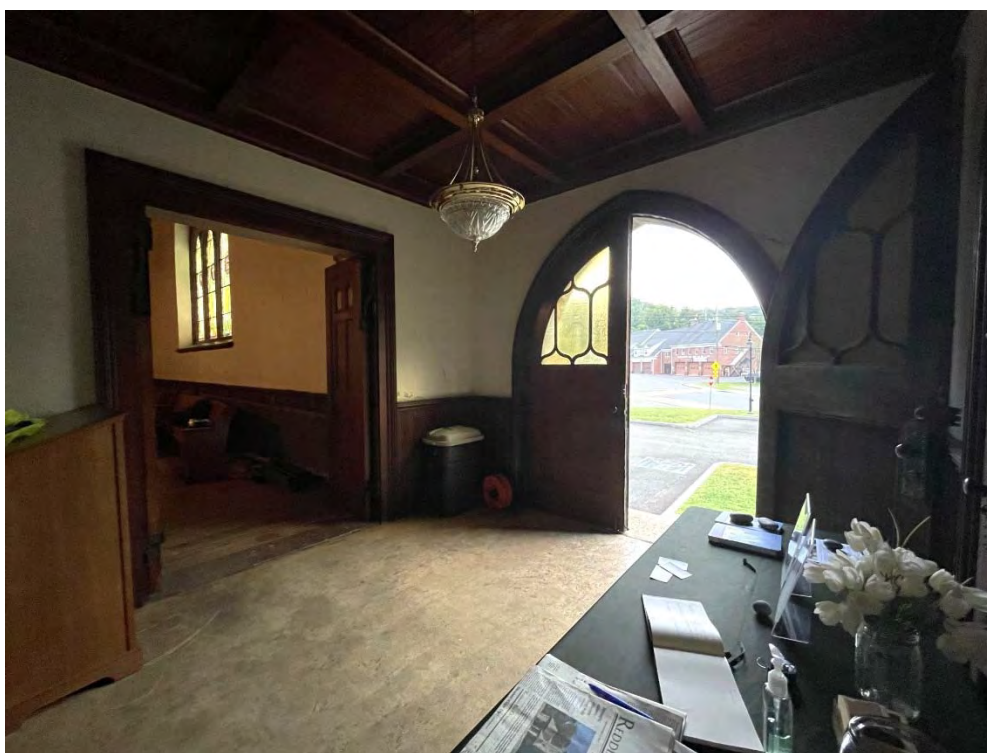
First Floor – Entrance Vestibule Looking Northwest

Finishes Generally in Good Condition with Areas of Plaster/Paint Damage from Previous Leaks

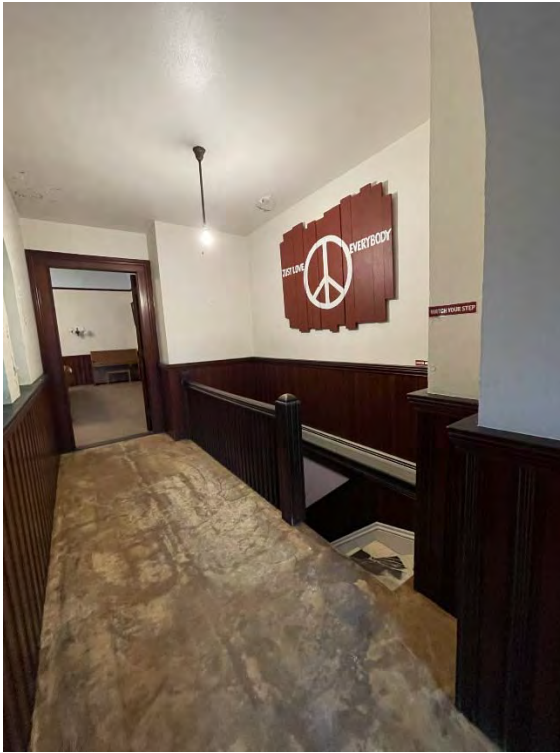
First Floor – Stair Hall Looking South

Finishes Generally in Good Condition with Areas of Plaster/Paint Damage from Previous Leaks; Floor Needs New Surfacing

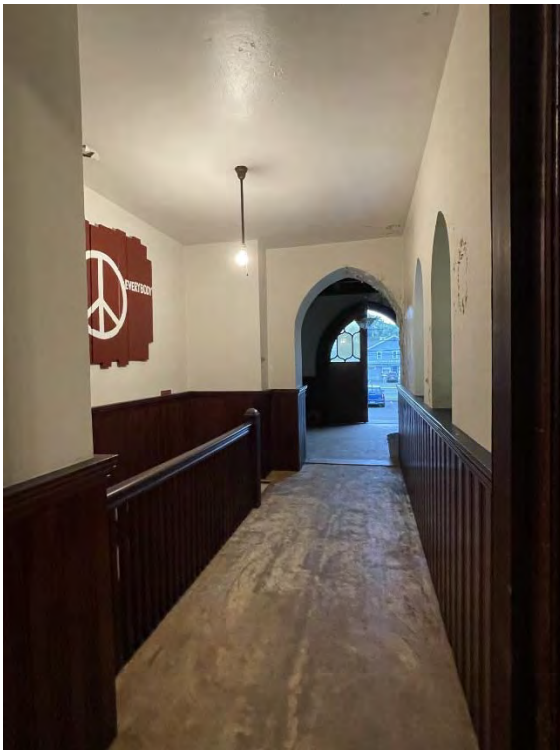
First Floor – Stair Hall Looking North

Finishes Generally in Good Condition with Areas of Plaster/Paint Damage from Previous Leaks; Floor Needs New Surfacing

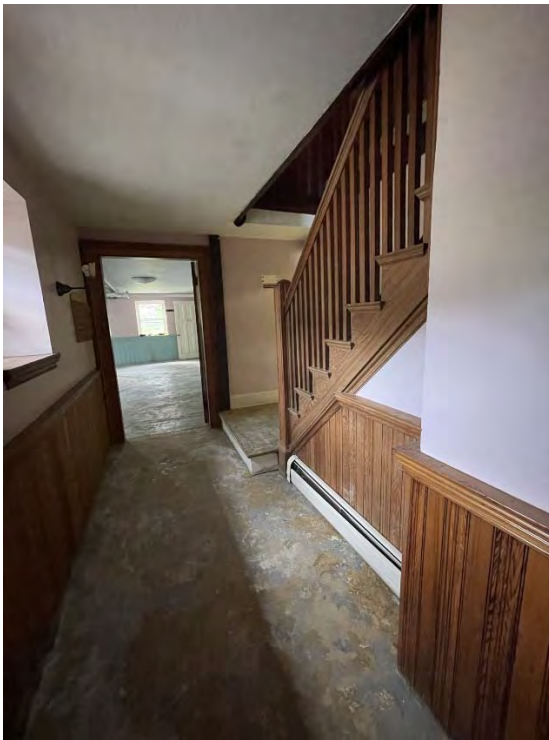
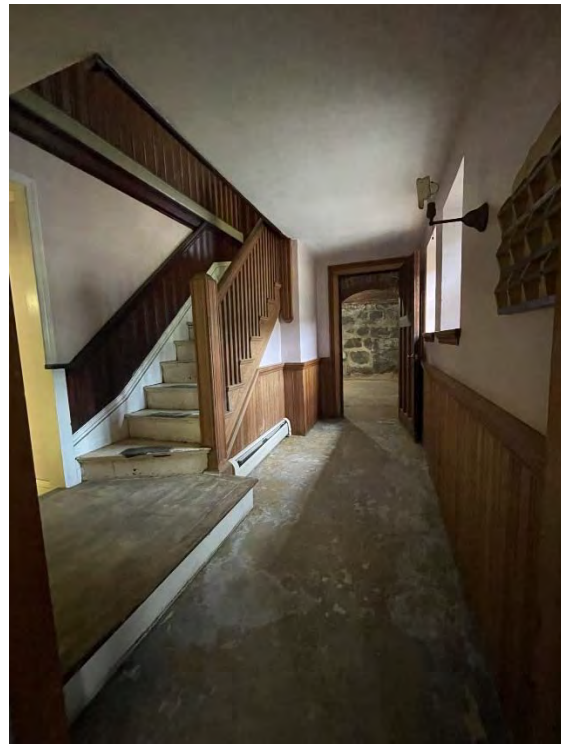
Granite Church – Existing Conditions – Interior Overall Views  
Basement – Stair Hall – Left: Looking South; Right: Looking North  
Finishes Generally in Good Condition; Floor Needs New Surfacing

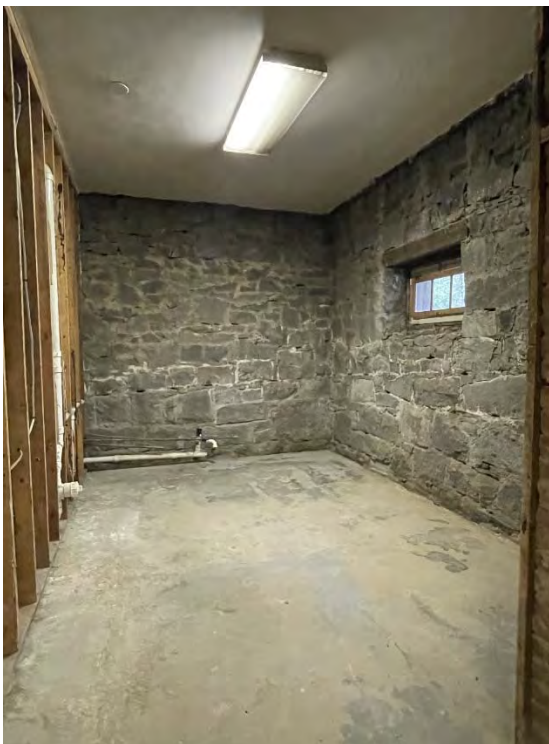
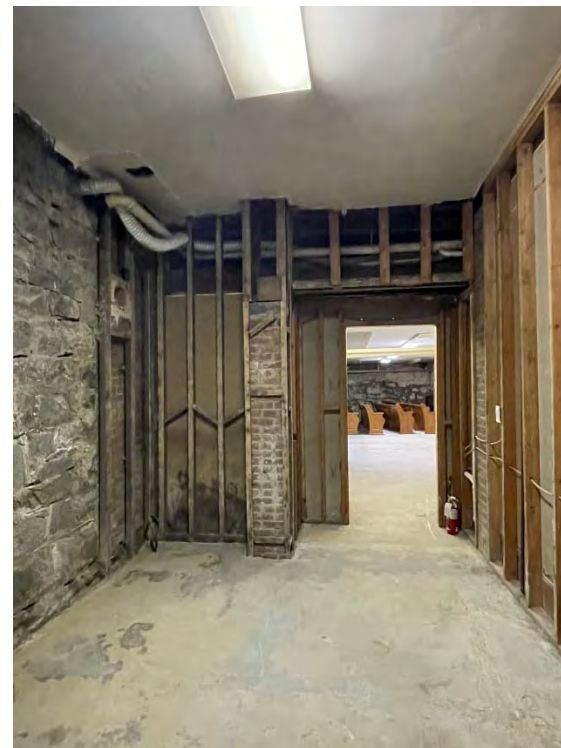
Granite Church – Existing Conditions – Interior Overall Views  
Basement – West Room Under Chancel – Left: Looking South; Right: Looking North  
Unfinished Walls, Floor and Ceiling

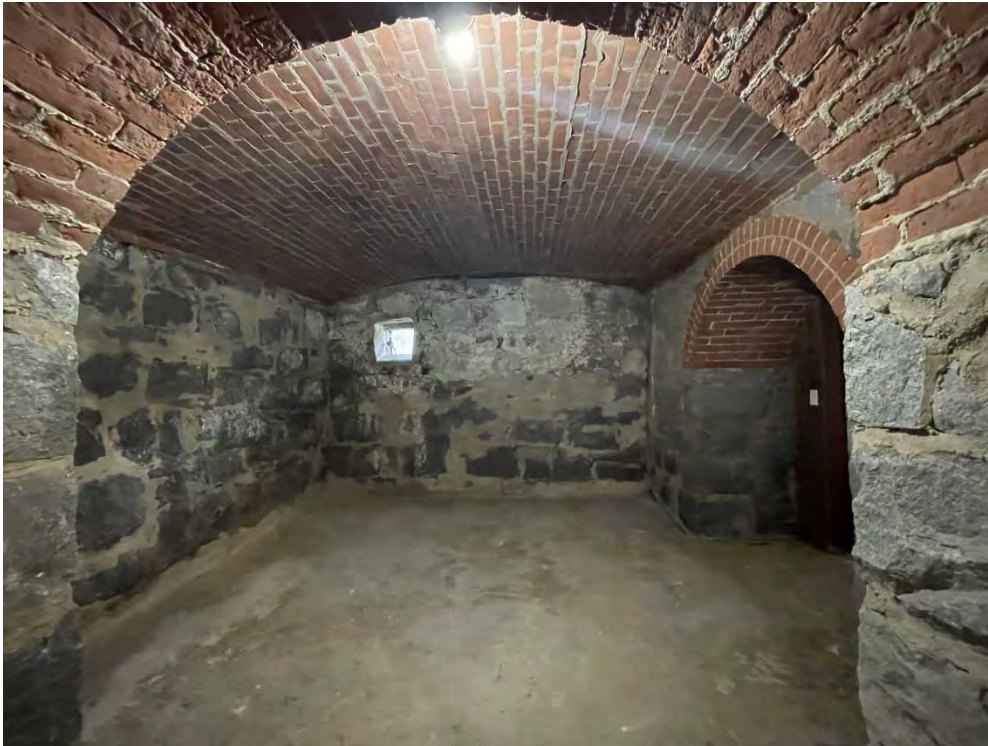
Granite Church – Existing Conditions – Interior Overall Views  
Basement – Vaulted Room Under Entrance Vestibule Looking East  
Unfinished Walls, Floor and Ceiling

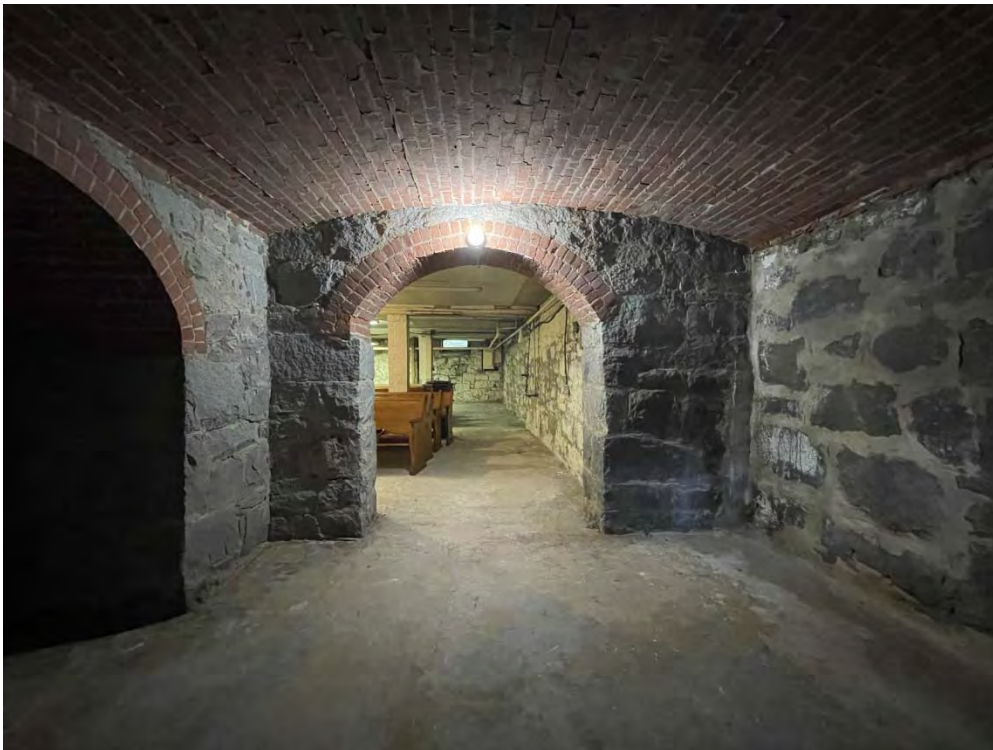
Granite Church – Existing Conditions – Interior Overall Views  
Basement – Vaulted Room Under Entrance Vestibule Looking West  
Unfinished Walls, Floor and Ceiling

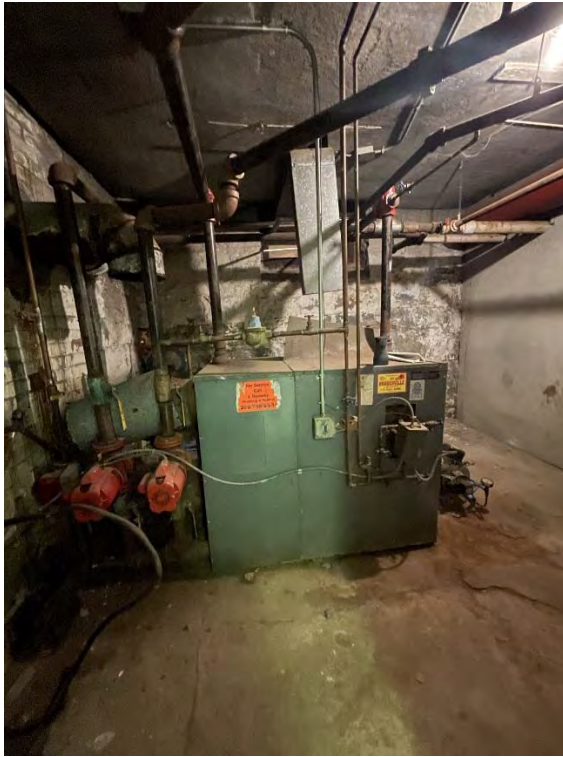
Granite Church – Existing Conditions – Interior Overall Views  
Basement – Boiler Room Under Sanctuary Looking West  
Unfinished Walls, Floor, and Ceiling

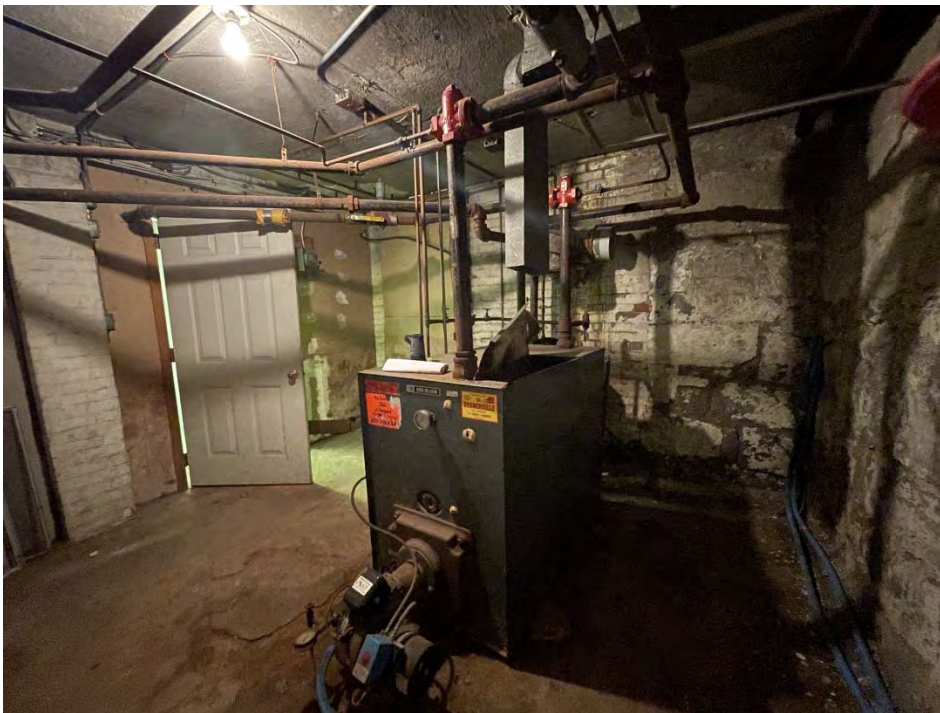
Granite Church – Existing Conditions – Interior Overall Views  
Basement – Boiler Room Under Sanctuary Looking Southeast  
Unfinished Walls, Floor, and Ceiling

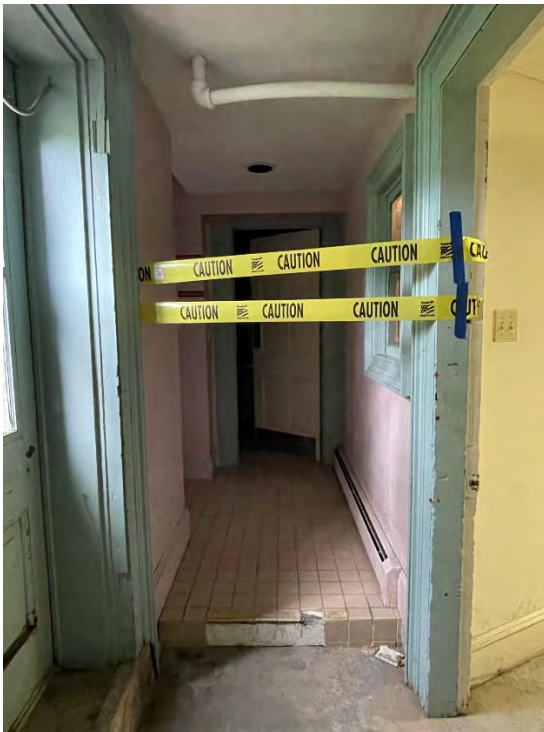
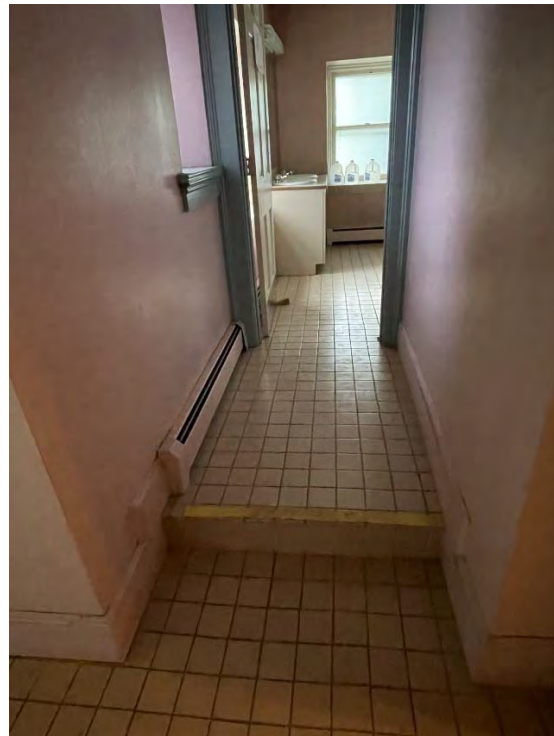
Granite Church – Existing Conditions – Interior Overall Views  
Basement – Access Hallway for Toilets  
Finishes in Fair Condition; Non-ADA Compliant

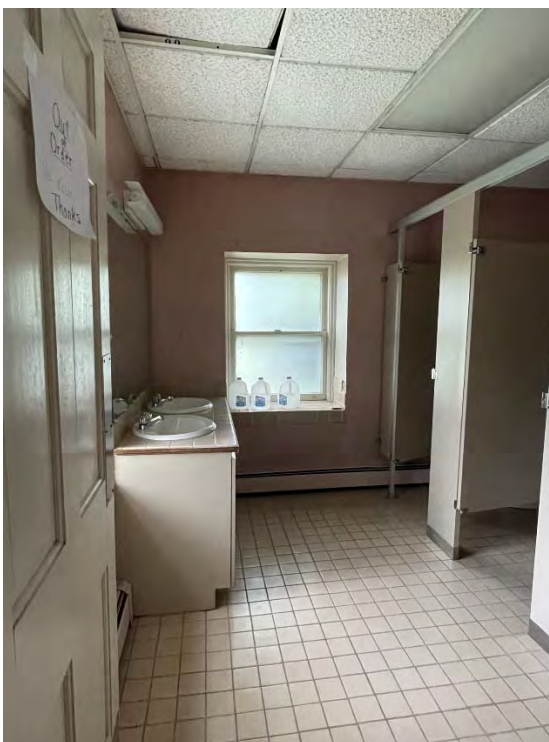
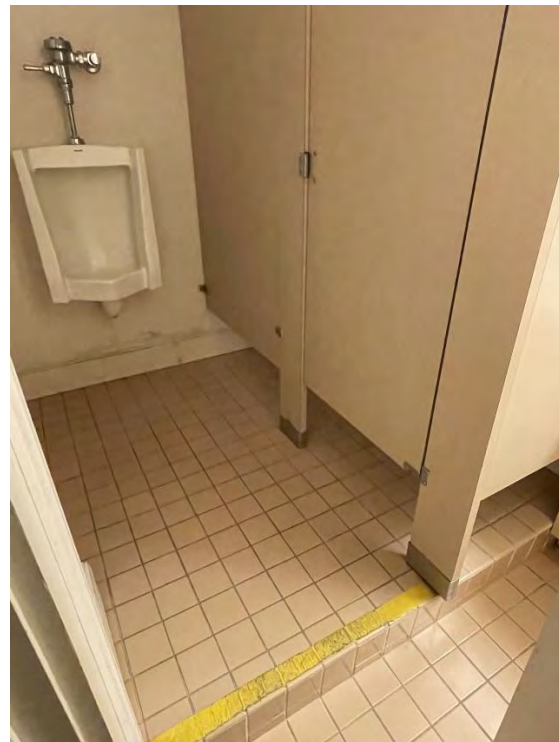
Granite Church – Existing Conditions – Interior Overall Views  
Basement – Toilets – Left: Women's Toilet; Right: Men's Toilet  
Finishes in Fair Condition; Non-ADA Compliant

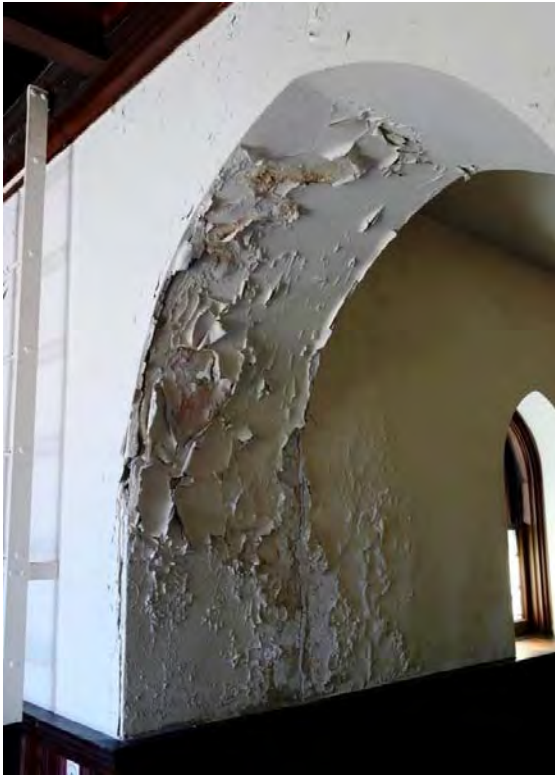
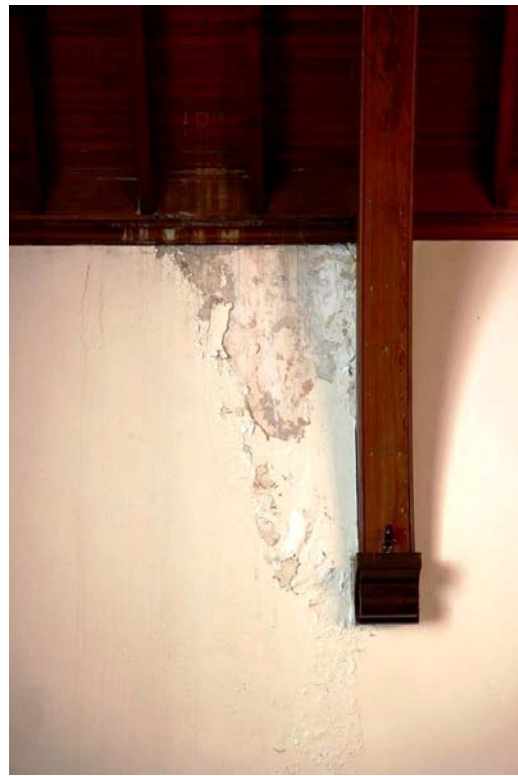
Granite Church – Existing Conditions – Interior  
Left: Arch in Vestibule; Right: South Wall of Sanctuary  
Damaged Plaster and Paint due to Previous Roof Leaks

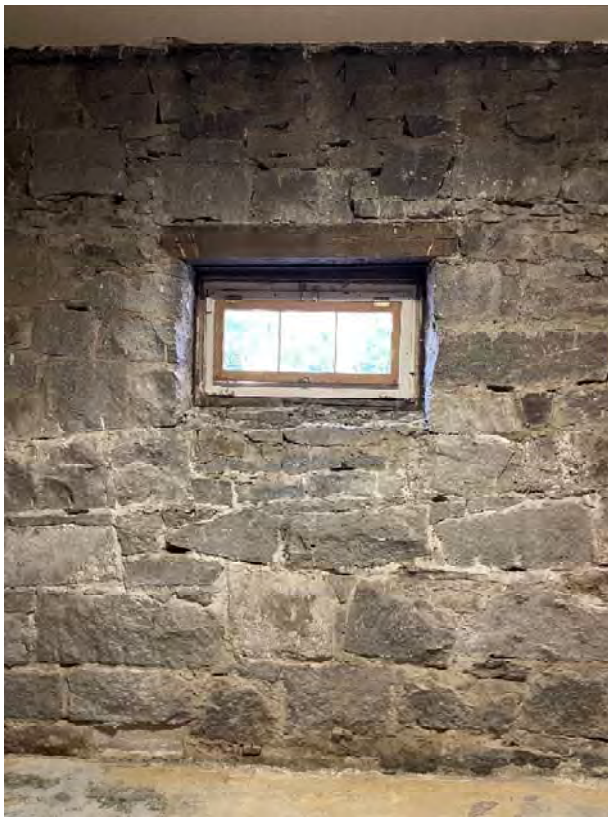
Granite Church – Existing Conditions – Interior  
Basement – West Room Under Chancel – West Wall  
Open Joints in Stonework

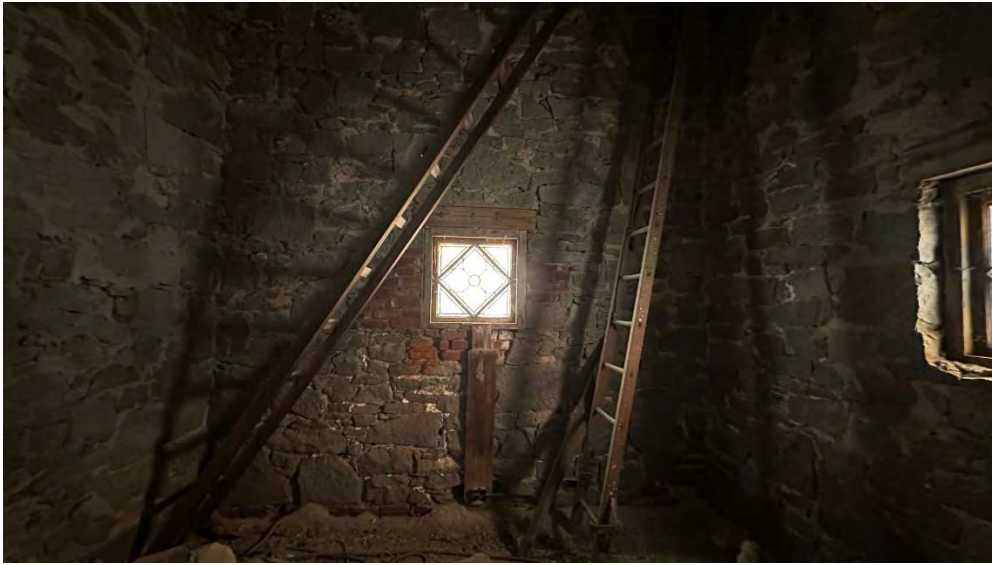
Granite Church – Existing Conditions  
Tower Interior  
Typical Conditions

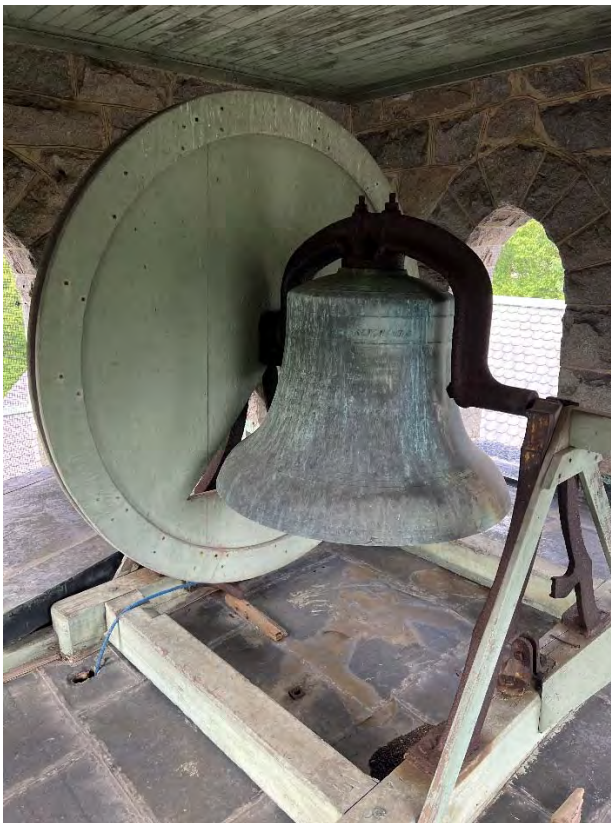
Granite Church – Existing Conditions  
Church Bell  
In Good Condition Overall

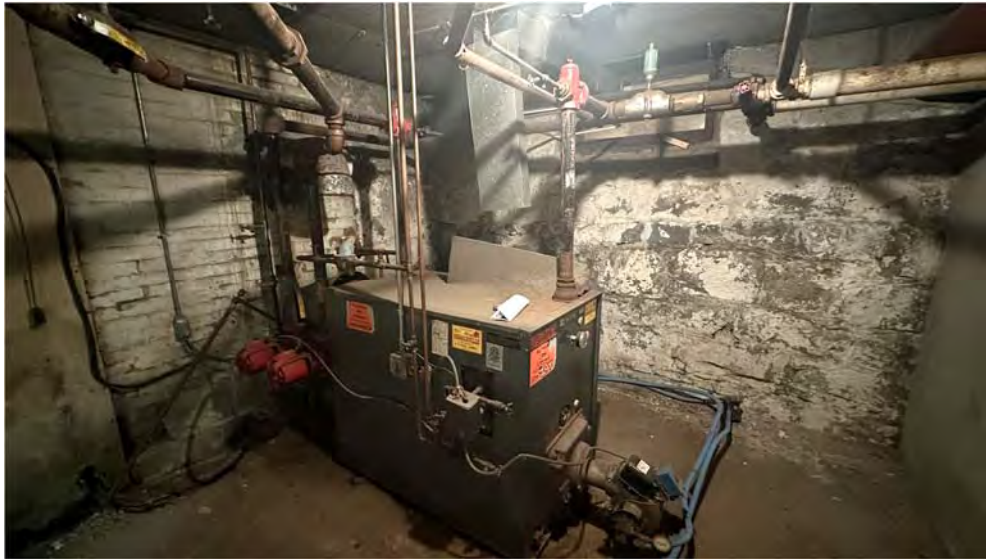
Granite Church – Existing Conditions – MEP  
Basement – Existing Gas Fired Boiler  
Boiler is Disconnected and Fuel Tanks Have Been Removed

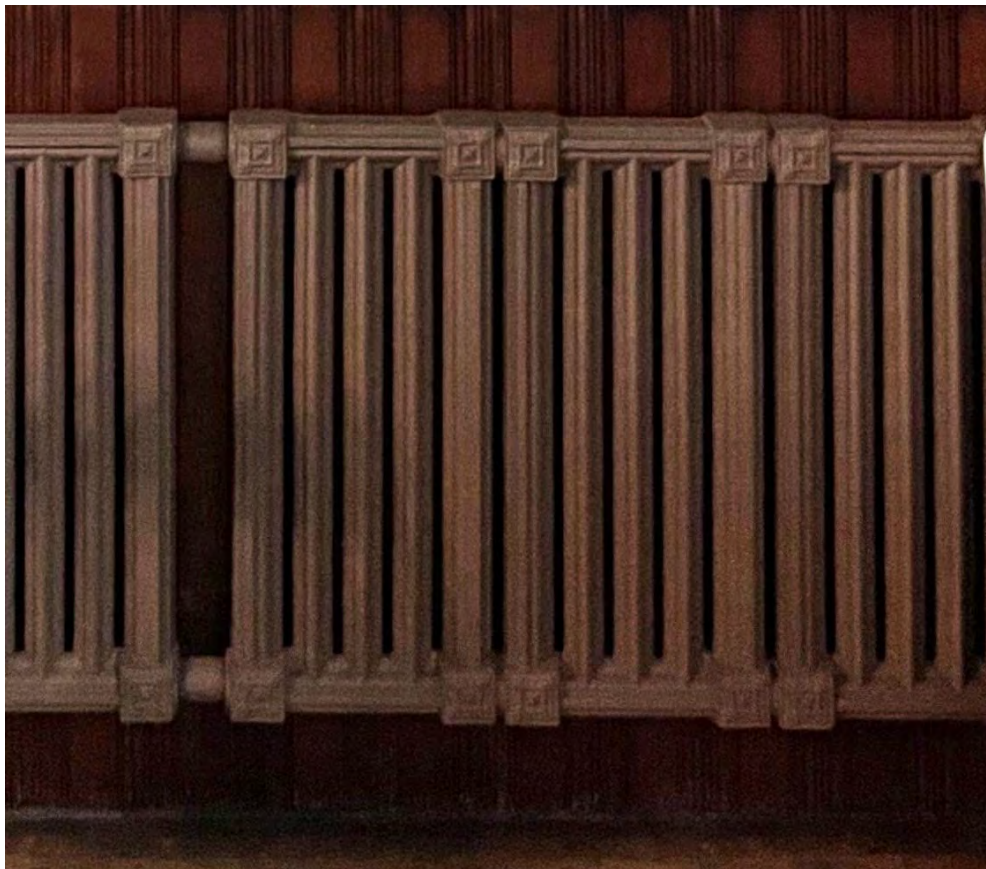
Granite Church – Existing Conditions – MEP  
First Floor – Sanctuary – Typical Existing Hot Water Radiator

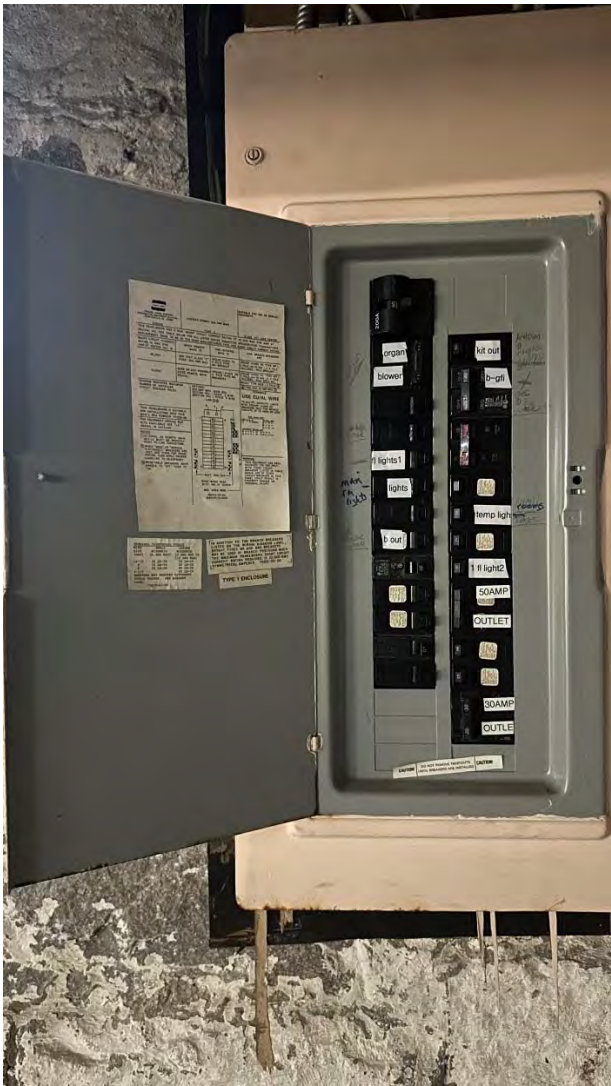
Granite Church – Existing Conditions – MEP  
Basement – Main Electrical Panel  
200 Amp, 1 Phase 3 Wire

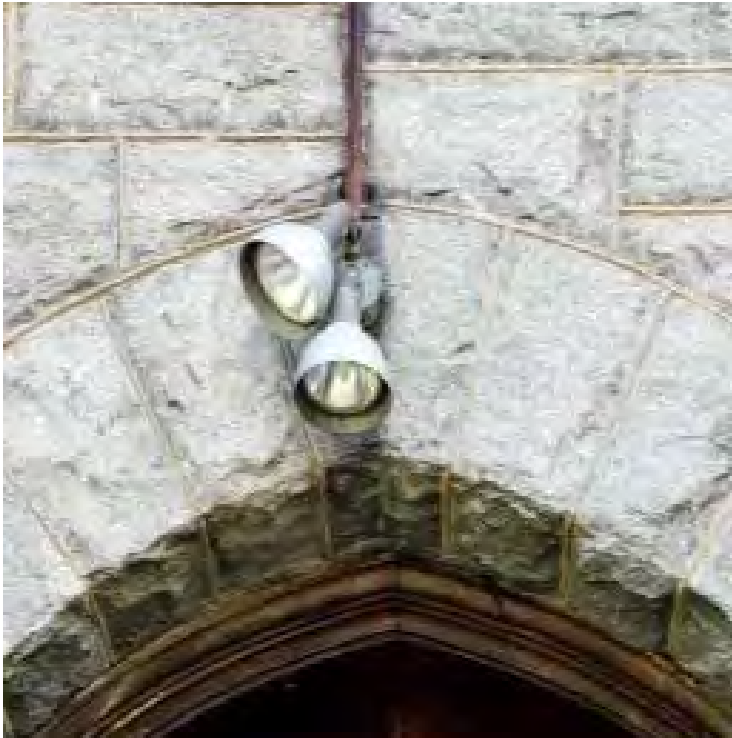
Granite Church – Existing Conditions – Lighting  
North Elevation – Light over Main Entrance  
Inappropriate Flood Lights

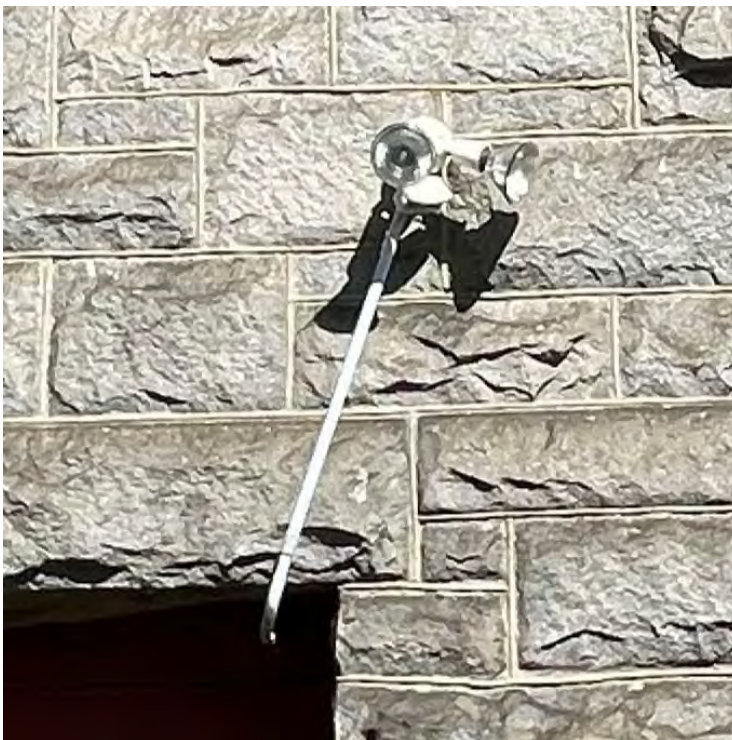
Granite Church – Existing Conditions – Lighting  
North Elevation – Light over Main Entrance  
Inappropriate Flood Lights

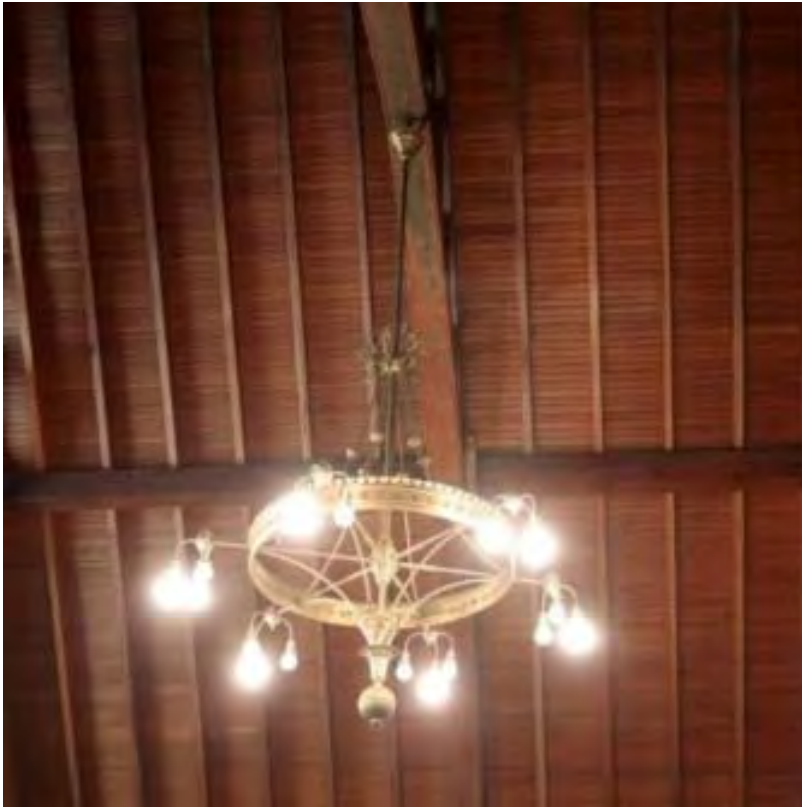
Granite Church – Existing Conditions – Lighting  
First Floor – Sanctuary - Chandelier  
Original - In Good Condition

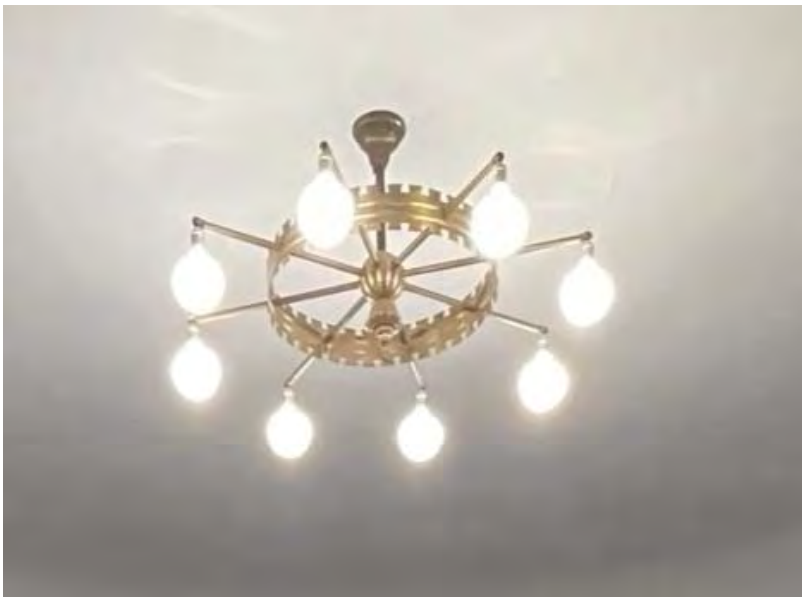
Granite Church – Existing Conditions – Lighting  
First Floor – East Meeting Room - Chandelier  
Original - In Good Condition

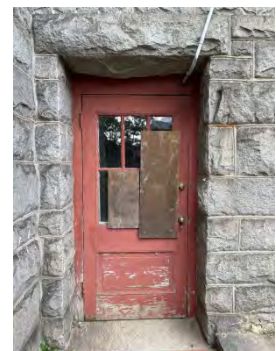
#### **DOOR BASEMENT**

Missing panes of glass, some damage and wear to wood at lower section.

Modern, replacement hardware.

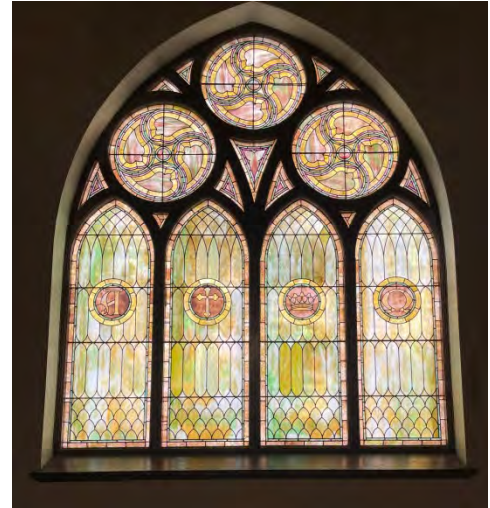
Some cracked and damaged panes of glass, settlement of window expressed at base by deflected, angled comes.

Acrylic sheeting panels on exterior are inappropriate and potentially damaging to stained glass window due to heat build up.

Wood framing on exterior exhibits extreme paint failure

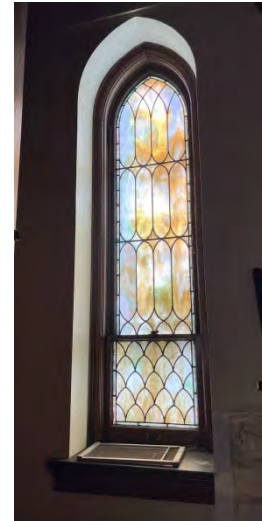
Some cracked and damaged glass, some settlement of window expressed at base by deflected, angled comes – West-most window on South being most pronounced.

Acrylic sheeting panels on exterior are inappropriate and potentially damaging to stained glass windows due to heat build up.

Wood framing on exterior exhibits extreme paint failure

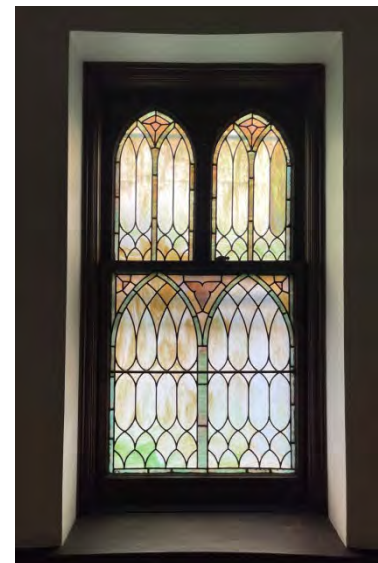
Exedra/Chapel (semi-circular room on east)

Two windows have a broken sash cord.

All existing storm windows, are in good condition and operable, but visually incompatible and inappropriate.

Wood framing on exterior exhibits extreme paint failure.

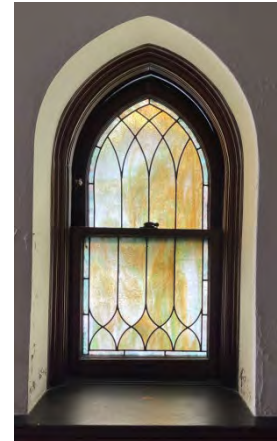
Stair Hall – First Floor

Some cracked and damaged glass, some settlement of window expressed at base by deflected, angled comes.

Both windows have one broken sash cord each.

Acrylic sheeting panels on exterior are inappropriate and potentially damaging to stained glass windows due to heat build up.

Wood framing on exterior exhibits extreme paint failure.

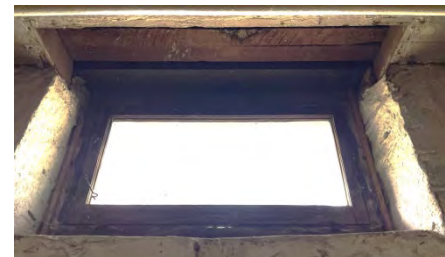
Common Space and Boiler Room

Windows are in poor condition. Boiler Room window has been altered to facilitate furnace ducting (now terminated) and is covered with plywood.

Wood framing on exterior exhibits extreme paint failure

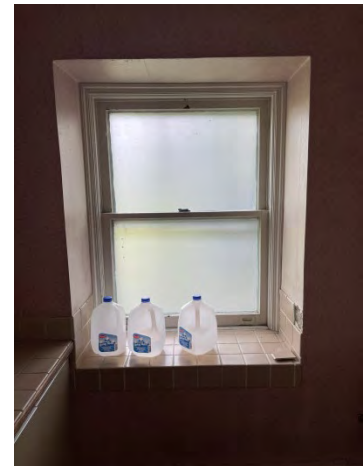
East window is in fair condition, glass in lower sash is cracked, one sash cord is broken. South window is in good condition.

Wood framing on exterior exhibits extreme paint failure.

Existing storm windows are in good condition and operable, but visually incompatible and inappropriate.

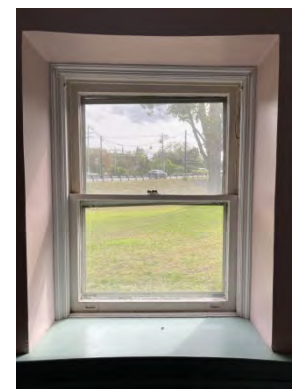
Exedra/Classroom (semi-circular room on south)

Windows in fair condition. Due East window has broken glass in lower sash. Due South and due North windows have deteriorated wood elements.

Five of six windows have a broken sash cord each.

All existing storm windows, except one (storm window facing due South is damaged), are in good condition and operable, but visually incompatible and inappropriate.

Wood framing on exterior exhibits extreme paint failure and is damaged and missing material on due South widow.

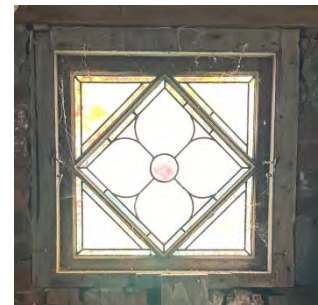
Windows is in good condition.

Wood framing on exterior exhibits extreme paint failure.

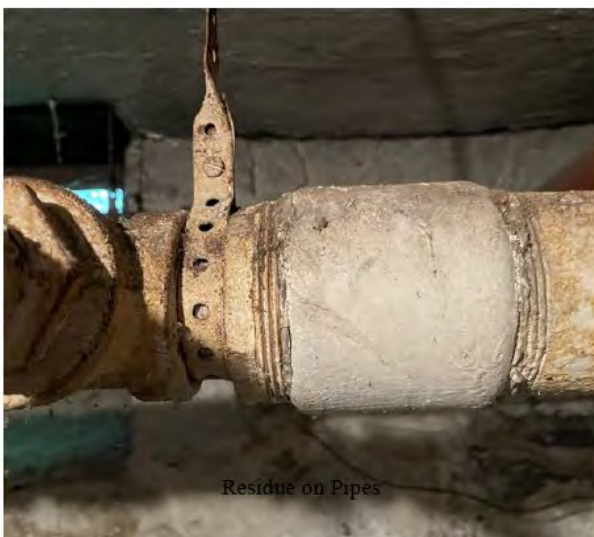
Residue on Pipes

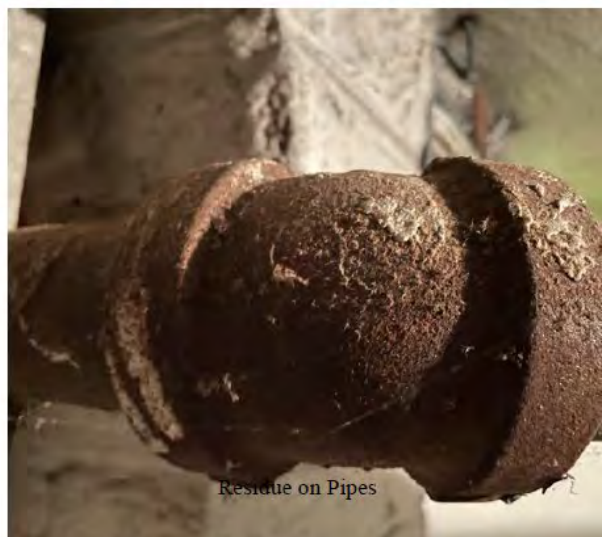
Residue on Pipes

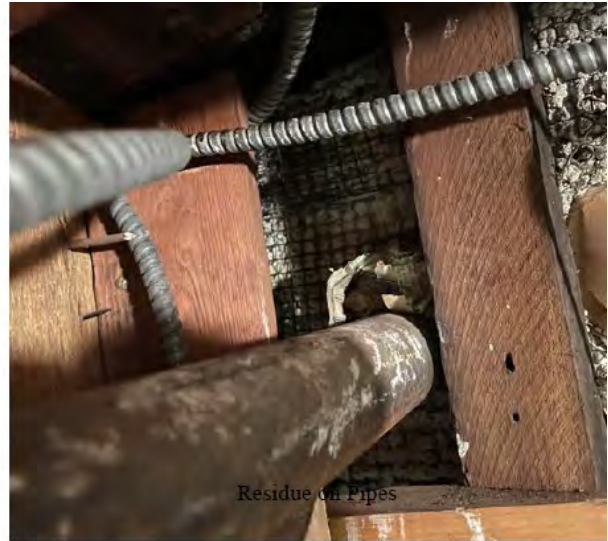
Residue on Pipes

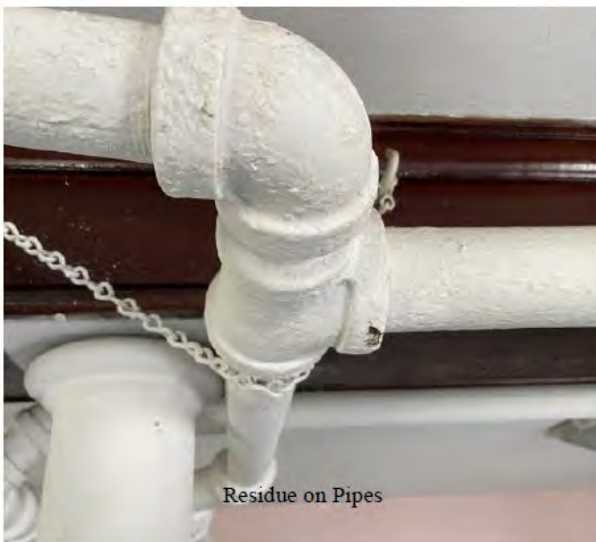
Residue on Pipes
